THE TECHNICIANS NOTEBOOK

By Jerry Gordon

The Technician's Notebook Table of Contents

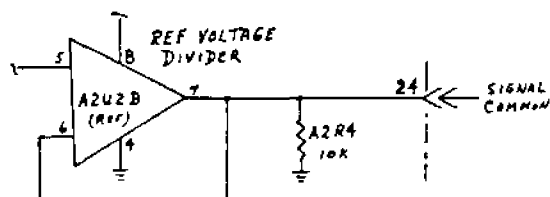
AV80-34 Power circuit improvements. Tech Aid No. 108 Installation of 10k resistor (PN 003410103) A2R4. If A2U2 is replaced on any CA-395A, A2R4 should be installed if it is not. Verify that capacitor A2C6 has been deleted as per Tech Aid No. 74. If not remove and discard. Install A2R4 as per drawing.

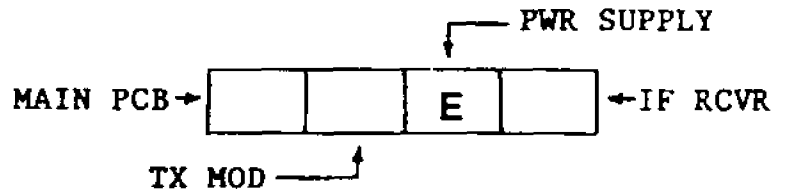
DME-890-1 A new power supply was developed and implemented commencing with power supply level E as shown below. This is not a mandatory mod but is recommended if replacement of the DME-890 power supply is necessary. A power supply kit is available under Narco part number: 03314-0505. Some modification on the main board is necessary.

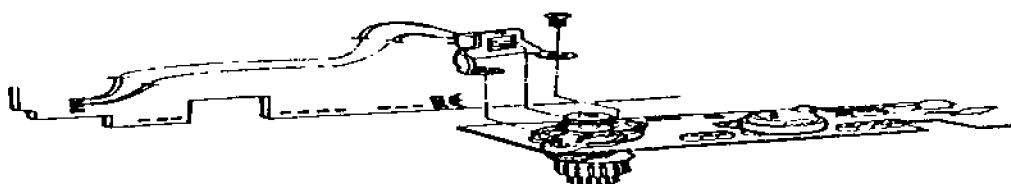
KR87-103 Change of S506 to a new style switch. (Applicable to SN 12112 and above.) The old style switch was mounted on the main board and would break when excessive pressure was applied to the selector knob. The new style switch is removed from the board and mounted on a bracket. This bracket and switch assembly is

available under KPN 250-00087-0000. If the old style switch breaks, replace it with this kit. Bus wire and teflon tubing for this is available under KPN 050-01783-0000. See following drawing.

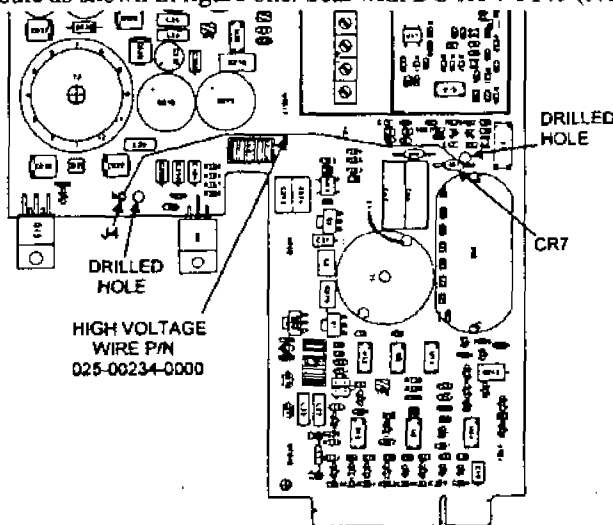
Figure 1
KT 76C Main Board
300-09093-0020 Rev 3

KT 76C-4 Applicable to P/N 066-01156-0101 S/N 6599 and below. Consists of bypassing a circuit trace with a jumper to prevent the 1300 volt line from shorting internally. Most units S/N 3181 to 6599 will have the jumper, but will not indicate that mod 4 was done. Two holes will have to be drilled in the main board to isolate the 1300 volt circuit trace. Then you use high voltage wire to jumper around the isolated trace. If there is a jumper between J4 and CR7, mark the unit as having mod 4 done. If not, drill a .12 inch hole in the circuit board at the two places indicated in figure two. Reconnect CR7 and J4 with high voltage wire (P/N 025-00234-0000). Route as shown in figure one. Seal with DC RTV 3145 (P/N 0116-01082-0000)

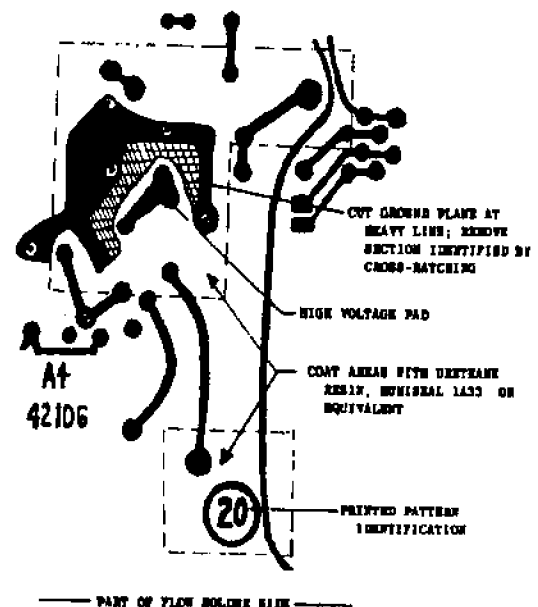
INSTRUCTIONS FOR ADDING COOLING AIR INLET HOLES

2. In current production transponders, the printed wiring pattern under A4T1 has been changed to eliminate the possibility of high voltage arcing. Units with this change are identified as "MOD 5" for RT-359A's and RT-459A's.

3. To modify a pattern "19" or "20" A4 assembly, proceed as follows:

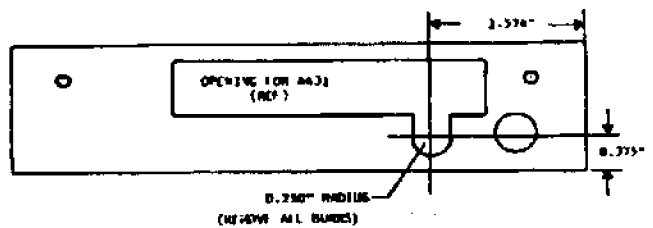
Figure 1. Transponder End Plate, Location for Cooling Air Input Opening

AV82-8 Tech Aid #151 Transponder modification to accept cooling air input. (Applicable to all 300 series Transponders Installed in Cessna MY '79 and earlier.
