Lycoming owners to be hit with a very nasty AD

FAA is expected to mandate compliance with Lycoming Mandatory Service Bulletin SB 632A

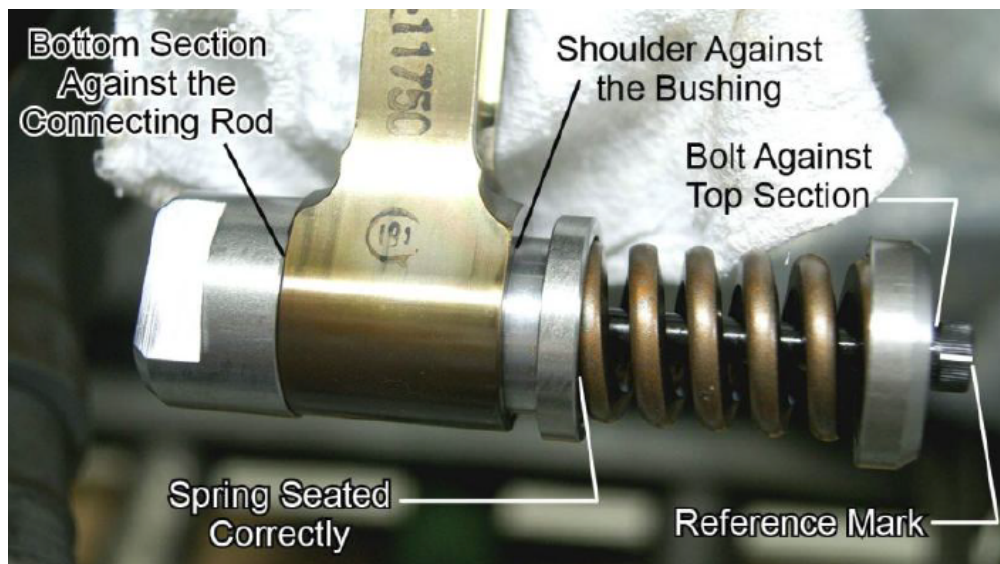
SB 632A requires that all engines that might possibly contain these non-conforming bushings have all their cylinders removed within the next 10 hours. With the cylinders removed, the securing of all small-end connecting rod bushings then must be tested using a special tool (ST-531 Connecting Rod Bushing Press-Out Verification Tool) to apply a calibrated force to the each bushing to see if it can be displaced. If the bushing moves during this press-out test, then the connecting rod assembly must be removed from the engine and sent to Lycoming, and a new connecting rod assembly with a known-good bushing must be installed. Lycoming estimates that the press-out test will have approximately a 20% flunk rate, which means that one in every five connecting rods may need to be replaced.

This is a horrifying prospect. The requirement to remove all cylinders within 10 hours is bad enough; there is a long history of catastrophic engine failure after removal and replacement of all cylinders in the field. But the prospect of having 20% of the connecting rods removed and replaced in

the field represents a far greater risk, because the majority of mechanics have never before performed this operation (notably tightening rod bolts to a specified stretch using a special micrometer). The rod bolts are the most highly-stressed component in the entire engine, and tightening them properly is ultra-critical. In my opinion and the opinion of every highly experienced A&P/IA I've spoken with, this is NOT work that should be attempted by line mechanics in the field working on engines mounted in airplanes. It really should be done only by an experienced technician in an engine shop with the engine mounted on a stand with unencumbered access.
