AIRCRAFT ACCIDENT REPORT 6/94

Air Accidents Investigation Branch

**Report on the accident to
Piper PA-31-325 C/R Navajo, G-BMGH
4 nm south east of King's Lynn, Norfolk
on 7 June 1993**

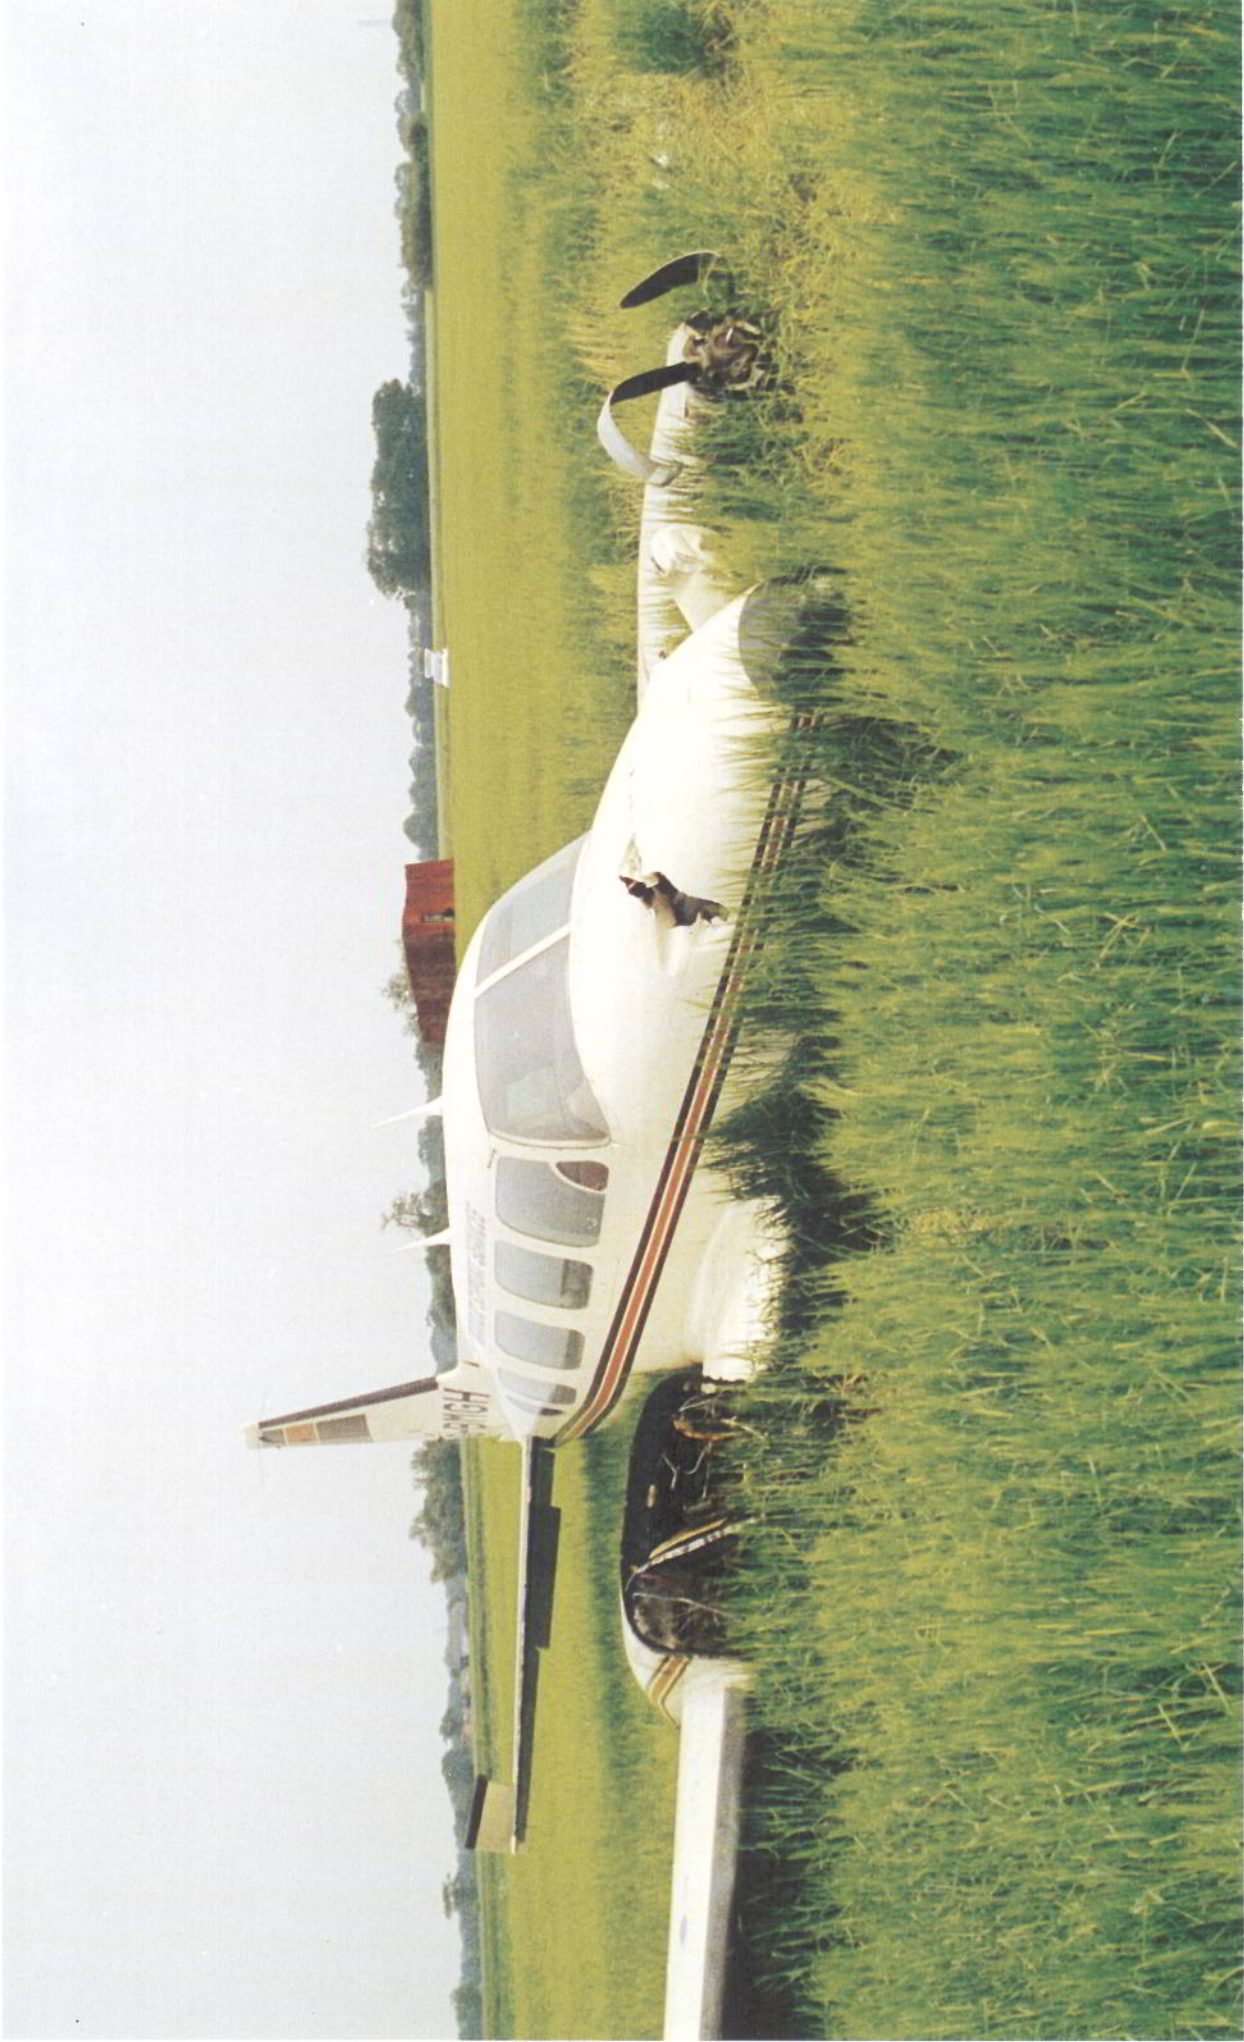
Photograph showing G-BMGH on site
