National Transportation Safety Board Aviation Accident Preliminary Report

Location:	Daytona Beach, FL	Accident Number:	ERA18FA120
Date & Time:	04/04/2018, 0953 EDT	Registration:	N106ER
Aircraft:	PIPER PA28R	Injuries:	2 Fatal
Flight Conducted Under:	Part 91: General Aviation - Instructional

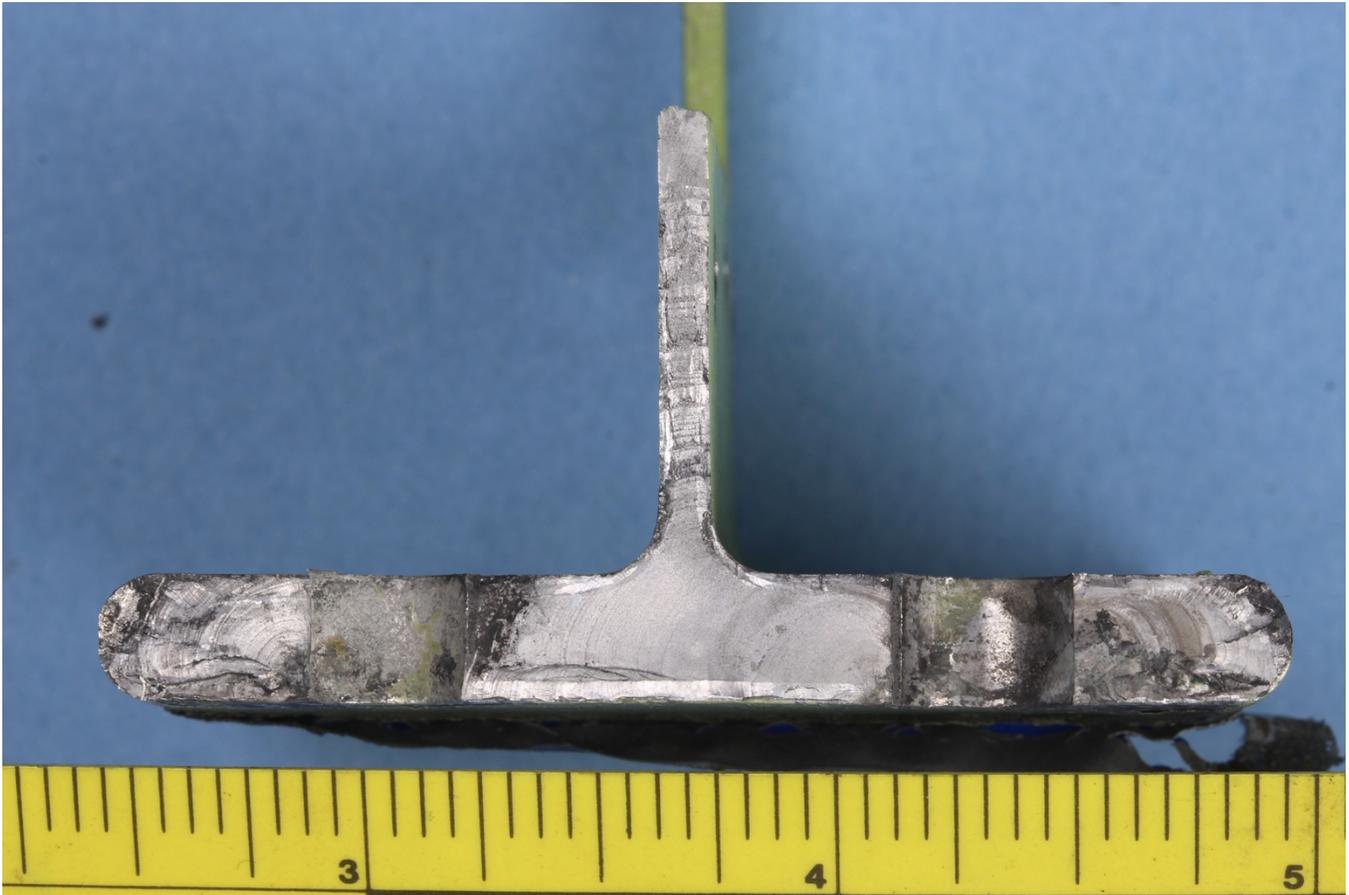
examination. Preliminary examination of the left wing main spar revealed that more than 80% of the lower spar cap and portions of the forward and aft spar web doublers exhibited fracture features consistent with metal fatigue (see figure 1).

Figure 1 - Left wing main spar lower cap fracture surface.

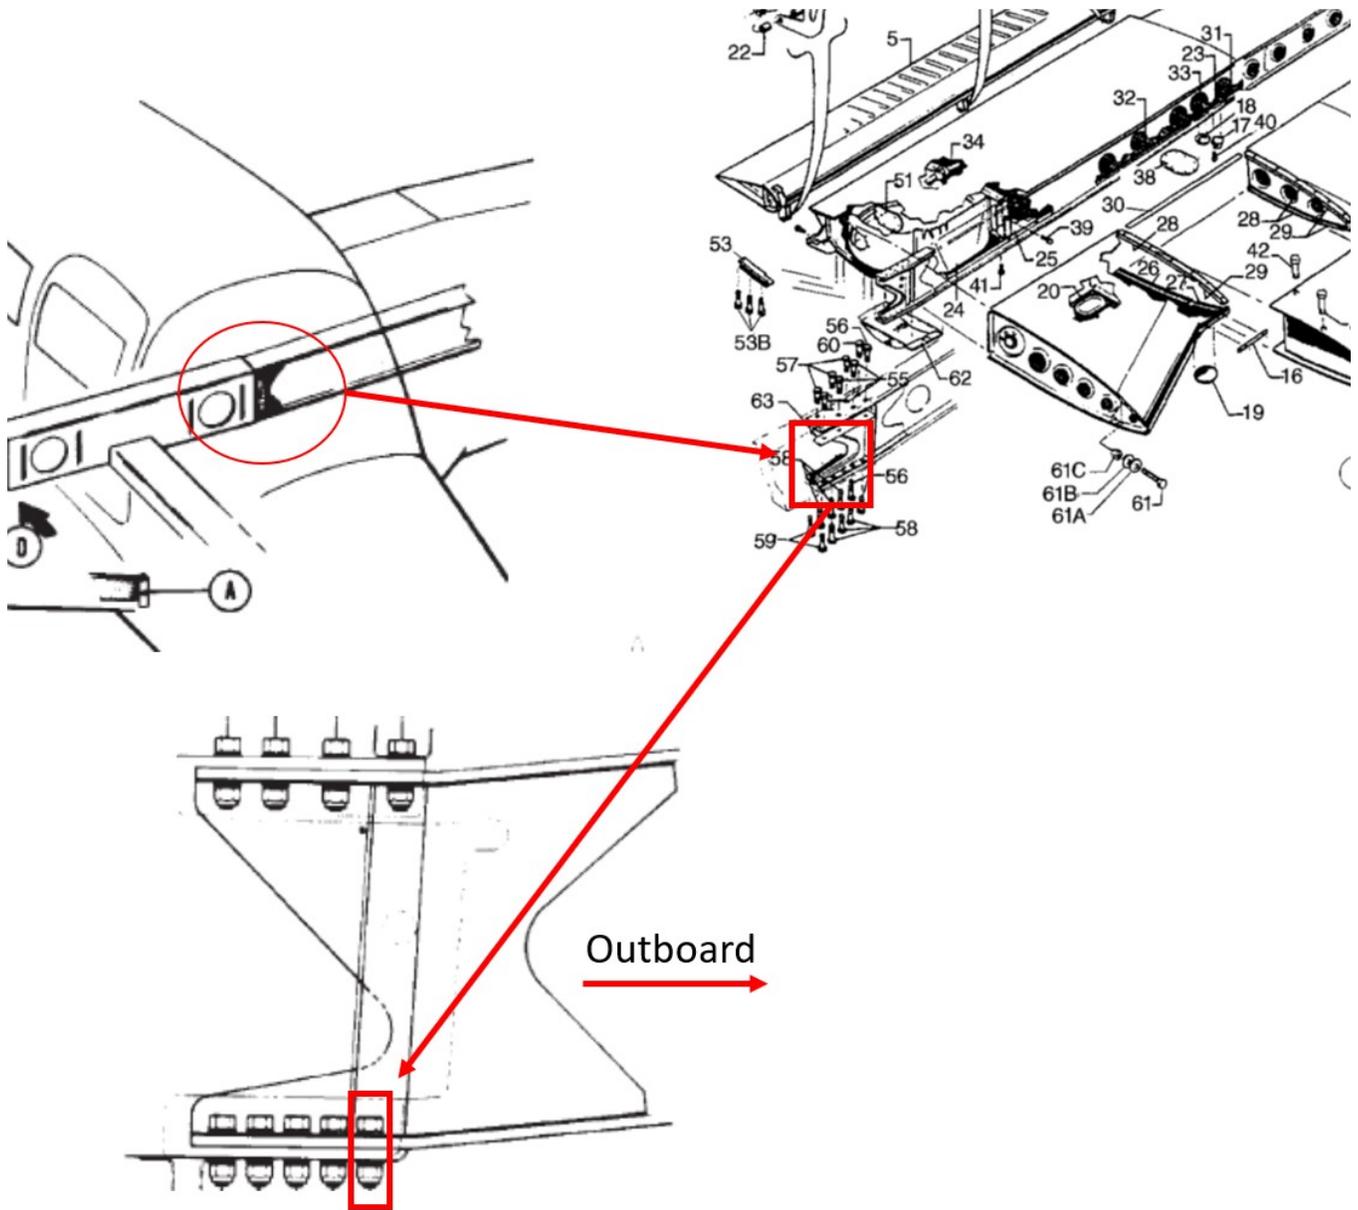
The remainder of the lower spar cap, spar web doublers, and upper spar cap displayed fracture features consistent with overstress fracture. The fatigue features originated at or near the outboard forward wing spar attachment bolt hole (see figure 2). None of the surfaces exhibited visible evidence of corrosion or other preexisting damage. The right wing also exhibited fatigue cracks in the lower spar cap at the same hole location extending up to 0.047-inch deep.

Figure 2 – Exploded view of left wing spar assembly and attachment bolts.
