MOTORSERVICE
RHEINMETALL AUTOMOTIVE

Piston damage – recognising and rectifying

SERVICE
TIPS & INFOS

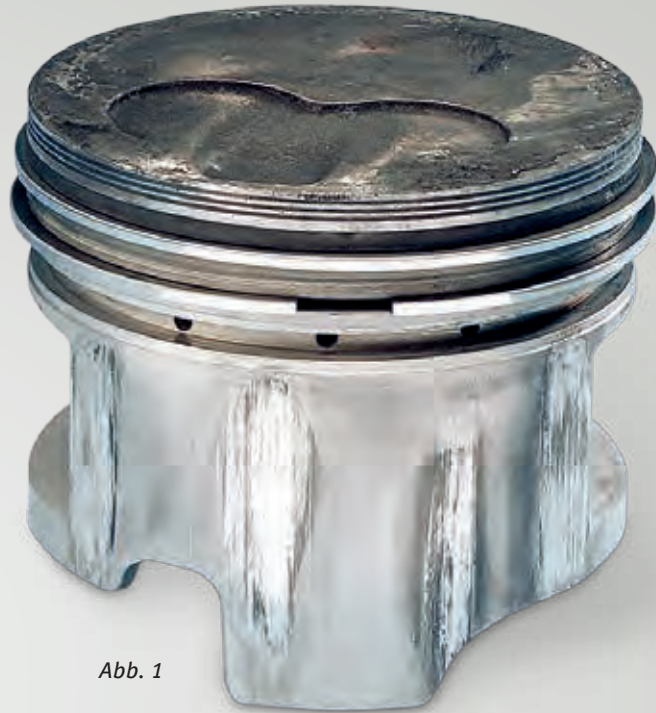
Abb. 1

- Several similar areas of seizure marks around the piston skirt.
- Seizure marks on both the pressure and anti-thrust sides of the piston skirt, i.e. seizure marks on opposite sides.
- Surface changes from bright wear marks to smooth, darkly discoloured areas of wear caused by rubbing.
- Undamaged ring zone.

- Cylinder bore too small.
- Cylinder head over-tightened or tightened unevenly (cylinder distortion).
- Uneven mating surfaces on the cylinder block or cylinder head.
- Dirty or damaged threaded bores or cylinder head bolts.
- Seized or insufficiently lubricated seating surfaces.
- Use of incorrect or unsuitable cylinder head gaskets.
- Cylinder distortion caused by uneven heating due to lime deposits, dirt or other malfunctions in the cooling system.

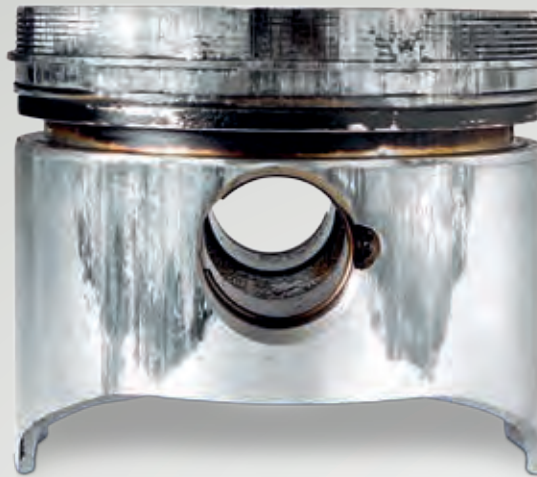
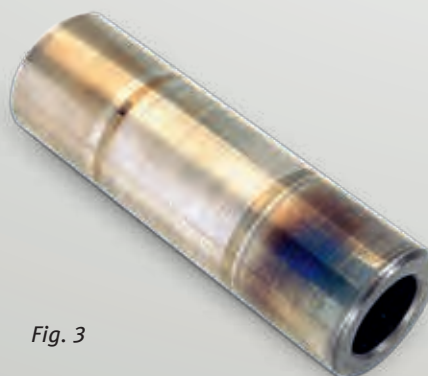
Fig. 1

- Seizure marks on both the pressure and anti-thrust sides, offset at approximately 45° to the piston pin axis.
- The seizures areas change from bright wear marks to relatively smooth, darkly discoloured areas of wear caused by rubbing (Fig. 1).
- Piston pin displays blue tempering colour (Fig. 3). Reason: piston pin bed has become hot due to insufficient clearance or a lack of oil.

- Mechanical overload of the connecting rod bearing, e.g. due to abnormal combustion.
- Malfunction/fracture in the oil injection jet.
- Insufficient or no oil pump pressure.
- Insufficient lubrication when the engine was first taken into operation. The piston pin was not or was insufficiently lubricated when it was assembled.
- Failure of the connecting rod bush (piston pin seizure) due to insufficient clearance or lubrication.

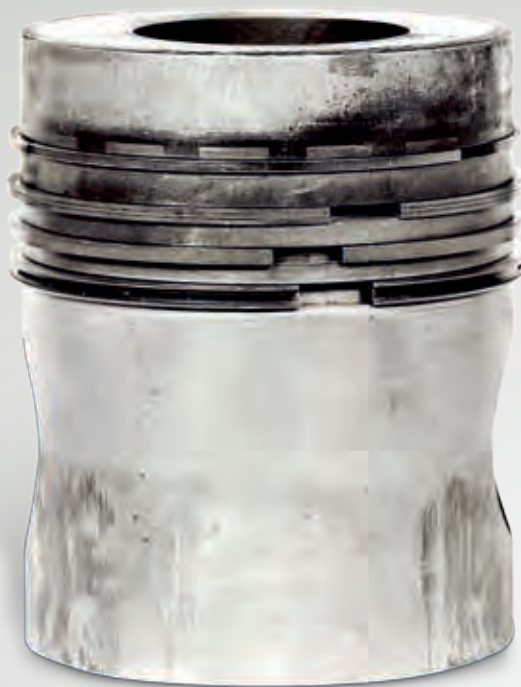
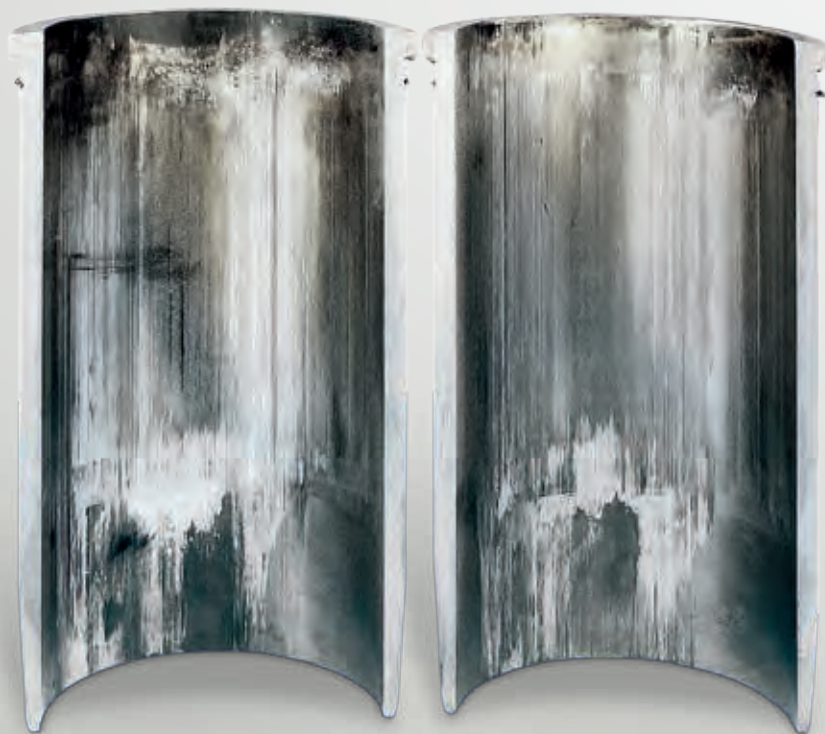
Fig. 1

- Seizure due to insufficient clearance at the bottom skirt ends, with wear marks and counter-wear marks.
- The marks change from bright wear marks to smooth, darkly discoloured areas of wear caused by rubbing (Fig. 1).
- There is nothing unusual about any of the remaining parts of the piston.
- Seizure marks in the cylinder liner in the area around the lower O-rings (Fig. 2).

The piston seizure at the bottom edge of the piston skirt was caused by distortion/restricted clearances in the lower area of the cylinder liner.

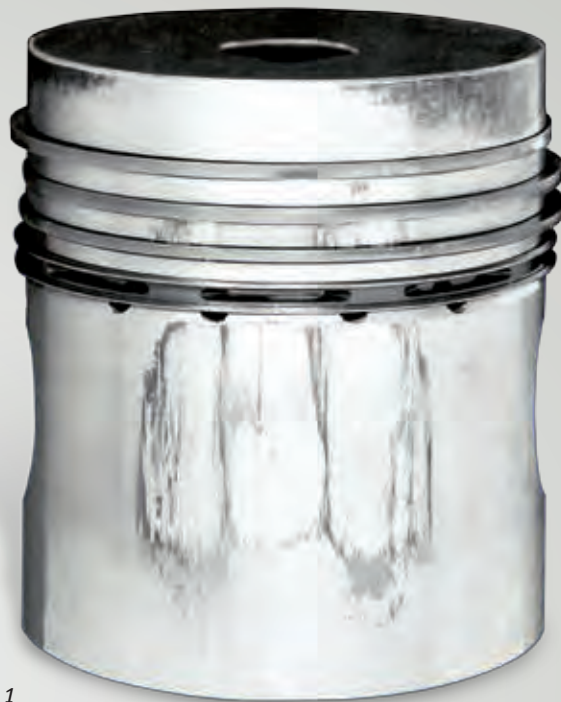
Fig. 1

- Seizure marks on the piston skirt on the pressure side, which in some cases extend into the piston ring zone.
- Slight seizure marks on the anti-thrust side.
- Surface of the seizure areas is light-coloured and has an almost pure metallic finish.

There was an acute lack of lubricant between the piston and the cylinder bore. The fact that the surface of the seizure areas has an almost pure metallic finish indicates that the oil film was present but significantly weakened at the time of the seizure. Due to the limited extent of the damage,

this concerns a temporary lack of oil or the early stages of damage. The damage would have been even more severe if engine had been operated further.

- Insufficient engine oil.
- Oil pressure in the engine too low (oil pump, pressure relief valve, etc.): not enough oil emerges at the crankshaft bearings. This means that not enough lubricating oil is supplied to the cylinder running surface, which is lubricated with splash oil and centrifugal oil from the crankshaft.
- Failure of the oil injection jet for cooling the piston.

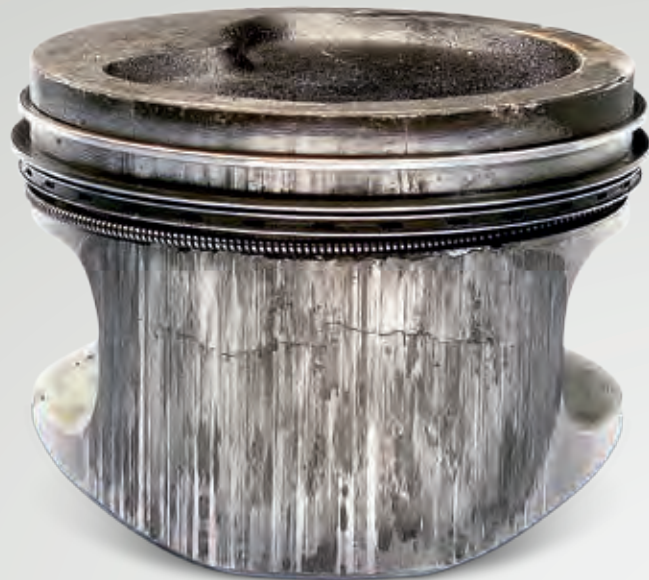
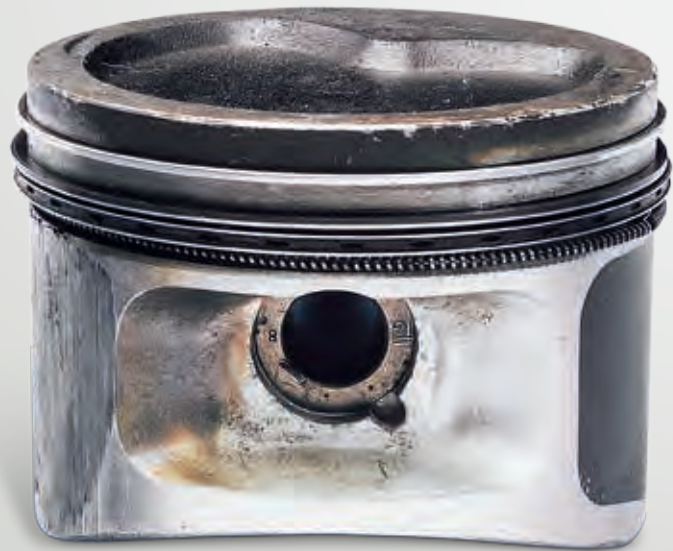
Fig. 1

- Severe, darkly discoloured seizure areas with a heavily worn surface on the pressure side of the piston.
- Opposite side of the piston skirt free of damage.
- Piston ring zone usually undamaged in the early stages.

This is a typical example of seizure due to lack of lubrication. It usually occurs on the pressure side and is less common on the anti-thrust side. This damage is caused when the lubricating film breaks down on only one half of the cylinder. It is caused either by a lack of lubrication within a

locally confined area or by the affected side of the cylinder overheating. Lack of clearance can be excluded as the potential cause here as, despite the severity of the seizure marks, there are no wear marks on the opposing counter-side.

- Partial collapse of the cooling mechanism due to lack of coolant, air bubbles, dirt deposits or other malfunctions in the cooling circuit.
- On ribbed cylinders, dirt deposits on the outside can lead to localised overheating and, consequently, a breakdown of the oil film.
- On air-cooled engines: defective, missing or incorrectly installed air baffles.
- Failure of the oil injection jet for cooling the piston.
- Insufficient oil pressure: insufficient lubrication on the cylinder pressure side for connecting rods with oil injection jets.
- Insufficient lubrication on the cylinder pressure side (which is subjected to greater loads) as a result of oil dilution or oil grades that are not suited to the intended purpose.

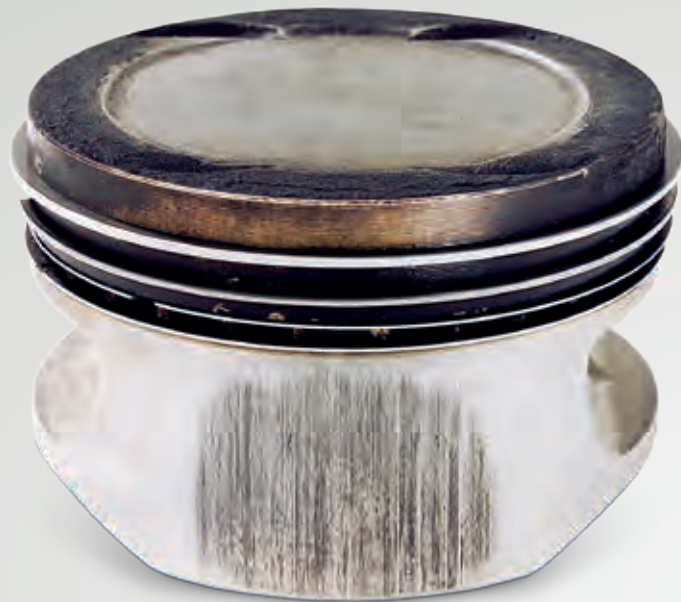
Fig. 1

- Narrow, sharply defined longitudinal friction marks on the piston skirt instead of the normal piston wear pattern.

In the case of damage caused by unburned fuel, the damage occurs at the load-bearing areas on the piston skirt. These are the points at which the normal wear pattern would have formed on an undamaged piston.

- Overrich engine operation and abnormal combustion caused by faults in the mixture preparation or in the ignition system.
- Insufficient compression and, as a result, incomplete combustion.
- Coldstart device defective or operated for too long (carburettor engines).
- Oil dilution caused by frequent short-distance driving or an overly rich mixture.

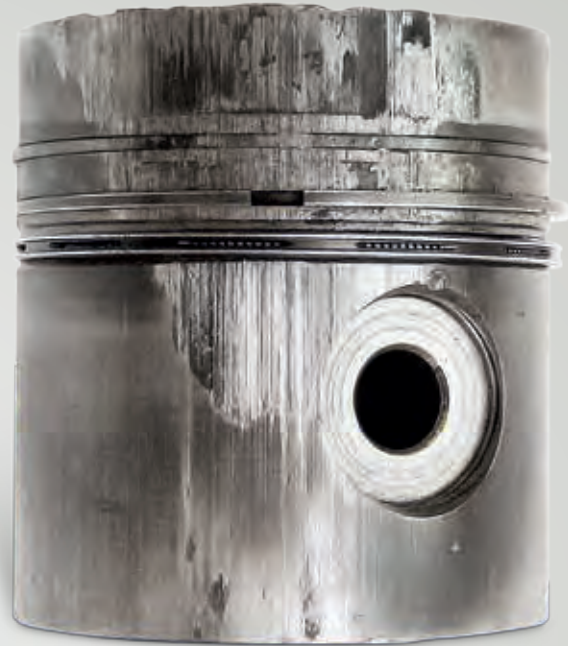
Fig. 1

- Localised seizures that mainly occur on the piston top land.
- Surface of the seizure areas is rough and worn, in some cases larger pieces of material have been torn out.

without any lubrication at all. As a result, the piston top land seized so severely that it was temporarily welded to the cylinder wall. This caused chunks to be torn from the piston head.

- Injection nozzles that are leaking, dripping after injection, clogged or the wrong type.
- Blocked injector nozzle needle due to bent injection nozzle body (incorrect tightening torque).
- Incorrect injection timing (start of delivery).

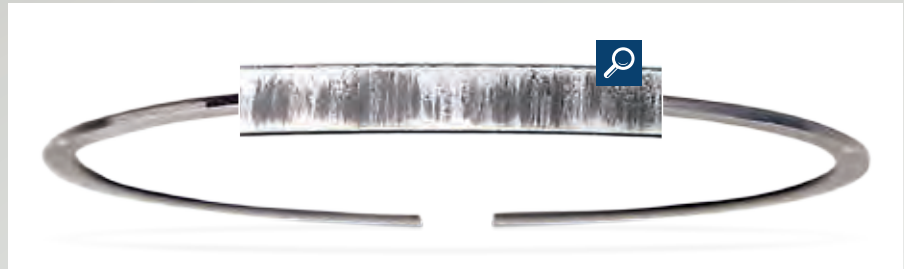
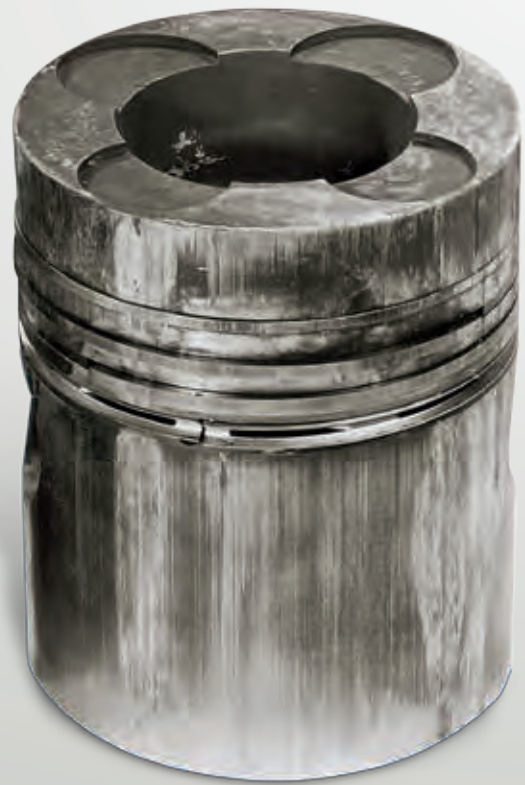
- Score marks and burned spots on the piston ring sliding surfaces (Fig. 1 and 2).
- Longitudinal scratches on the cylinder bores (not shown).
- In the early stages: initial rubbing marks can be seen on the piston top land (Fig. 3, top right).
- In a more advanced stage: the damaged areas have spread over the entire piston (Fig. 4).

This type of damage primarily occurs during the running-in phase under heavy loads, when the piston rings are not yet run in and hence do not yet provide a full seal (mostly on diesel pistons). The combustion gases streaming past the piston rings heat up the rings and the cylinder wall excessively and cause the oil film to break down.

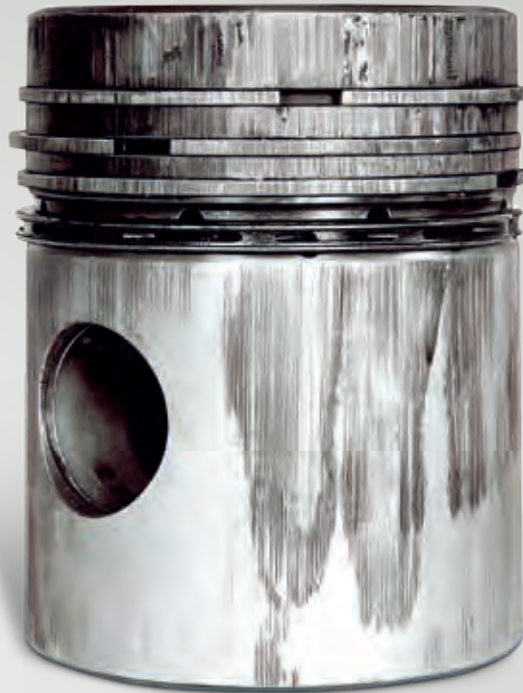
Fig. 1

- Severe seizure starting from the piston head and lessening as it progresses towards the skirt end.
- Seizure marks are distributed around the entire circumference of the piston head.
- Surface of the seizure areas has a dark discolouration with severe scoring marks, and has broken up in places.
- Piston ring running surfaces show signs of seizure, which decrease in intensity towards the oil control ring.

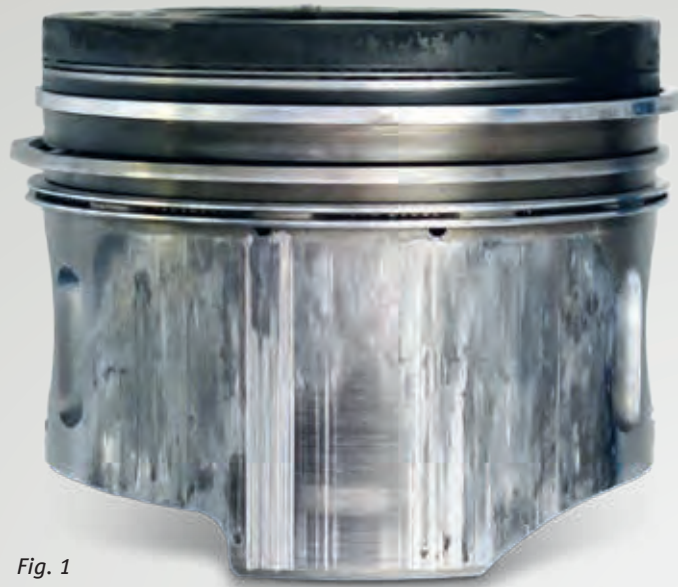
Fig. 1

- The piston skirt has seized on both sides.
- The surface of the seizure marks has a dark discolouration and is rough and severely broken up.
- The piston ring zone is often only slightly damaged or not damaged at all.

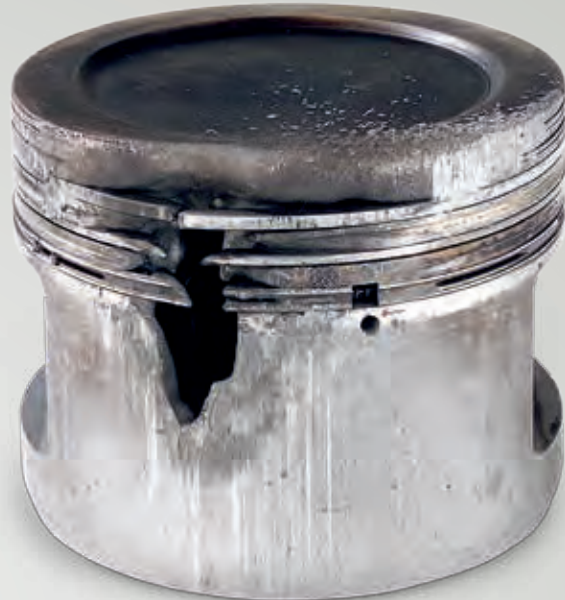
Abb. 1

- The piston head has melted through behind the piston rings.
- The piston skirt has not seized; melted material has been worn away off the damaged area onto the piston skirt.

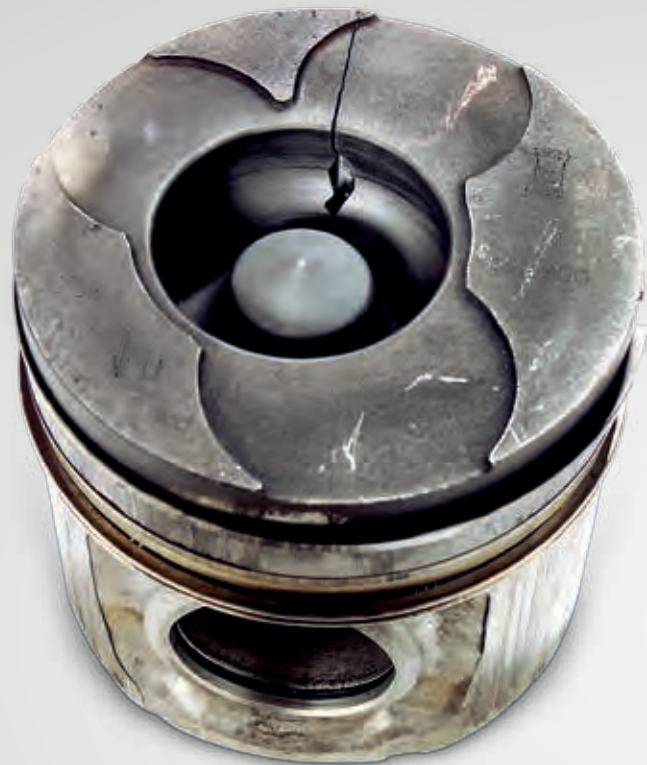
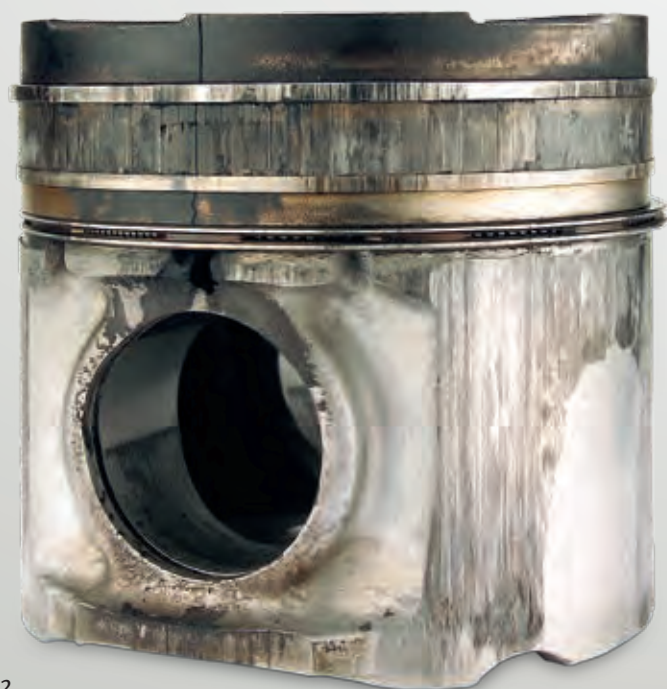
- Stress cracks on the edge of the bowl.
- Major crack extends to the piston pin boss.
- Channel burned from the bowl to below the oil control ring by combustion gases streaming through the major crack.

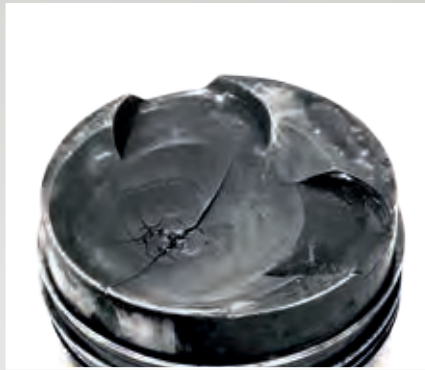
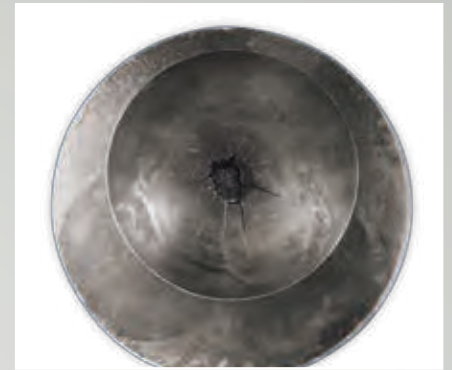
The piston material is heated up significantly in localised areas – at the point where the prechamber jets make contact on prechamber engines (Fig. 3 and Fig. 4), and on the edge of the bowl on direct injection engines (Fig. 1). The material expands more than elsewhere in these areas. As the overheated areas are surrounded by colder materials, the material is plastically deformed here beyond its limit of elasticity. Exactly the opposite happens when it then cools down again: in the areas where before the material was previously buckled and forced away, there is now a shortage of material. This results in tensile stresses, which ultimately cause stress cracks. If there are superimposed stresses caused by bending of the piston pin in addition to the thermal stresses, then the stress cracks turn into a much larger major crack, which causes complete breakage and failure of the piston.

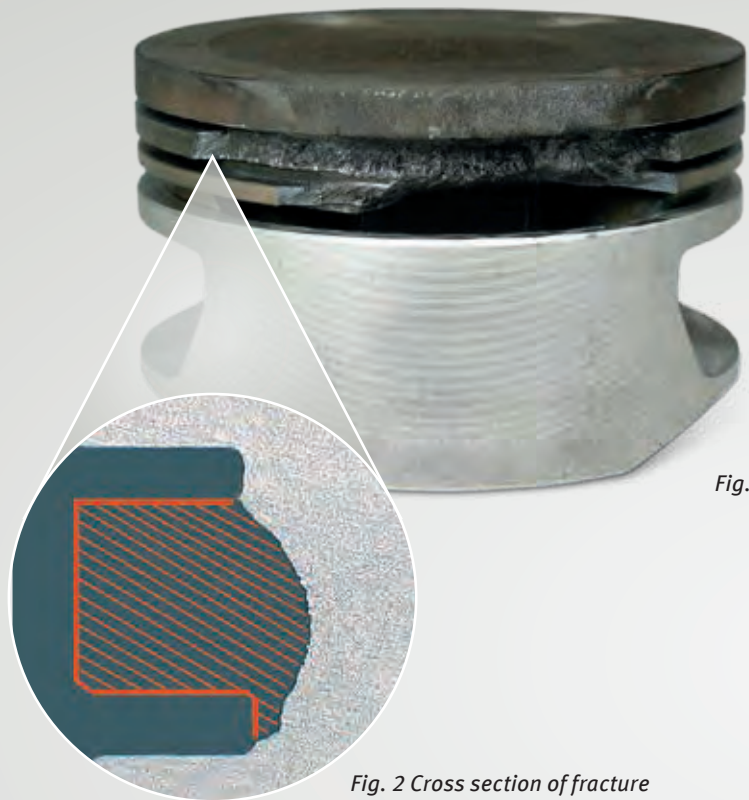
Fig. 1

- Ring land fracture on one side of the piston between the first and second compression ring (Fig. 1).
- Fracture, starting at the groove base at the top and running at a diagonal angle into the piston material, emerging at the groove base underneath (Fig. 2).
- Fracture is extended downwards.
- No piston seizure marks or signs of overheating.

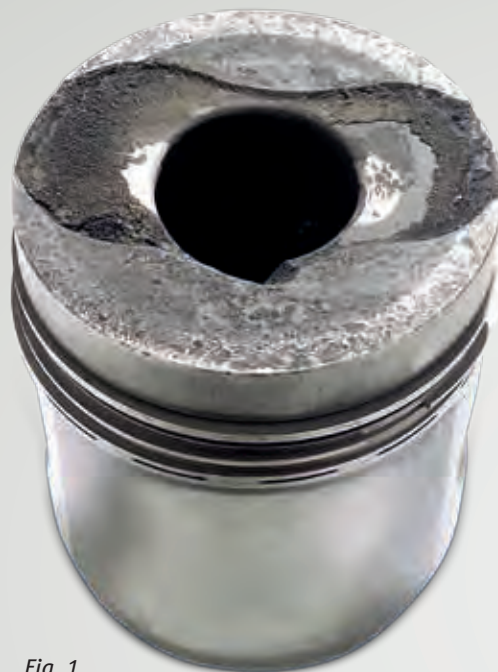
Fig. 1

- Severe impact marks on the piston head (Fig. 1). Nearly all oil carbon deposits removed.
- Scarring and oil carbon deposits pressed into the piston crown.
- Severe wear on the piston rings, particularly on the oil control ring.
- Imprint of the swirl chamber on the front edge of the piston crown (Fig. 2).
- Imprint of the valve on the right-hand side of the crown.
- First indicators of initial dry running damage due to lack of lubrication on the piston skirt (Fig. 4).

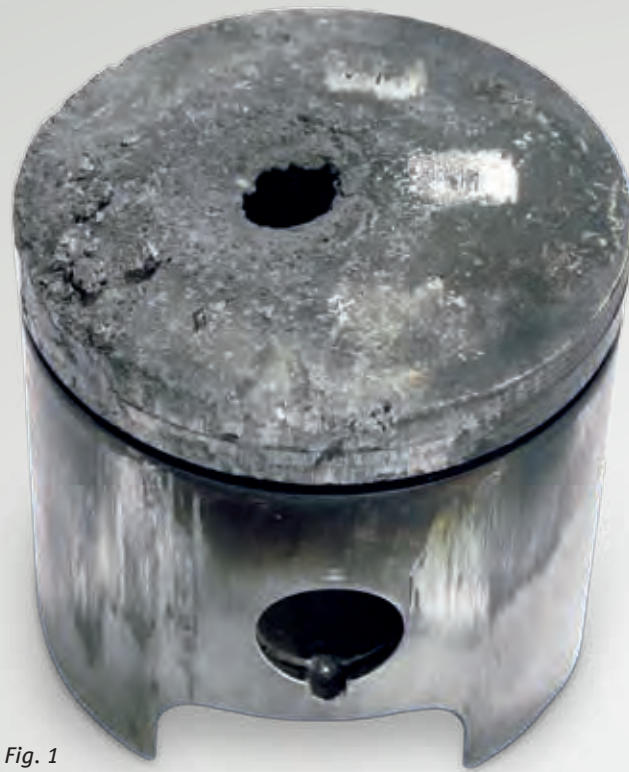
Fig. 1

- Piston crown has a hole that penetrates all the way through, covered by the molten material.
- Skirt area displays seizure marks.
Reason: the high temperatures and the piston material that has been ground down.

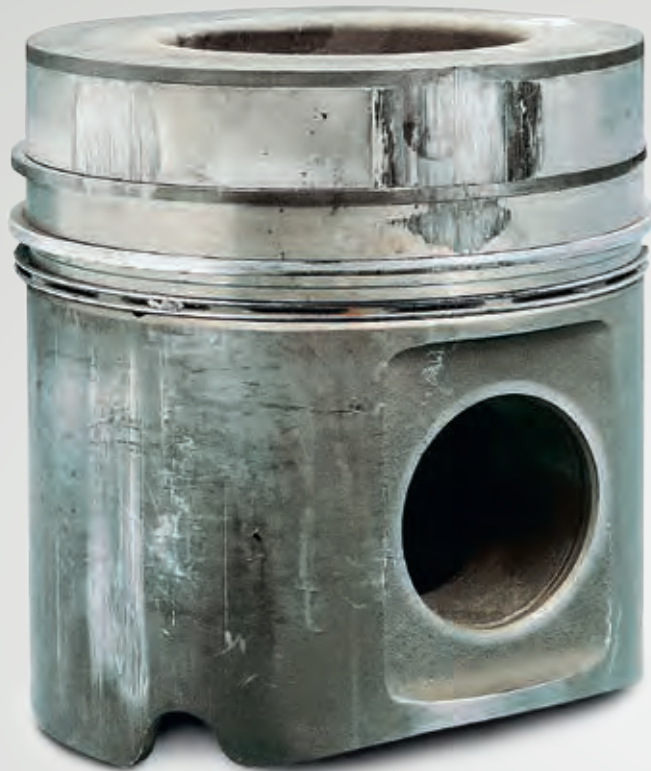
Fig. 1

- Localised score marks can be seen on the piston head, going all around the circumference of the piston.
- Score marks start at the piston crown and end at the second compression ring.
- Score marks are centred around the piston top land.

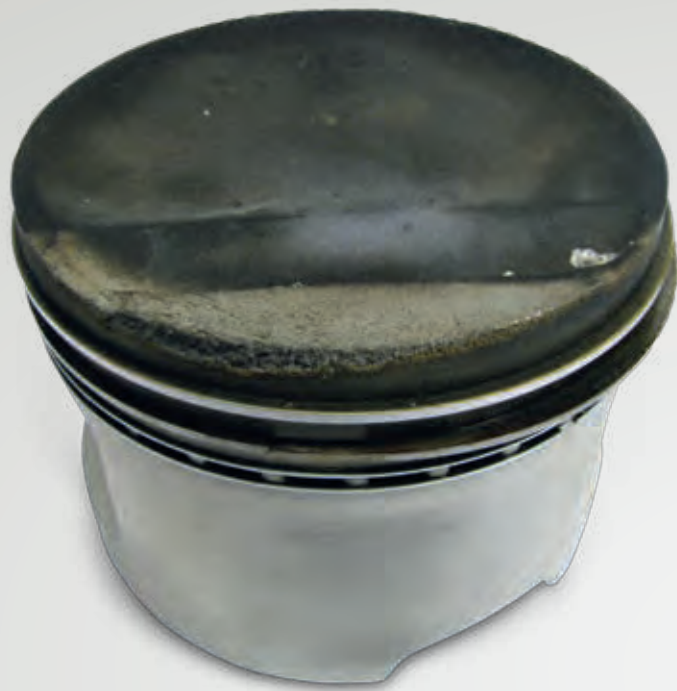
Fig. 1

- Erosion-type removal of material from the piston top land (Fig. 2) or surface of the piston crown (Fig. 3).

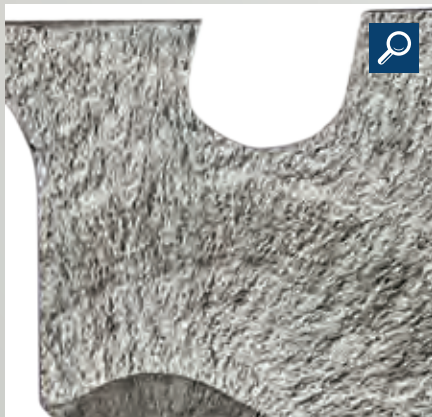
Fig. 2

The fracture surfaces of a forced fracture appear grey. They are not worn down and display no line markings. The piston breaks suddenly without any fracture development.

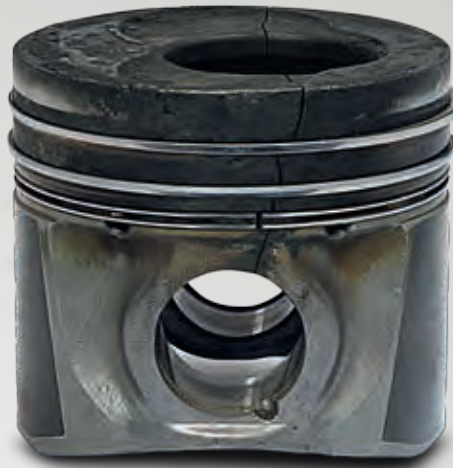
Fig. 1

- Formation of a cleavage fracture that leads to the piston crown. This results in the piston being split into two parts (Fig. 1).
- Boss fatigue crack in the centre axis of the piston pin bore (Fig. 2 and 3).

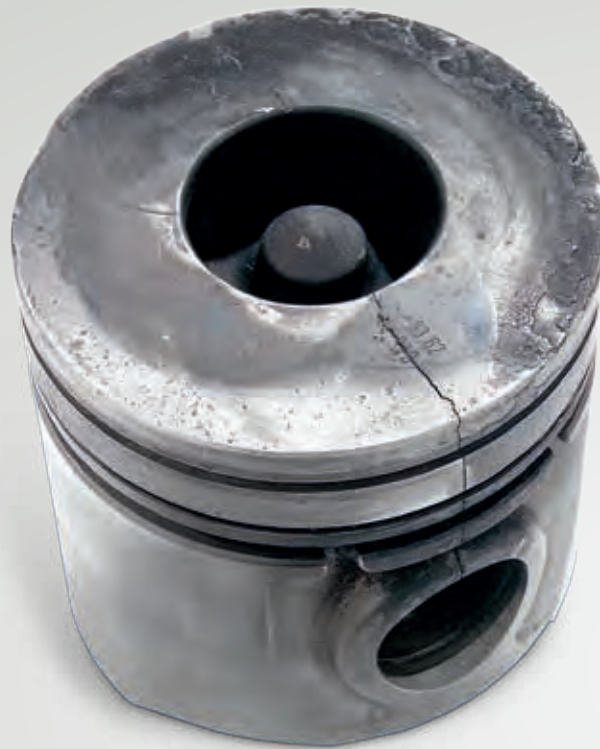
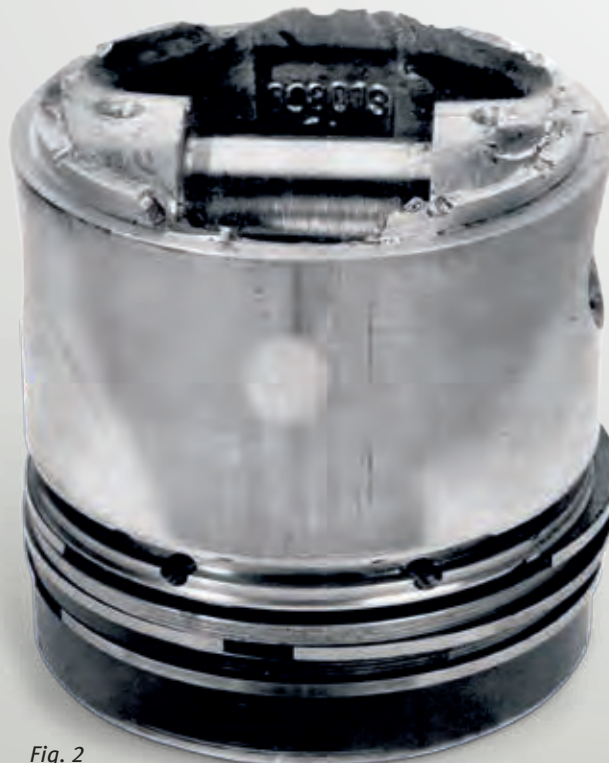
- Impact marks on the piston crown (Fig. 1), cylinder head mating surface and both valves (not shown).
- Fracture in the direction of the piston pin due to vibrations and the effects of violent impact.
- Piston skirt has broken off in the lower oil ring groove, fracture surfaces display the characteristics of a fatigue fracture (Fig. 2).

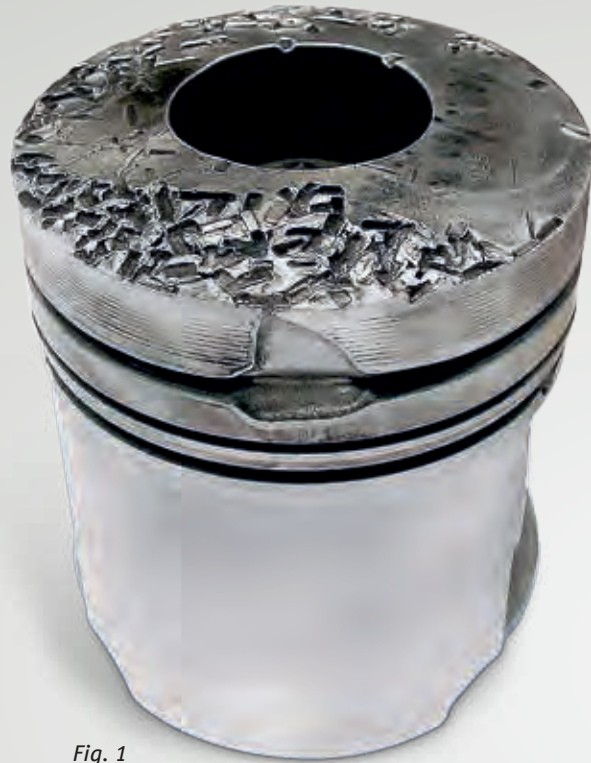
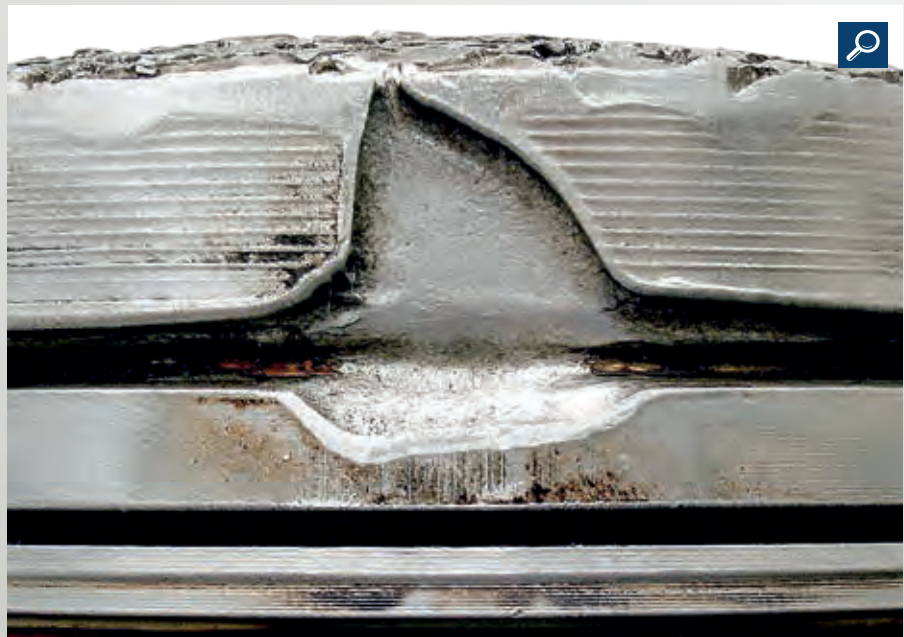
- Severe material washout reaching as far as the piston crown in the ring zone in the area of the first ring groove.
- Severe axial wear on the first ring groove.
- Severe mechanical damage on the piston crown.
- Running pattern of the piston skirt has a matt, buffed appearance.

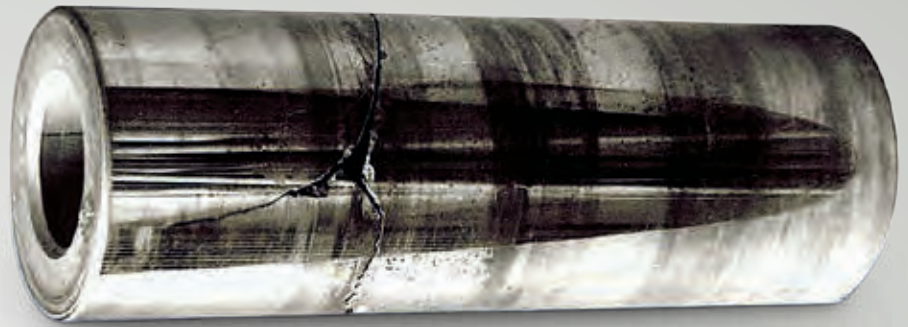
Fig. 1

- Lateral fracture on the piston pin (Fig. 1) at the transition between the connecting rod and the piston pin boss.
- Shorter fragment split along its length.
- Fracture surfaces display the characteristics of a fatigue fracture.

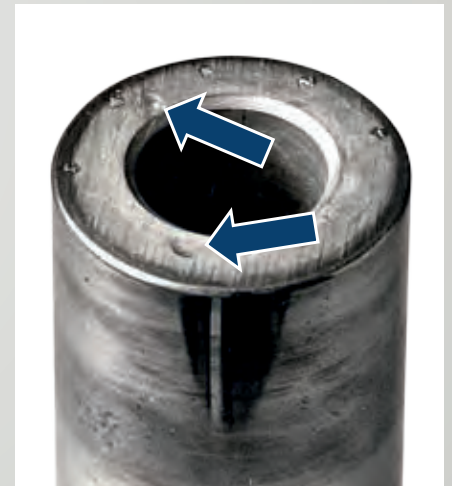
Abb. 2

Fig. 2 shows that an incipient crack may not only be caused by overstressing, but also as a result of improper installation of the piston pin. The end face of the broken piston pin clearly shows that the incipient crack was caused by impact damage (hammer blow). An incipient crack can lead to breakage of the piston pin, even under normal load conditions.

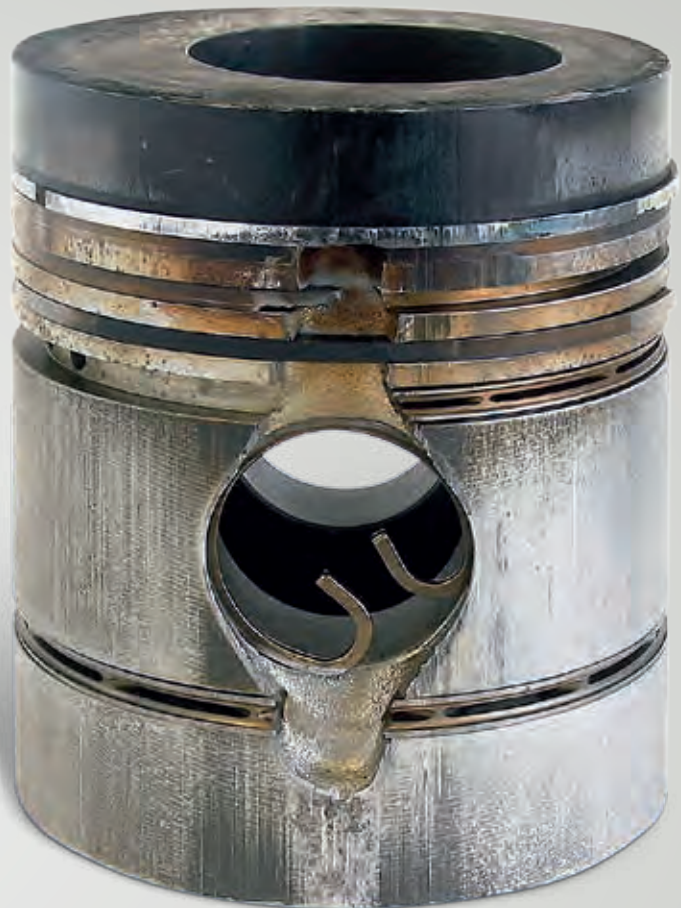
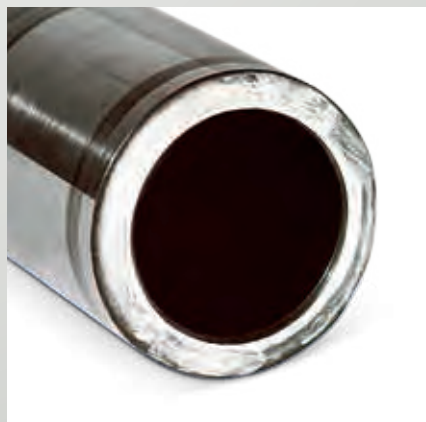
- End of the piston pin bore on both sides of the piston suffered serious damage, in some places as far as the ring zone (Fig. 1).
- Circlip jumped out of the retaining groove and broke into fragments.
- Second circlip damaged.
- Due to the lack of retention, the piston pin has wandered outwards towards the cylinder running surface.
- Front face of the piston pin worn to a convex shape due to prolonged contact with the cylinder running surface (Fig. 2).
- Asymmetrical running pattern of the piston.

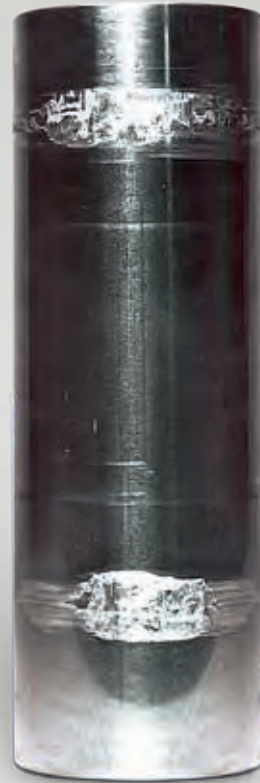
Fig. 1

- Piston pin has seized in the piston pin bores.
- Piston material has been welded onto the piston pin (Fig. 1).
- Piston pin displays a blue discolouration in the area of the connecting rod bush.

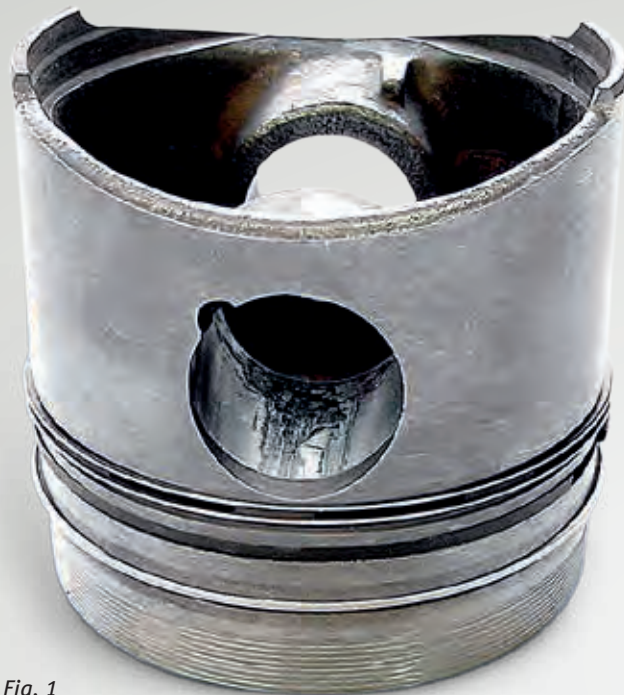
Fig. 1

- Piston has only run for a short length of time.
- No wear marks on the piston skirt.
- The piston pin bosses have seized on the upper side, i.e. the side under pressure load (Fig. 1).
- The surface at the seizures is clean bare metal; no traces of burned-in oil.

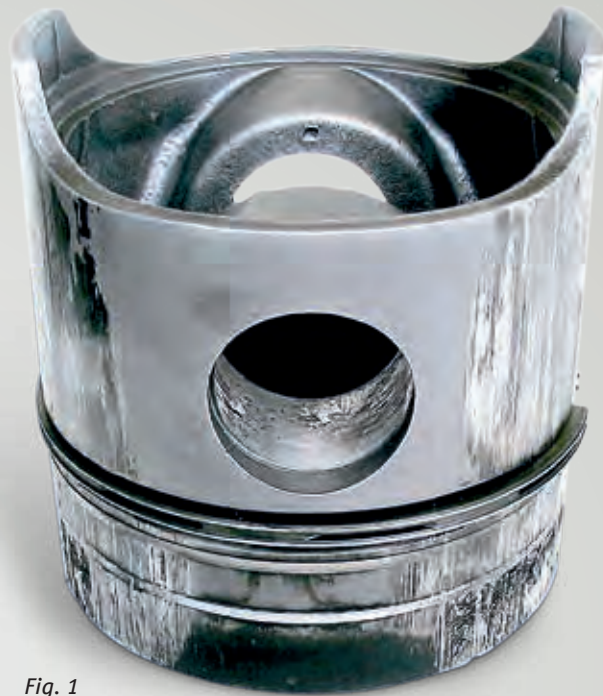
Fig. 1

- Piston skirt has seized on both sides, starting at the piston head.
- Compression rings have become blocked in the ring grooves.
- Seizure marks are present in the piston pin bosses.

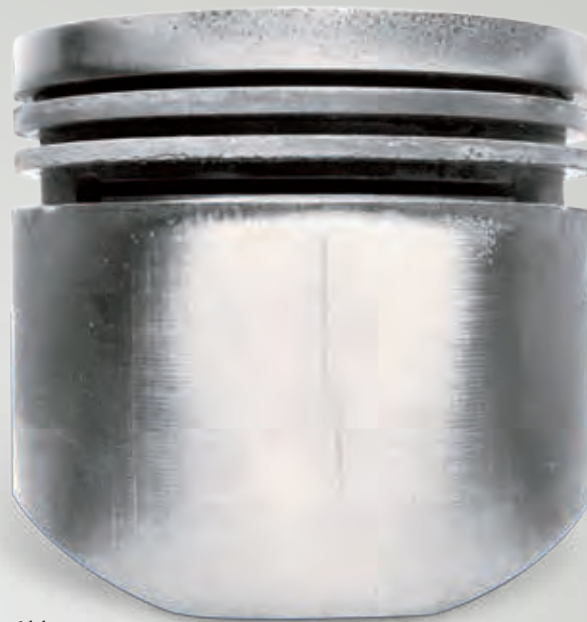
Abb. 1

- Piston top land has impact marks in the tilting direction (Fig. 1).
- The piston skirt displays a more pronounced running pattern to the top and bottom than in the middle of the skirt.

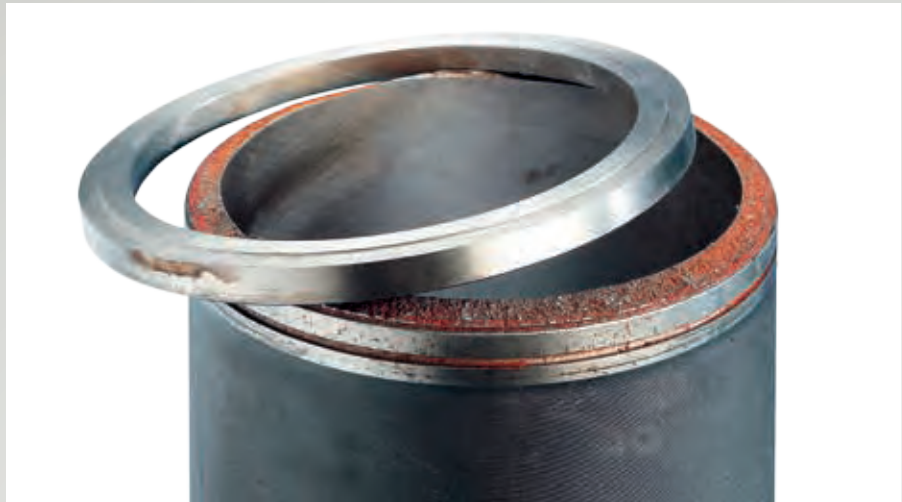
Fig. 1

- Liner flange has been torn off.
- The flange crack starts at the base of the bottom edge of the liner flange and extends upwards at an angle of approx. 30°.

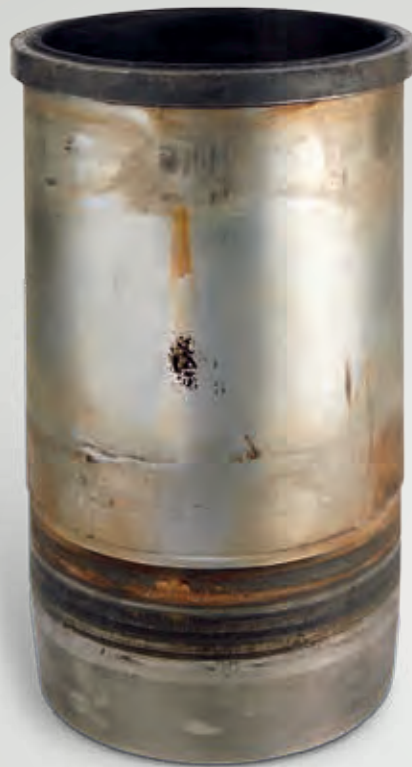
Fig. 1

- Severe cavitation on the water jacket of the wet cylinder liner (Fig. 1 and 2).
- Coolant has penetrated through into the combustion chamber.

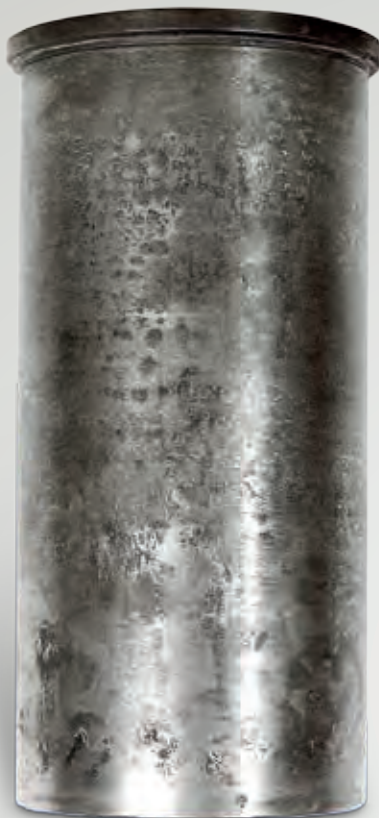
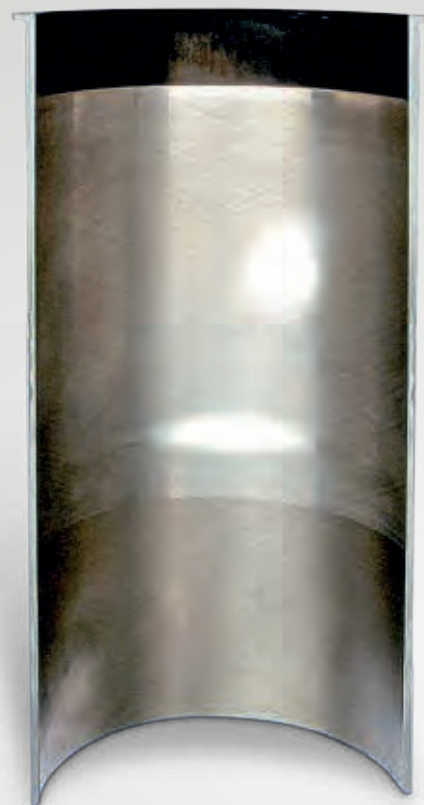
- Corrosion on the outside diameter of the cylinder liner (Fig. 1).
- Uneven wear pattern with individual bright areas on the cylinder surface (Fig. 2).
- Piston undamaged.
- Oil loss at the sealing points, in particular the radial oil seals.

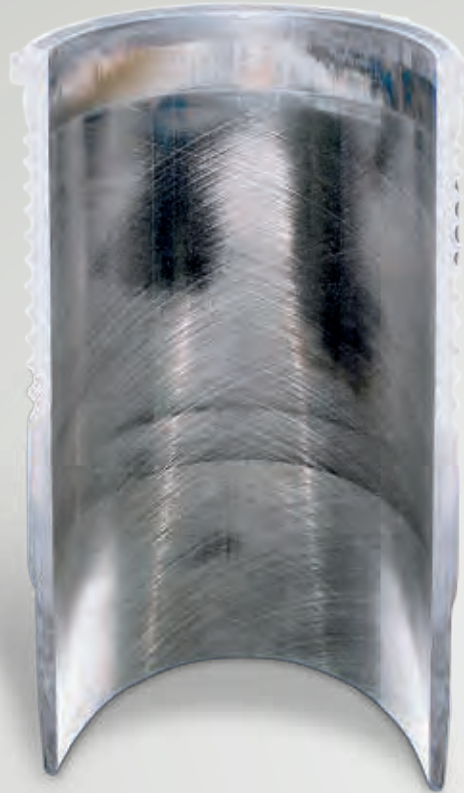
- Bright, bare areas with no honing structure on cylinder sliding surface (Fig. 1 and 2).
- No signs of wear on the piston.
- Oil carbon deposits on the piston top land.
- Increased oil consumption.

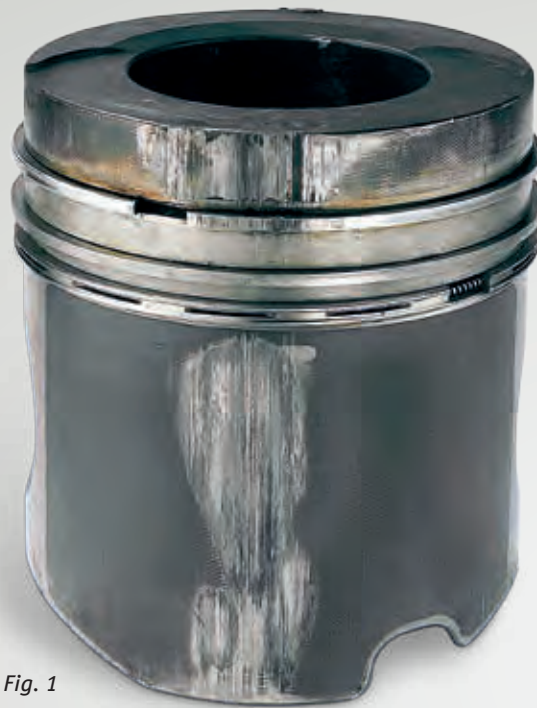
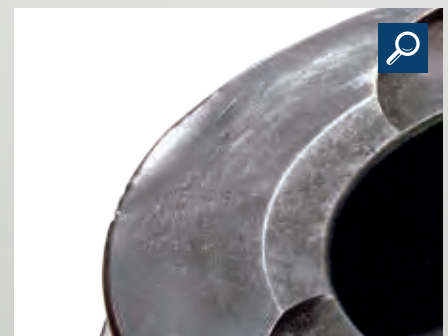
- Upper area of cylinder liner displays severe damage due to a crack and seizure marks on the sliding surface (Fig. 2 and 3).
- Piston displays seizure marks on the pressure and anti-thrust sides.
- In the piston crown: bowl-shaped recess in the area of the seizure marks (Fig. 4).

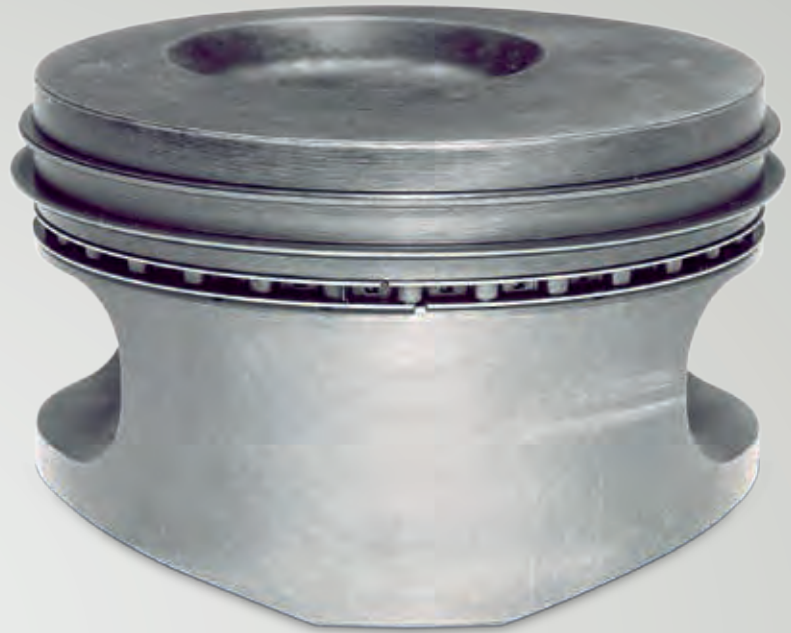
Fig. 1

- No signs of wear on piston rings or piston (Fig. 1).
- End of the expander spring of the 3-piece oil control ring broken off.
- Scratches in the groove base of the oil control ring.

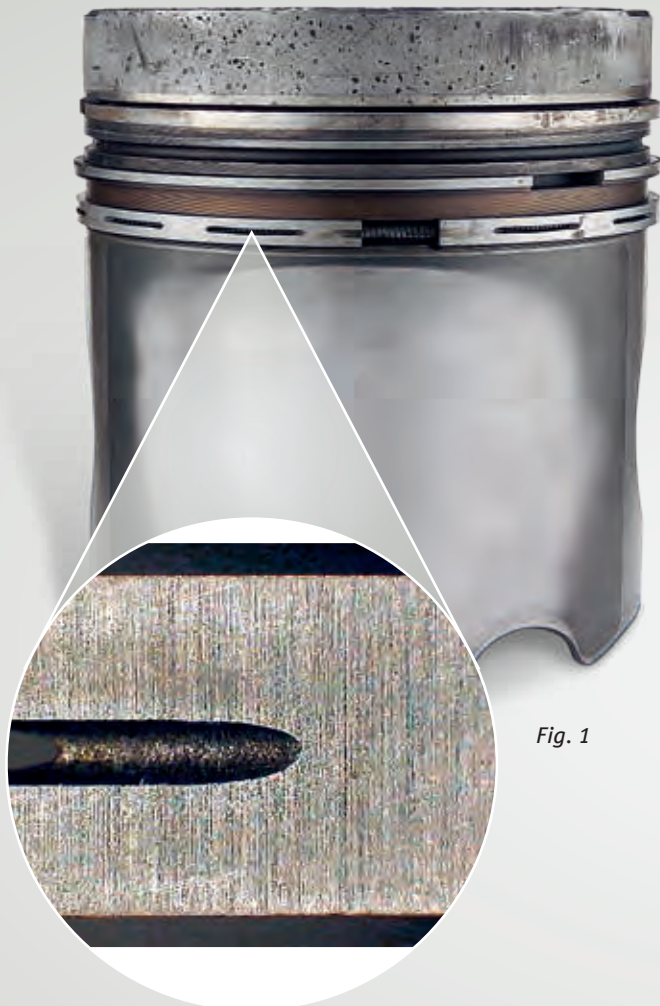
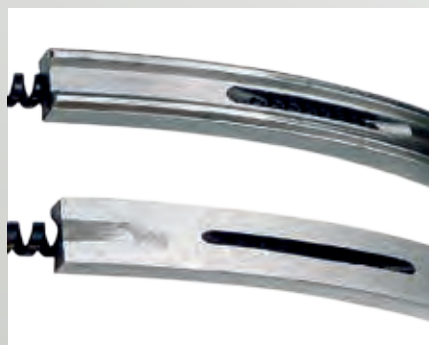
- Severe signs of wear on the piston top land and piston skirt.
- Friction marks on the piston skirt, characteristic of dry running due to fuel flooding.
- Piston rings display severe radial wear (Fig. 1). Both webs (support surfaces) on the oil control ring have been worn down (Fig. 2). By way of comparison in Fig. 3: profile of a new and worn oil control ring (double-bevelled spiral expander ring).
- Increased oil consumption.

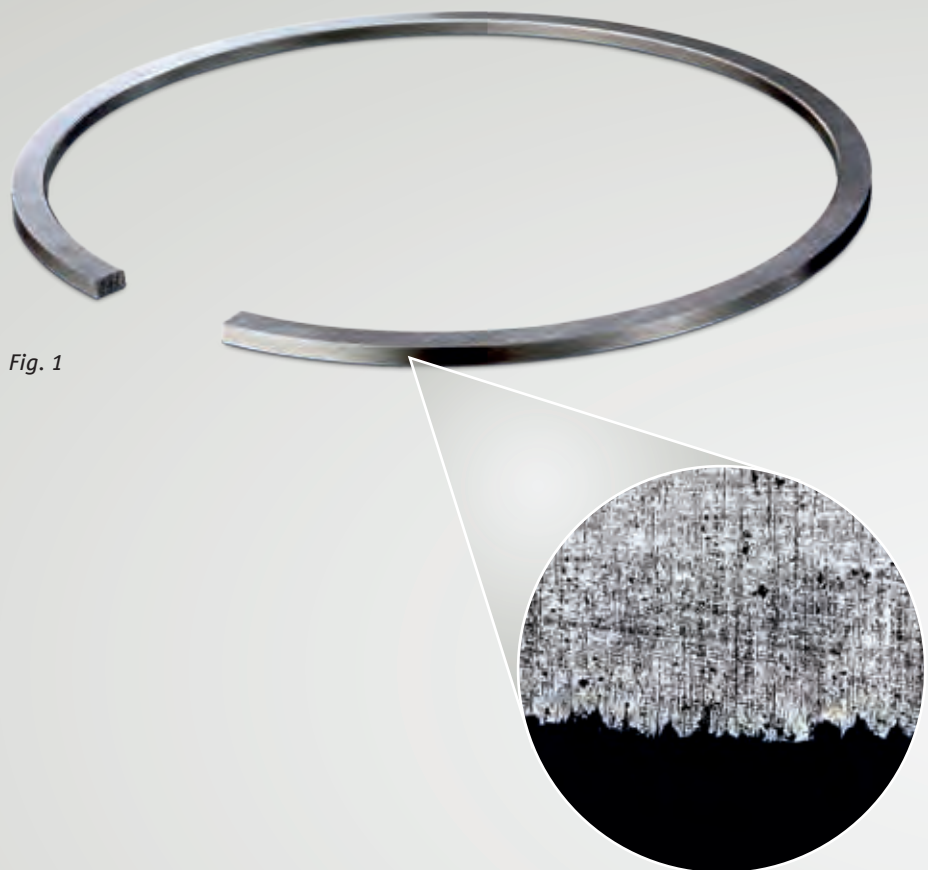
Fig. 1

- No damage or wear on piston.
- Superficial inspection of piston rings reveals no wear marks, however, closer inspection reveals abnormal wear on the oil-scraping ring edges, mostly on the bottom ring edges (see magnified image).
- Tangible burr on the bottom edge of the piston ring running surface.
