Safety Summit

"Maintenance"

Presented to: "14CFR part 141 Pilot Schools"

Orlando District Part 141 Findings

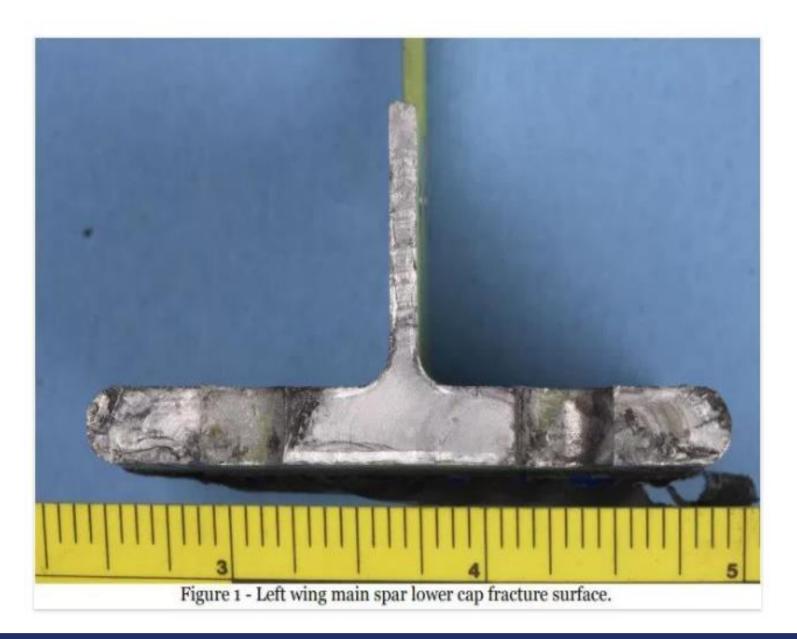
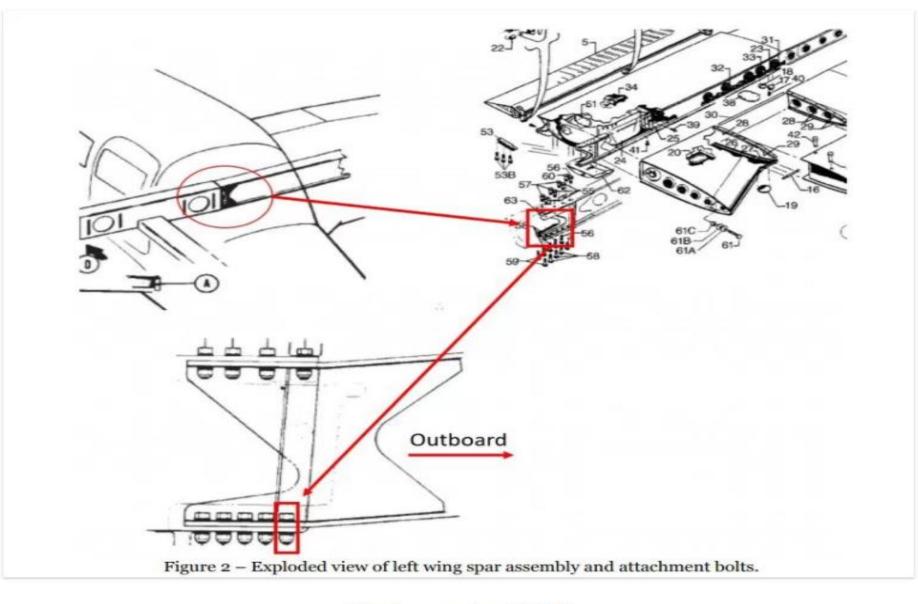
The left wing of the aircraft separated from the airplane shortly after the pilot completed a touch and go landing on runway 25 Left at Daytona Beach International airport (DAB)...

A preliminary report released by the NTSB this week said the left wing main spar of the 2007 Arrow "revealed that more than 80 percent of the lower spar cap and portions of the forward and aft spar web doublers exhibited fracture features consistent with metal fatigue."

Radar data indicated the Piper had climbed to approximately 900 feet heading southwest before radar contact was lost. A number of eye witnesses within a half mile of the aircraft all reported the aircraft operating normally until the left wing separated from the fuselage and landed in a field a few hundred feet from where the main fuselage came to rest...

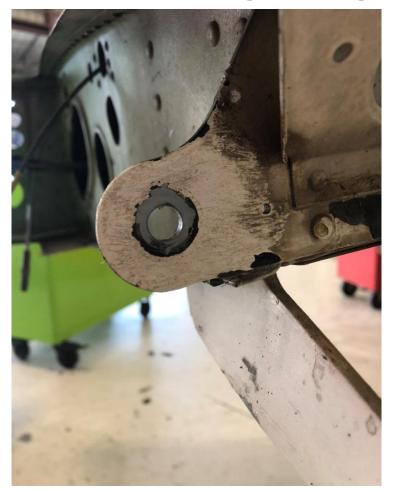
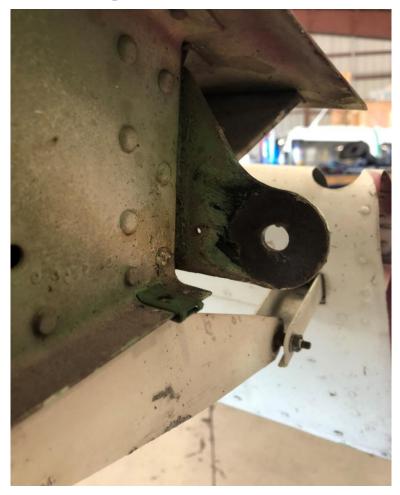
PA-28R-201 "Arrow" TTIS: 8570.2 – Wing movement noted. No wing damage noted in logbook.

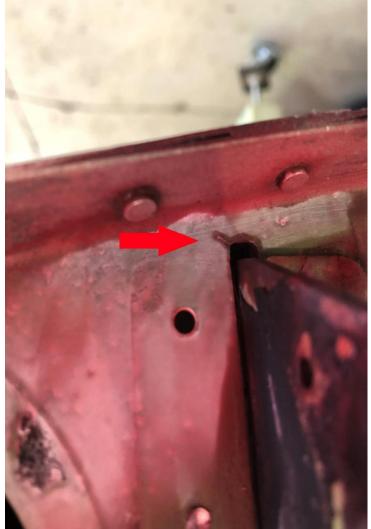
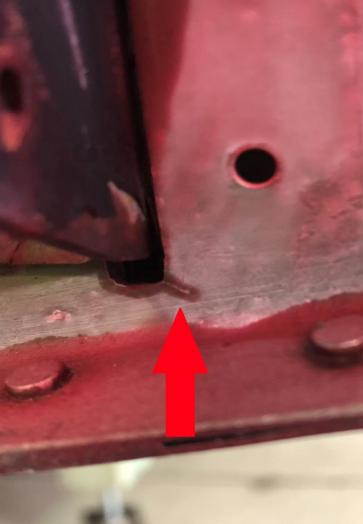
Small crack on forward leading edge top and bottom of bracket.

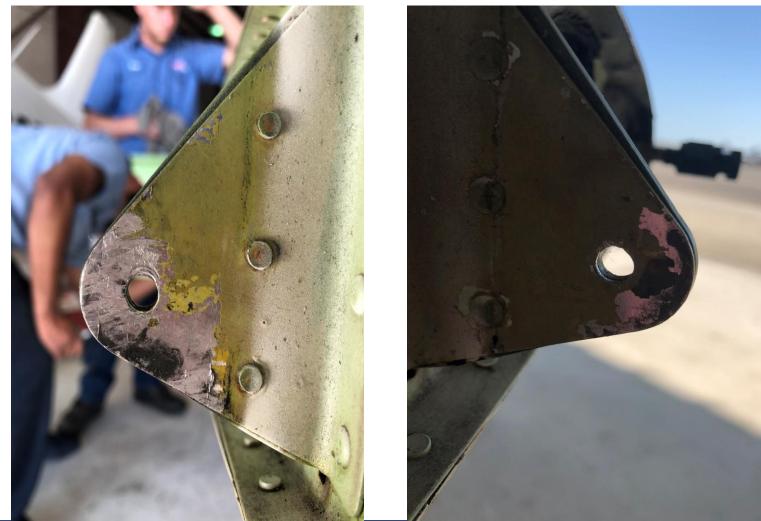
TTIS: 6672.4 – Wing movement noted. No wing damage noted in logbook.

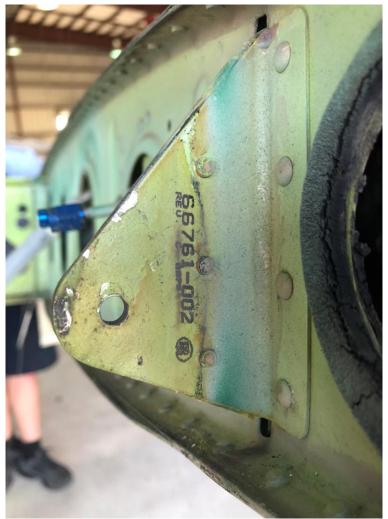
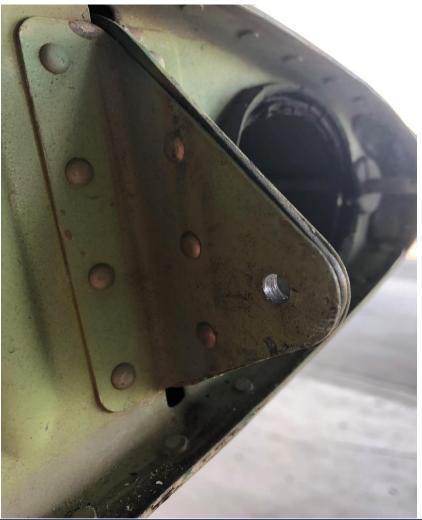
TTIS: 9041.1 – Wing movement noted. No wing damage noted in logbook.

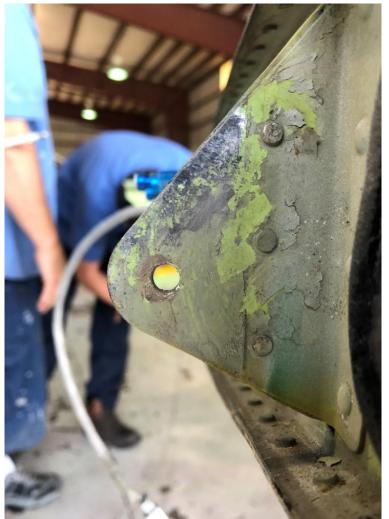
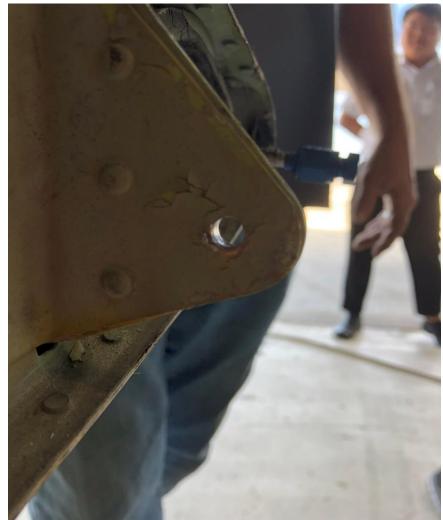
TTIS: 12383.4 – Wing movement noted. No wing damage noted in logbook.

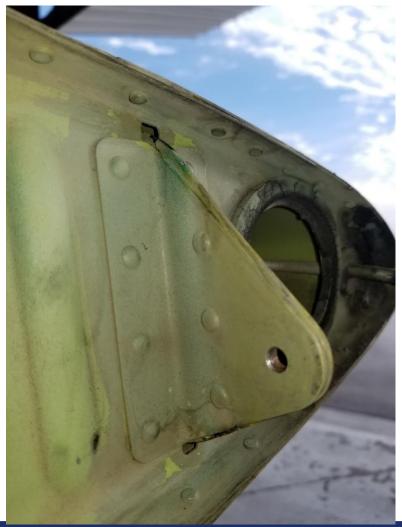
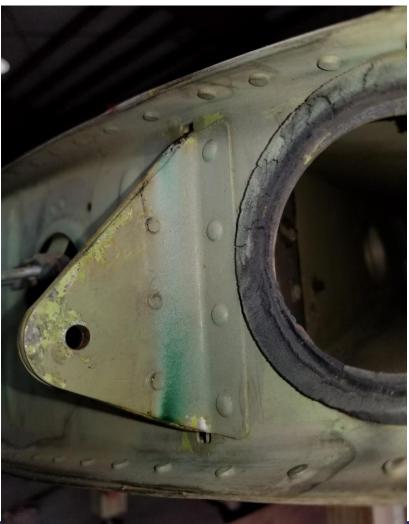
TTIS: 12913.9 – Wing movement noted. No wing damage noted in logbook.

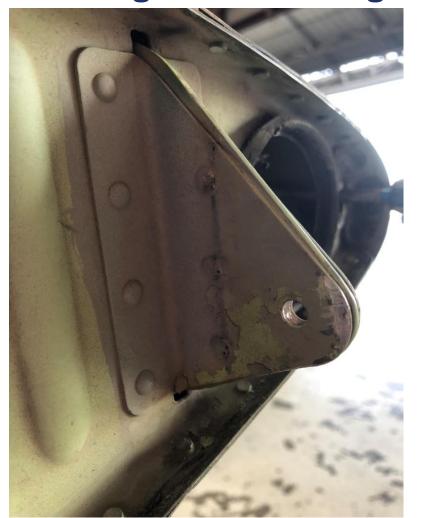
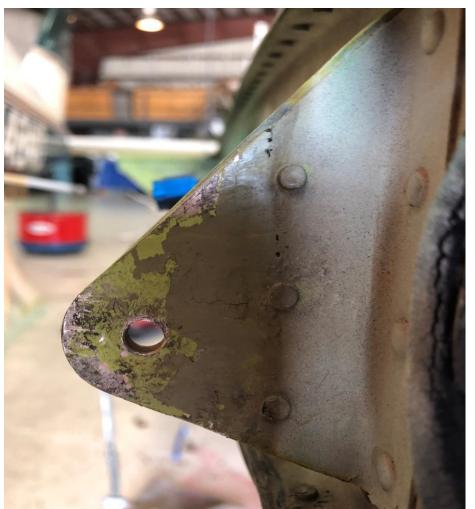
TTIS: 11697.7 – Wing movement noted. No wing damage noted in logbook.
