Complicated wing rebuild tests a mechanic's skills

REPAIR OF A LIFETIME

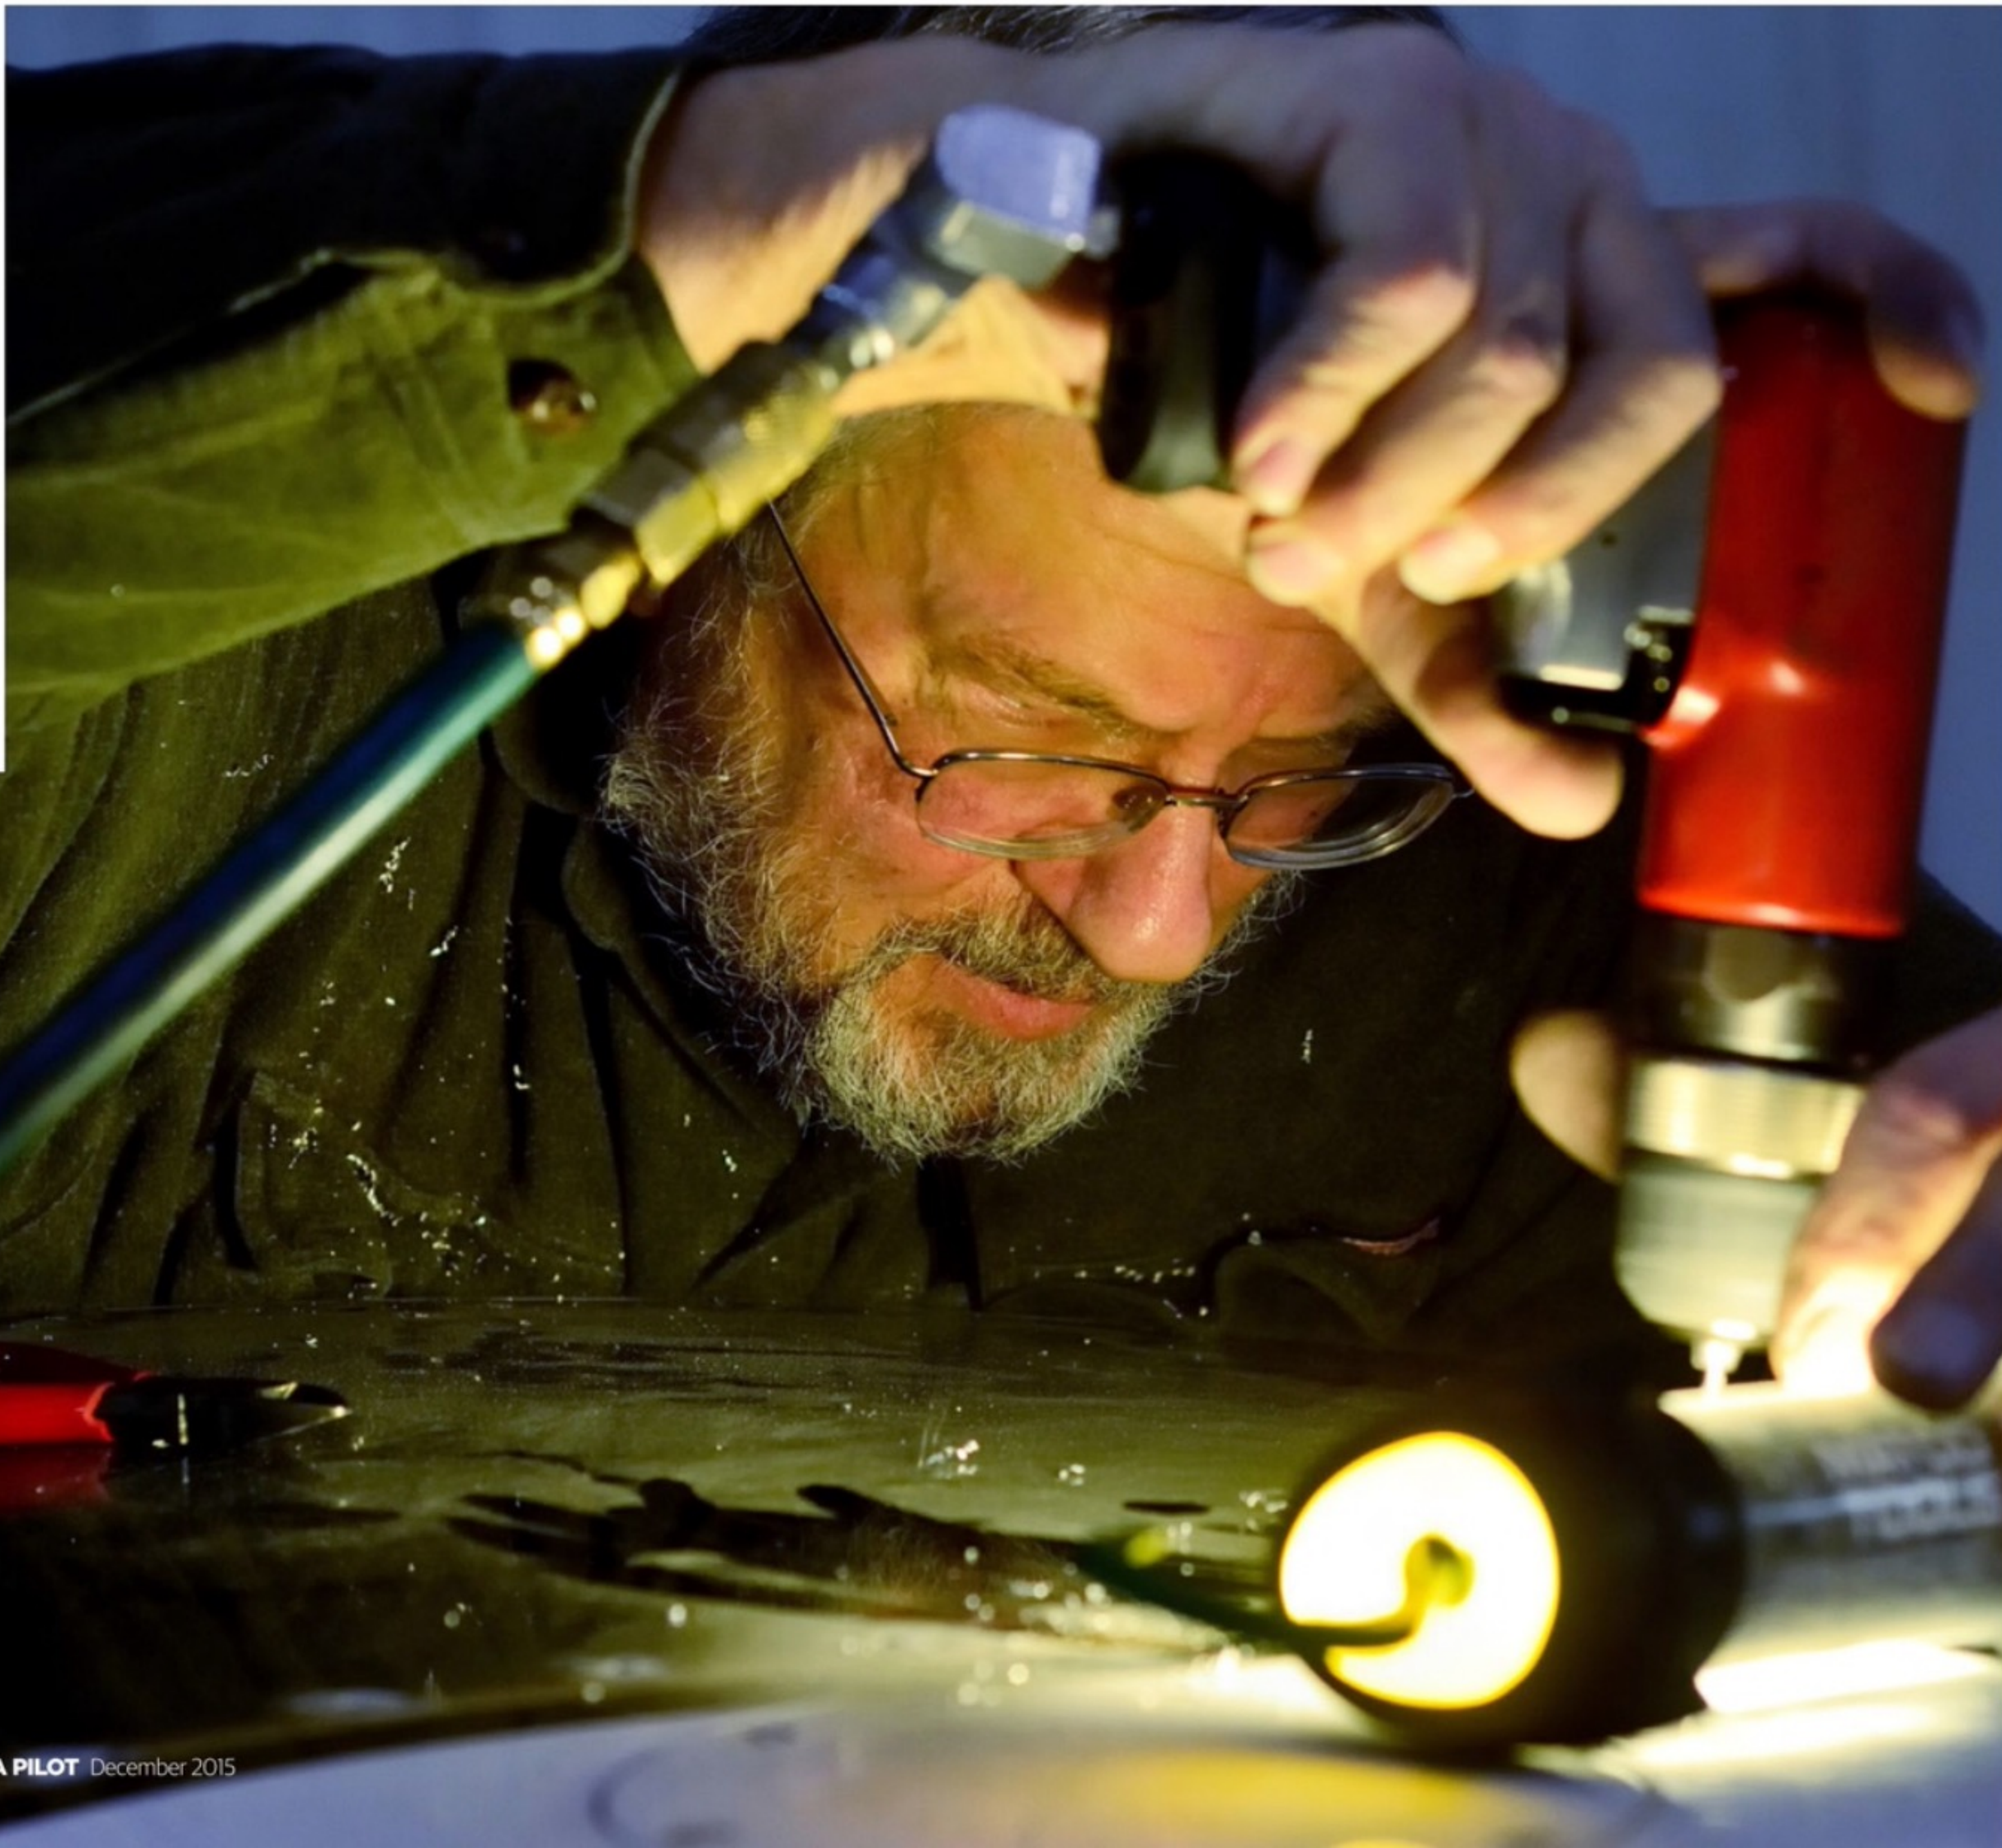
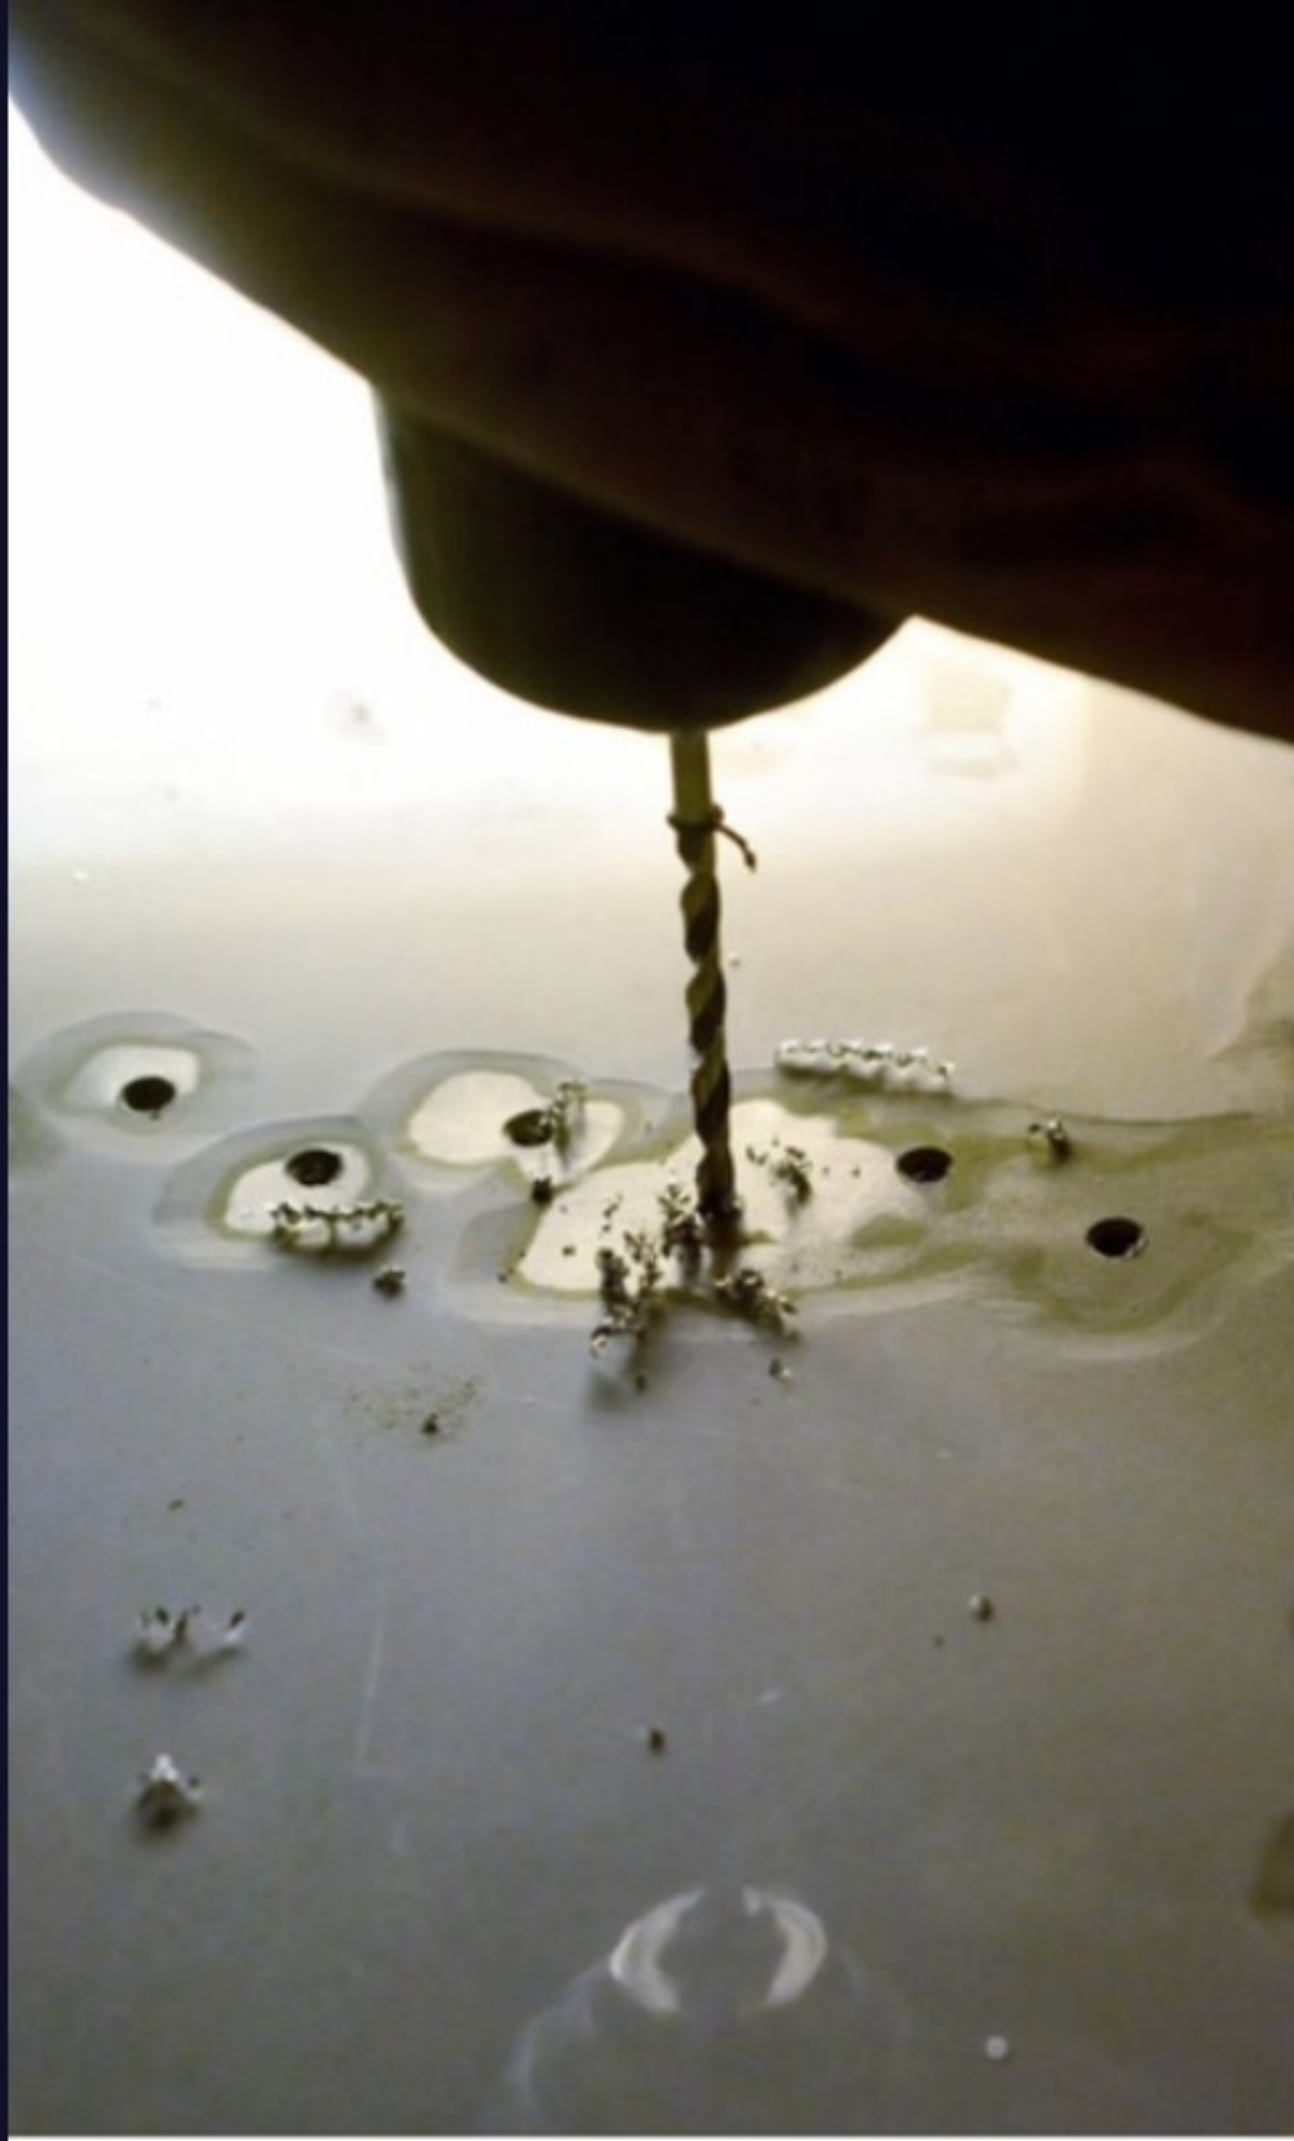
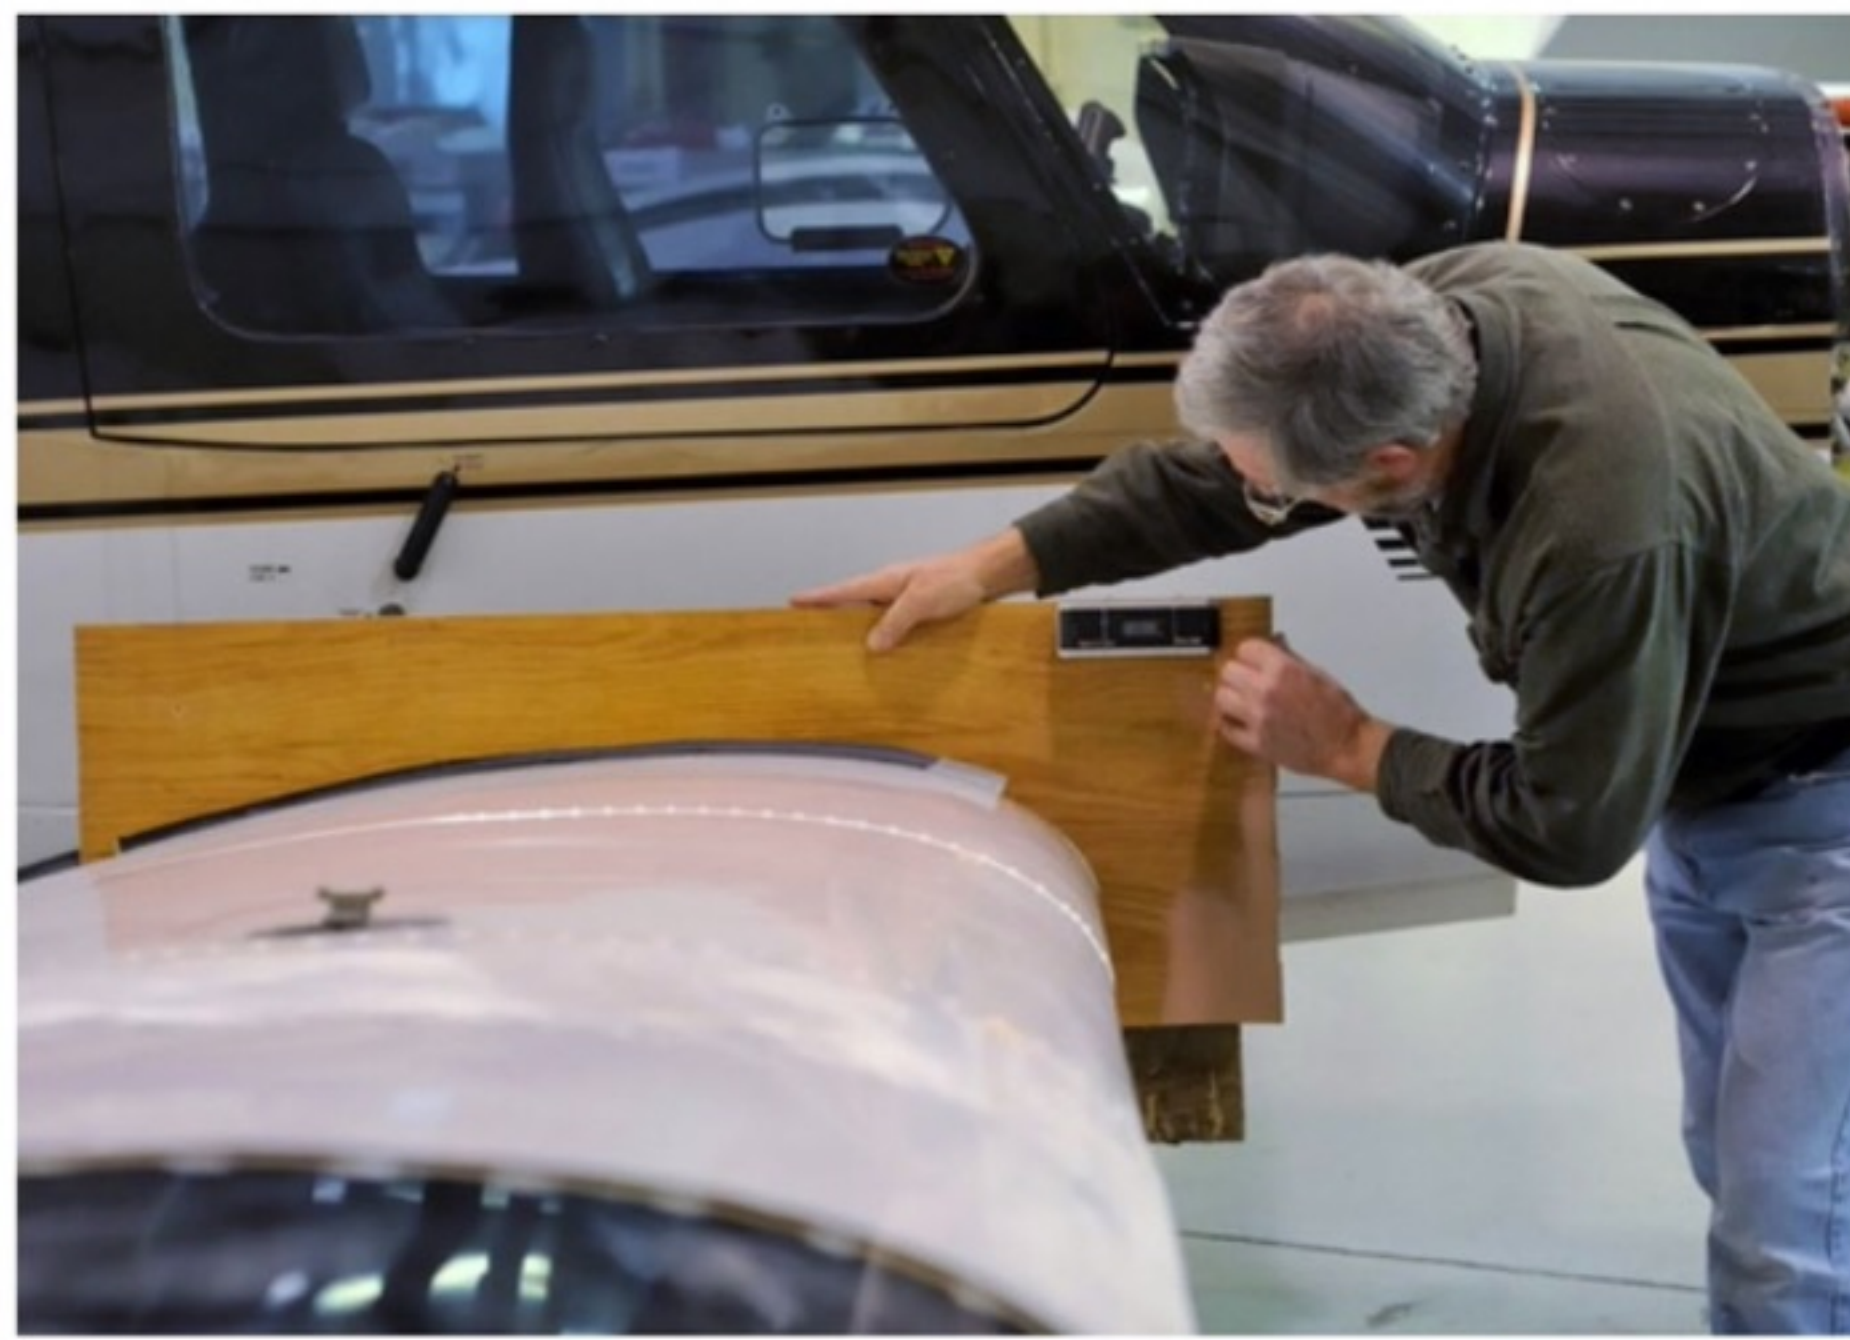
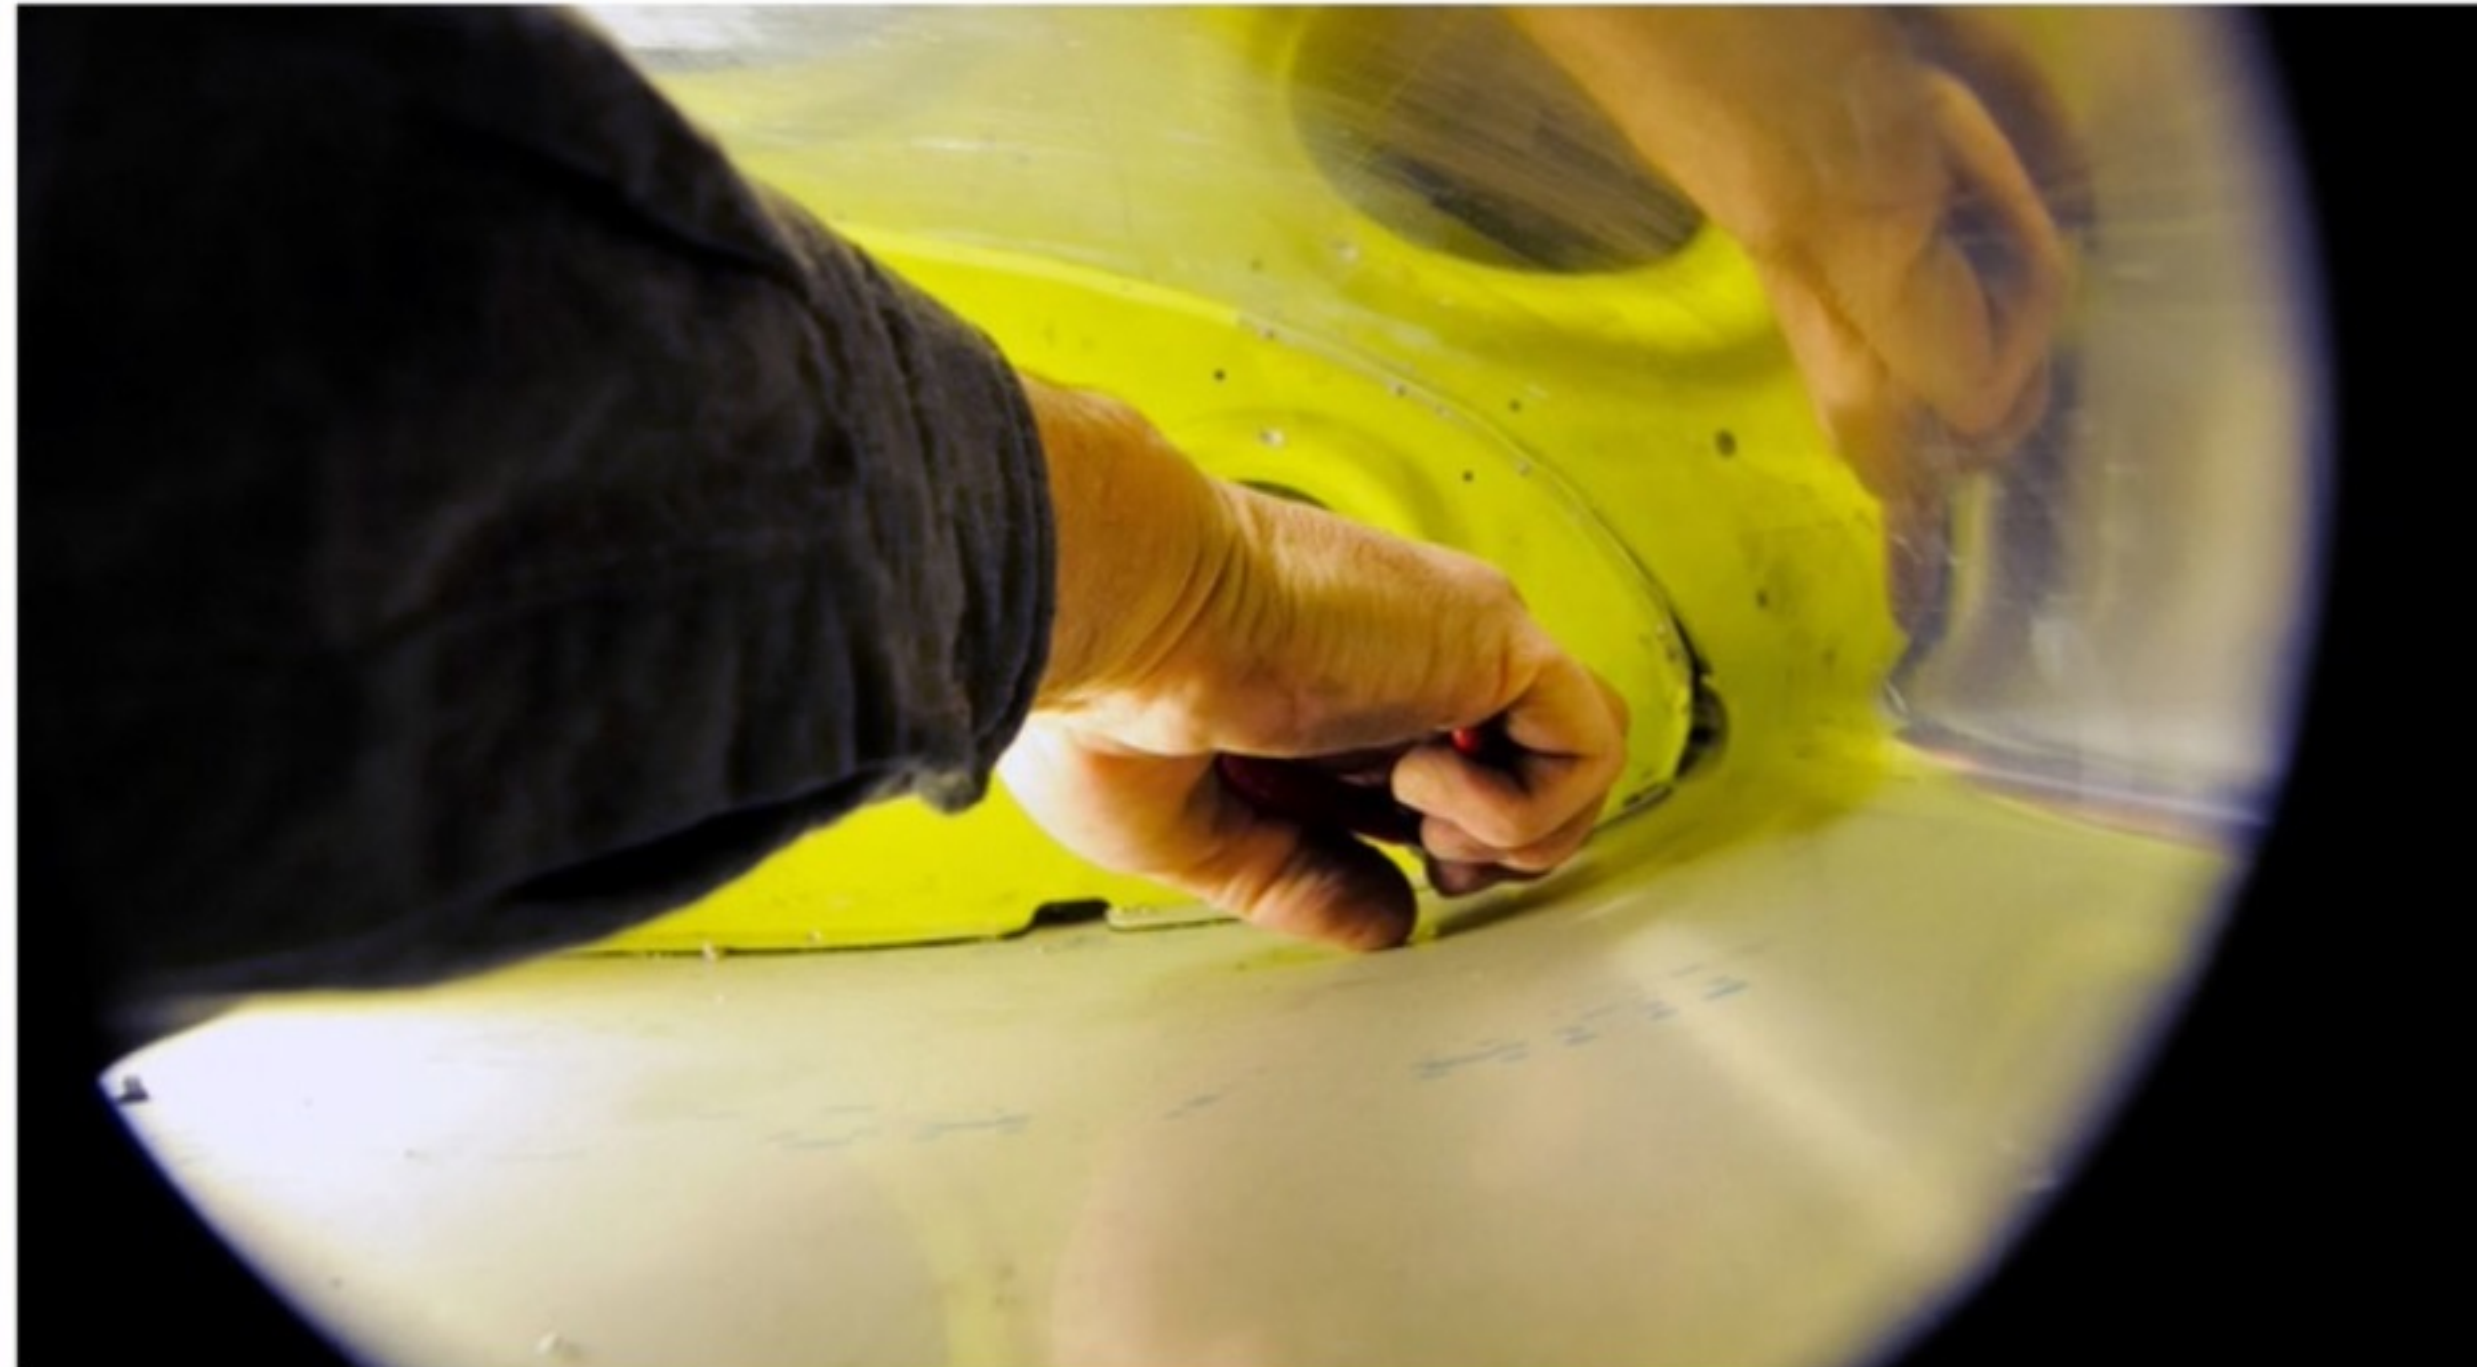
A&P MECHANIC TOM YOUNG drills through rivets to remove them as he prepares to take the right wing skins off a Socata TB-21 Trinidad (below). The wing had been repaired improperly after an accident. Young drills out rivets along the Trinidad’s spar (right).
