Complicated wing rebuild tests a mechanic's skills

REPAIR OF A LIFETIME

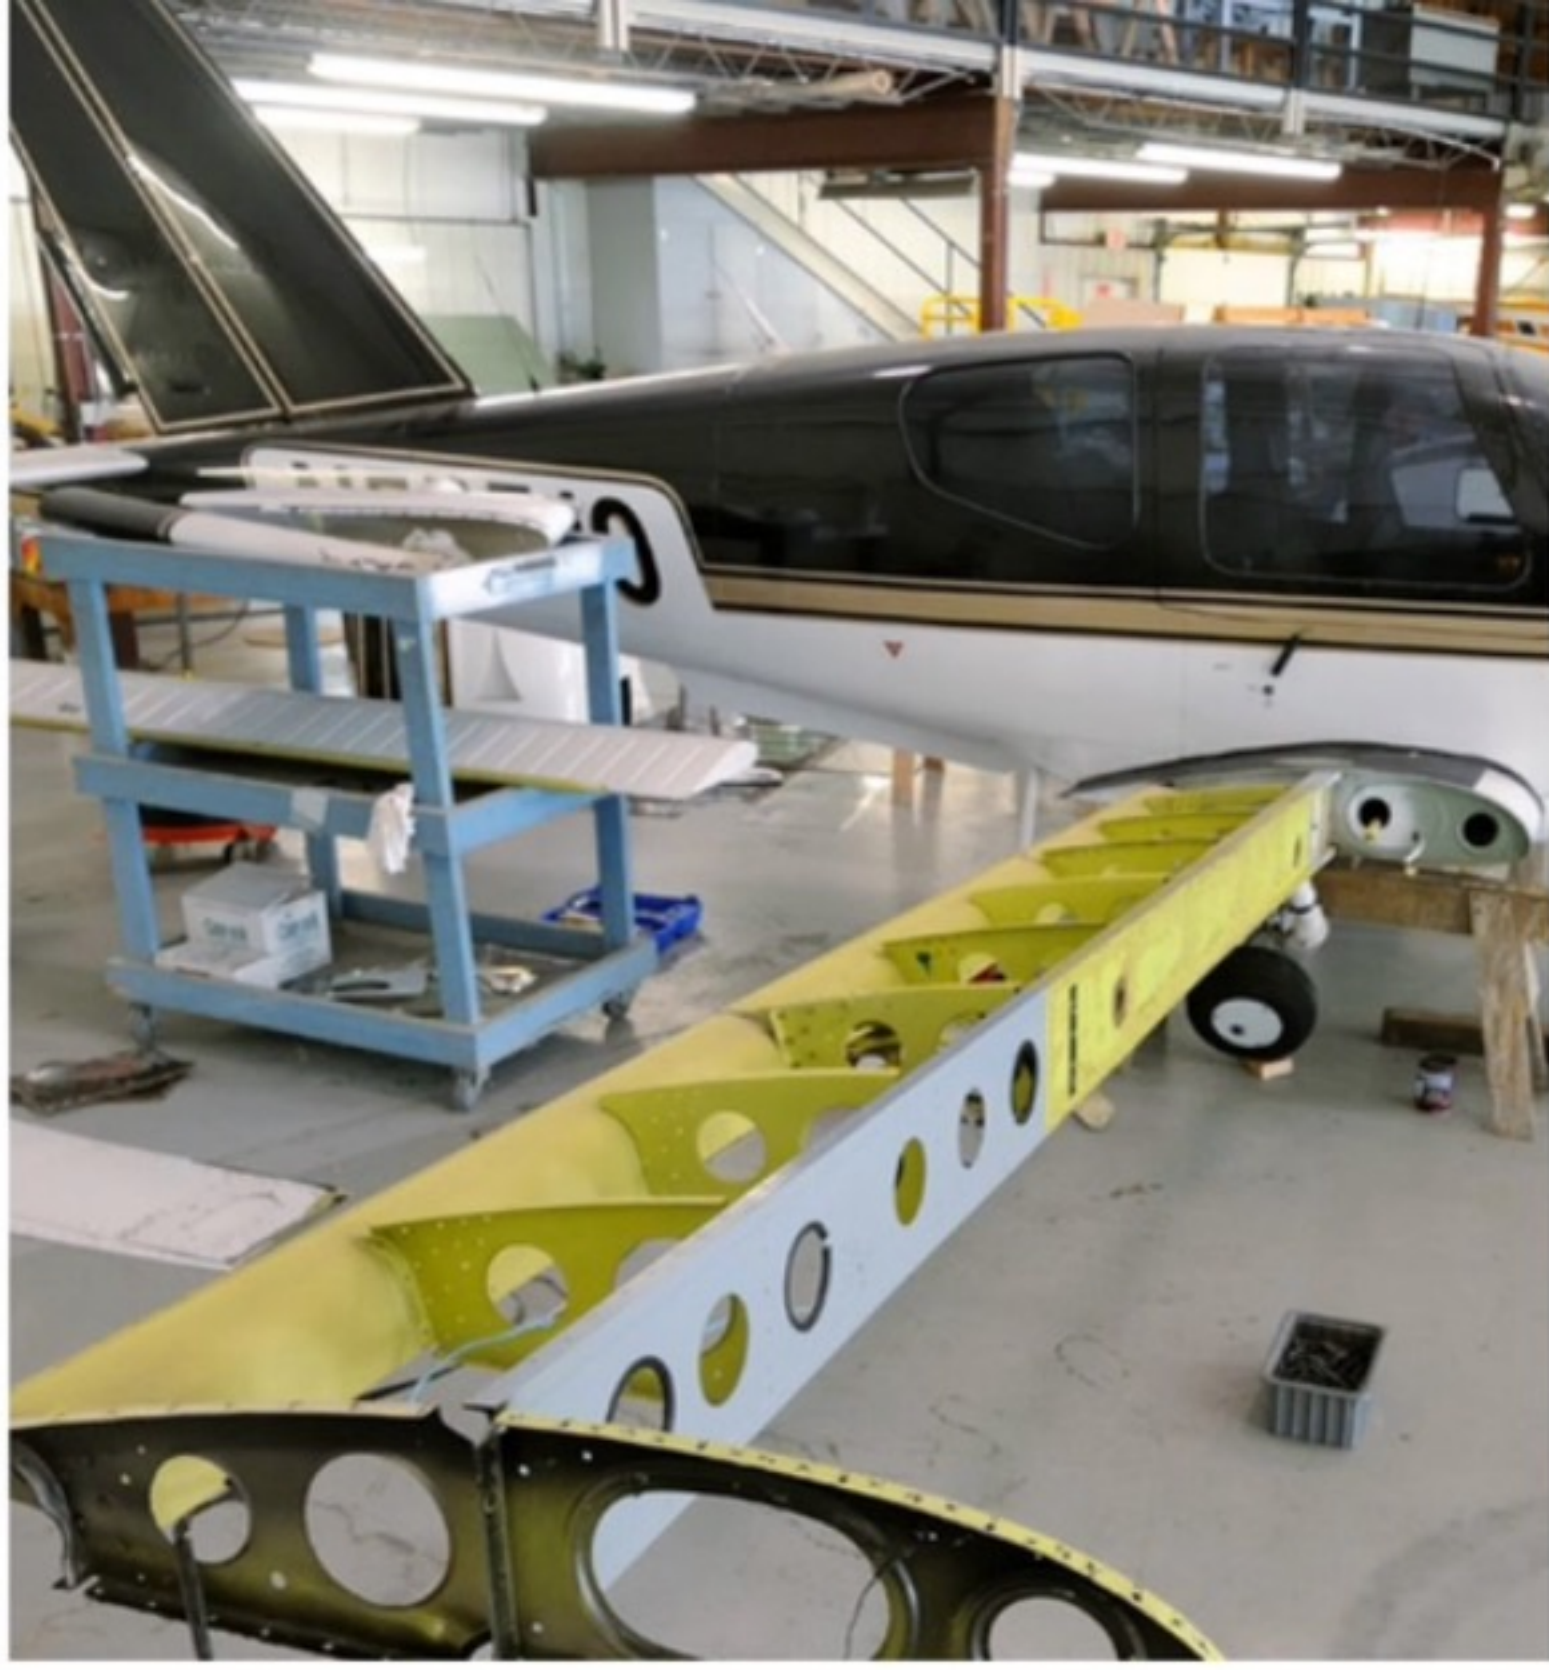
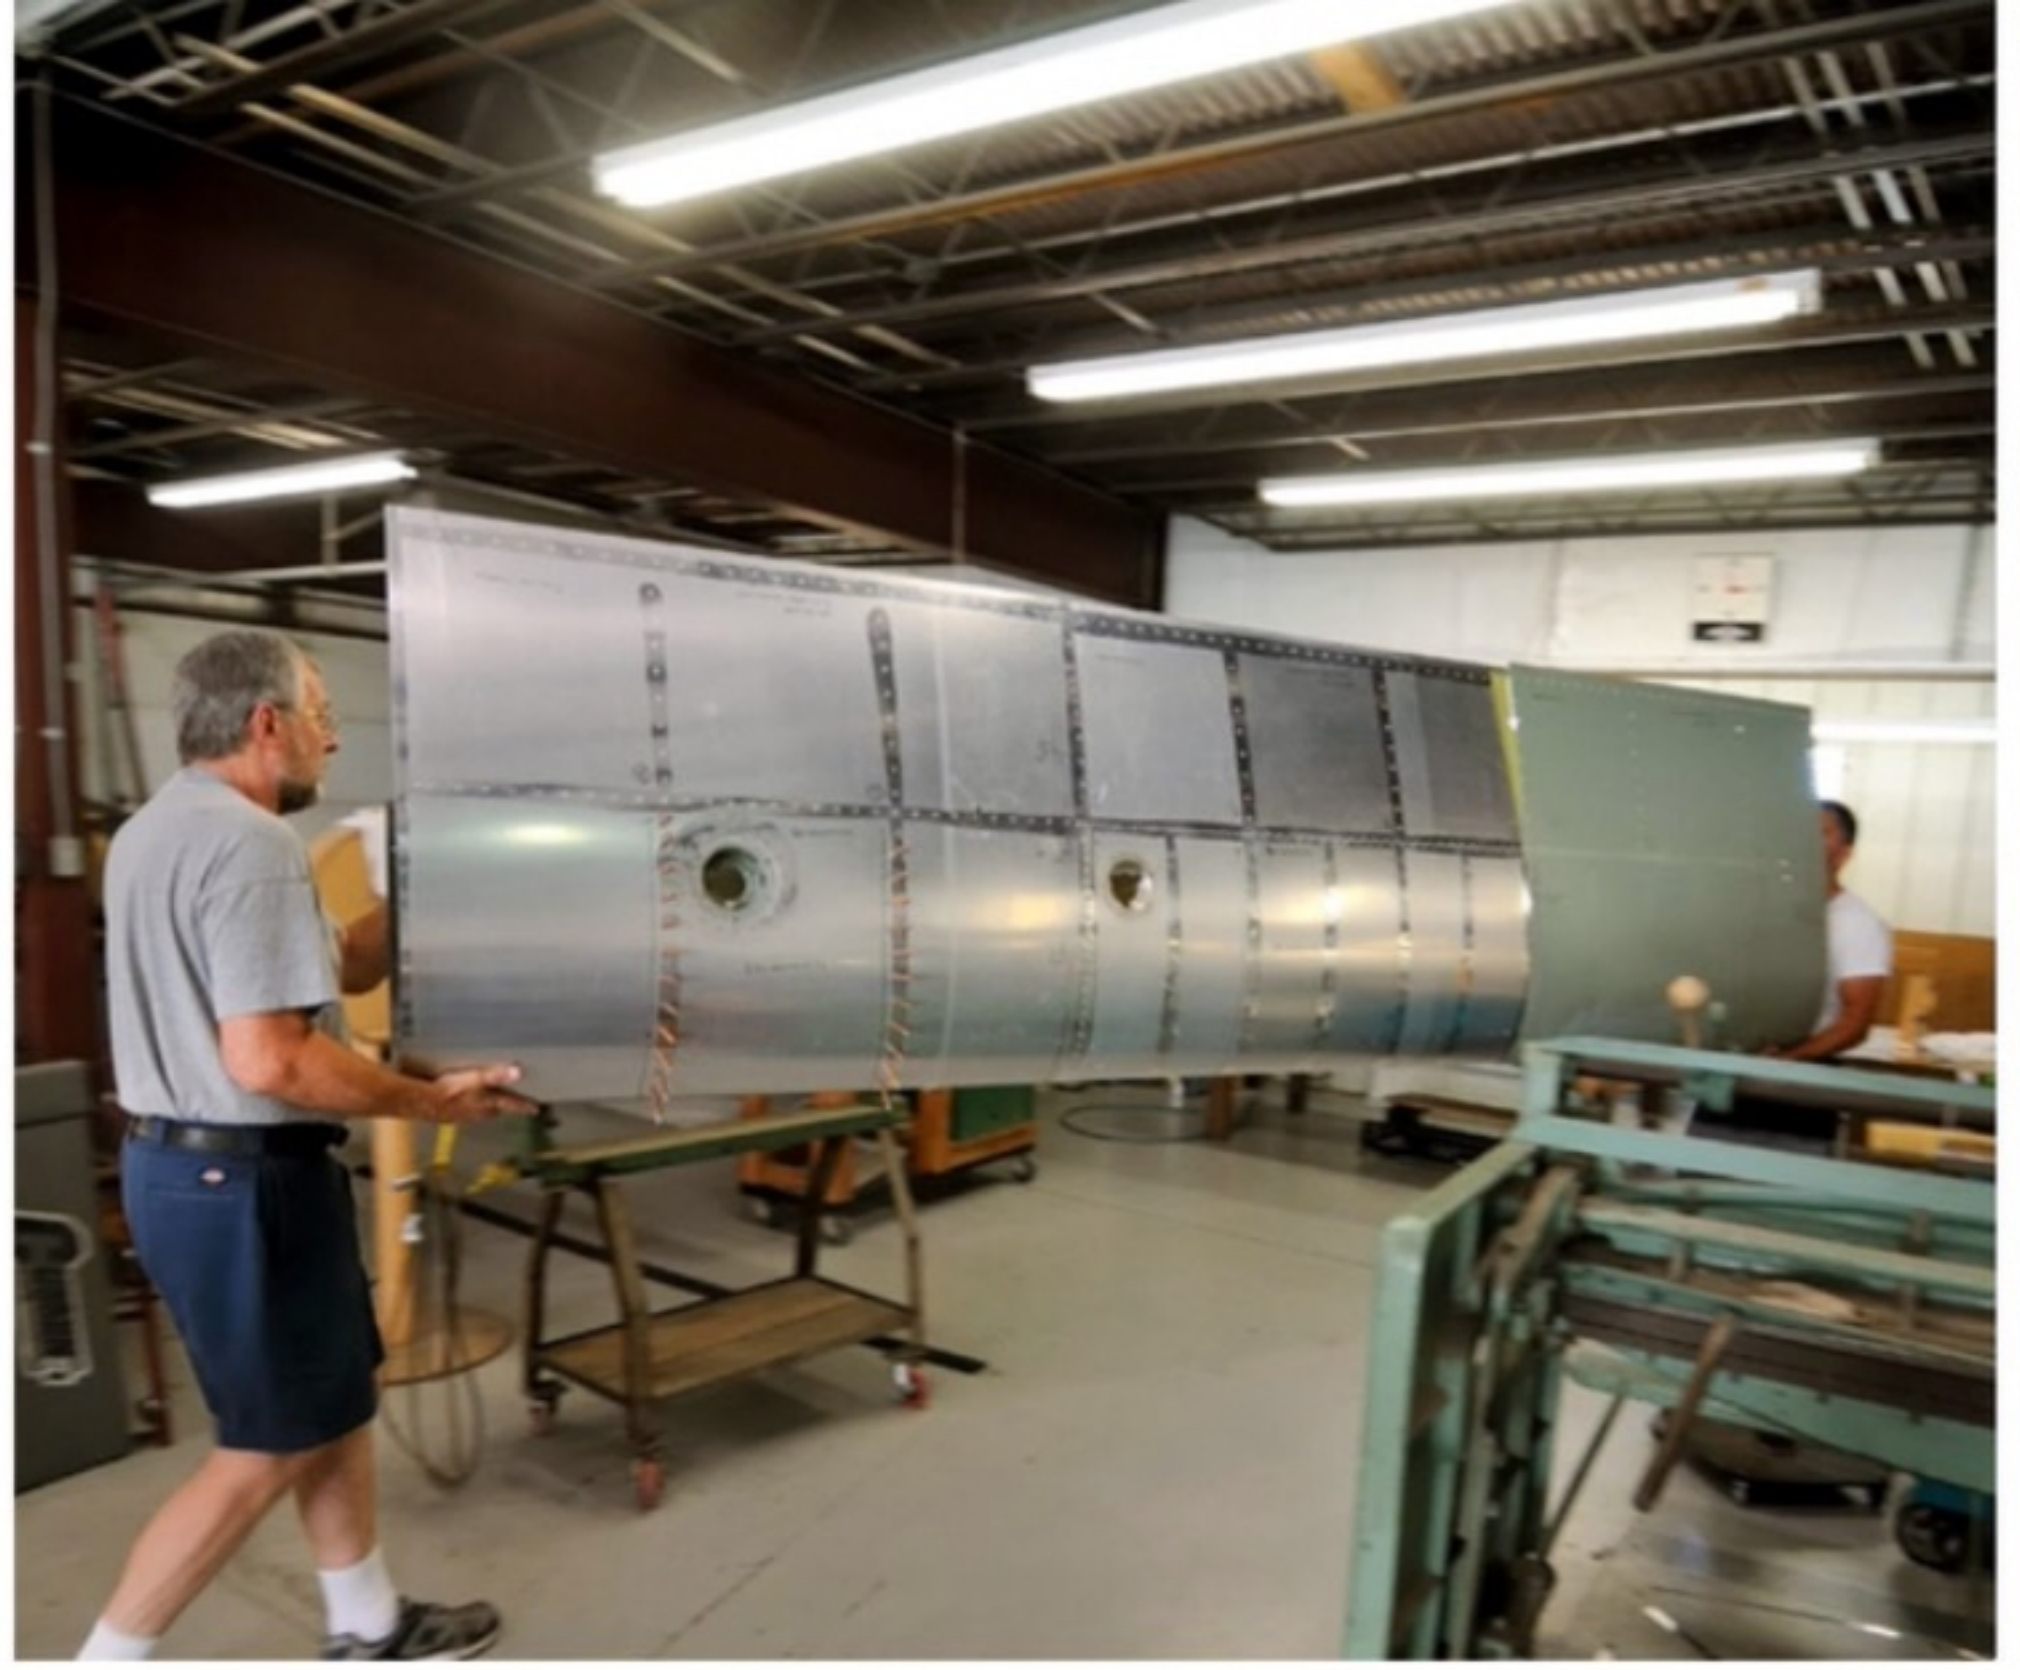
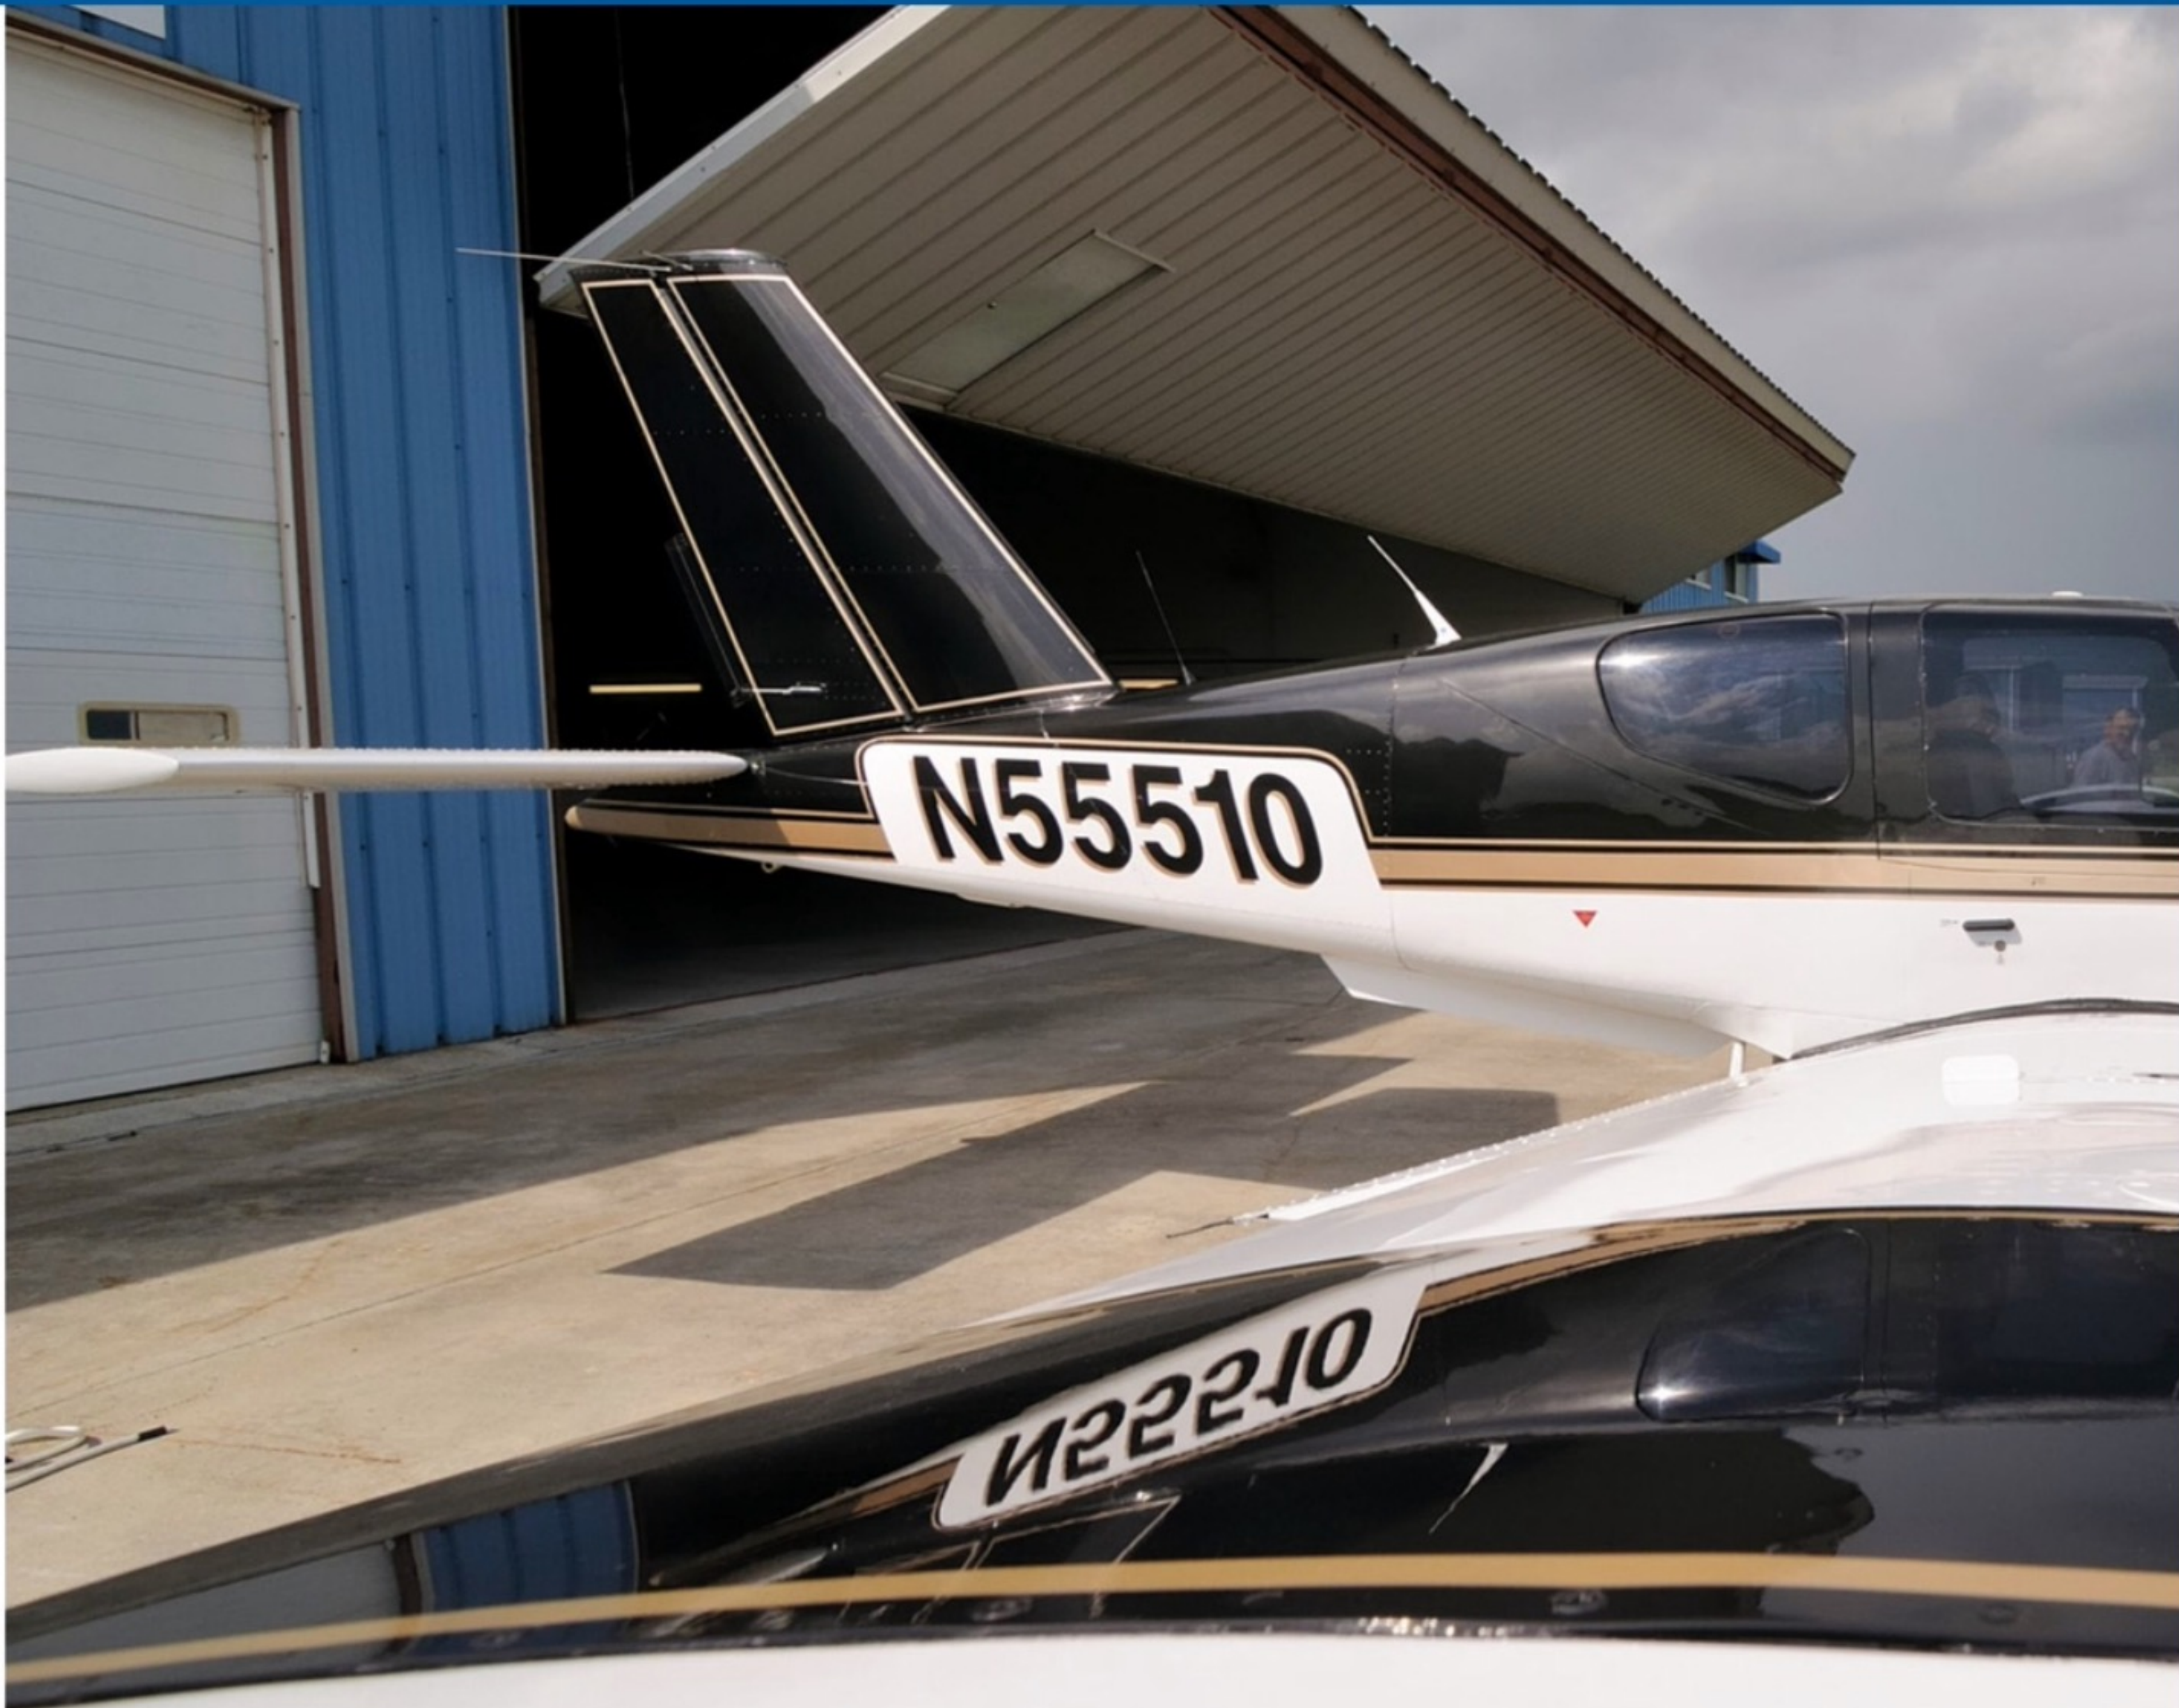
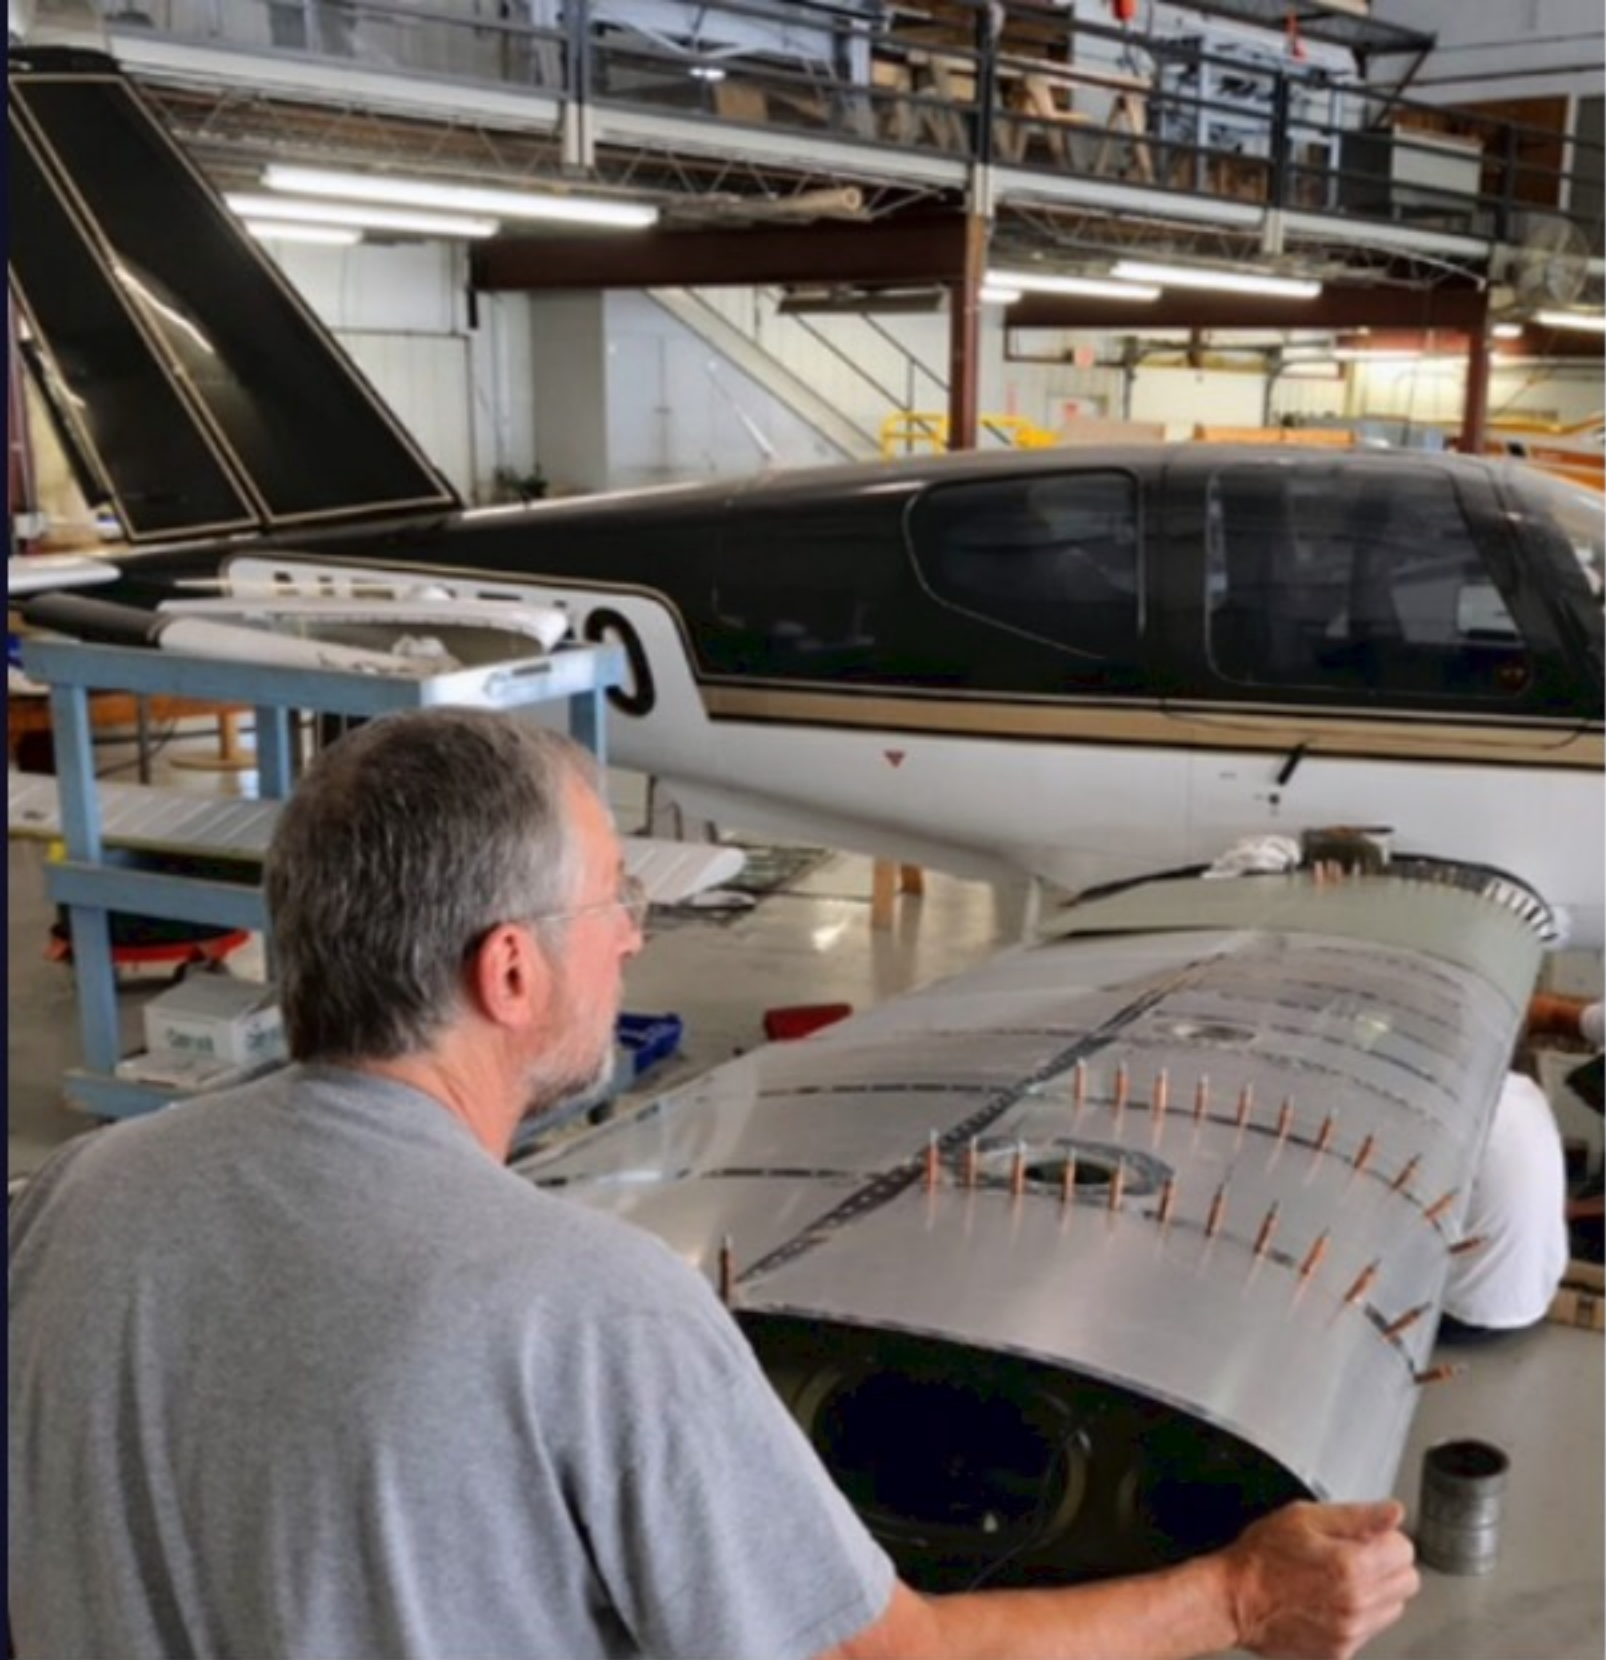
RONNIE COLE, A SHEET metal technician, helps Young position skins on the wing; the jig holds them snug against the ribs (below). A forest of Cleco fasteners holds the new skins on the wing (top right). Michael Kissel, maintenance shop manager, bucks rivets as Young drives them (bottom right).

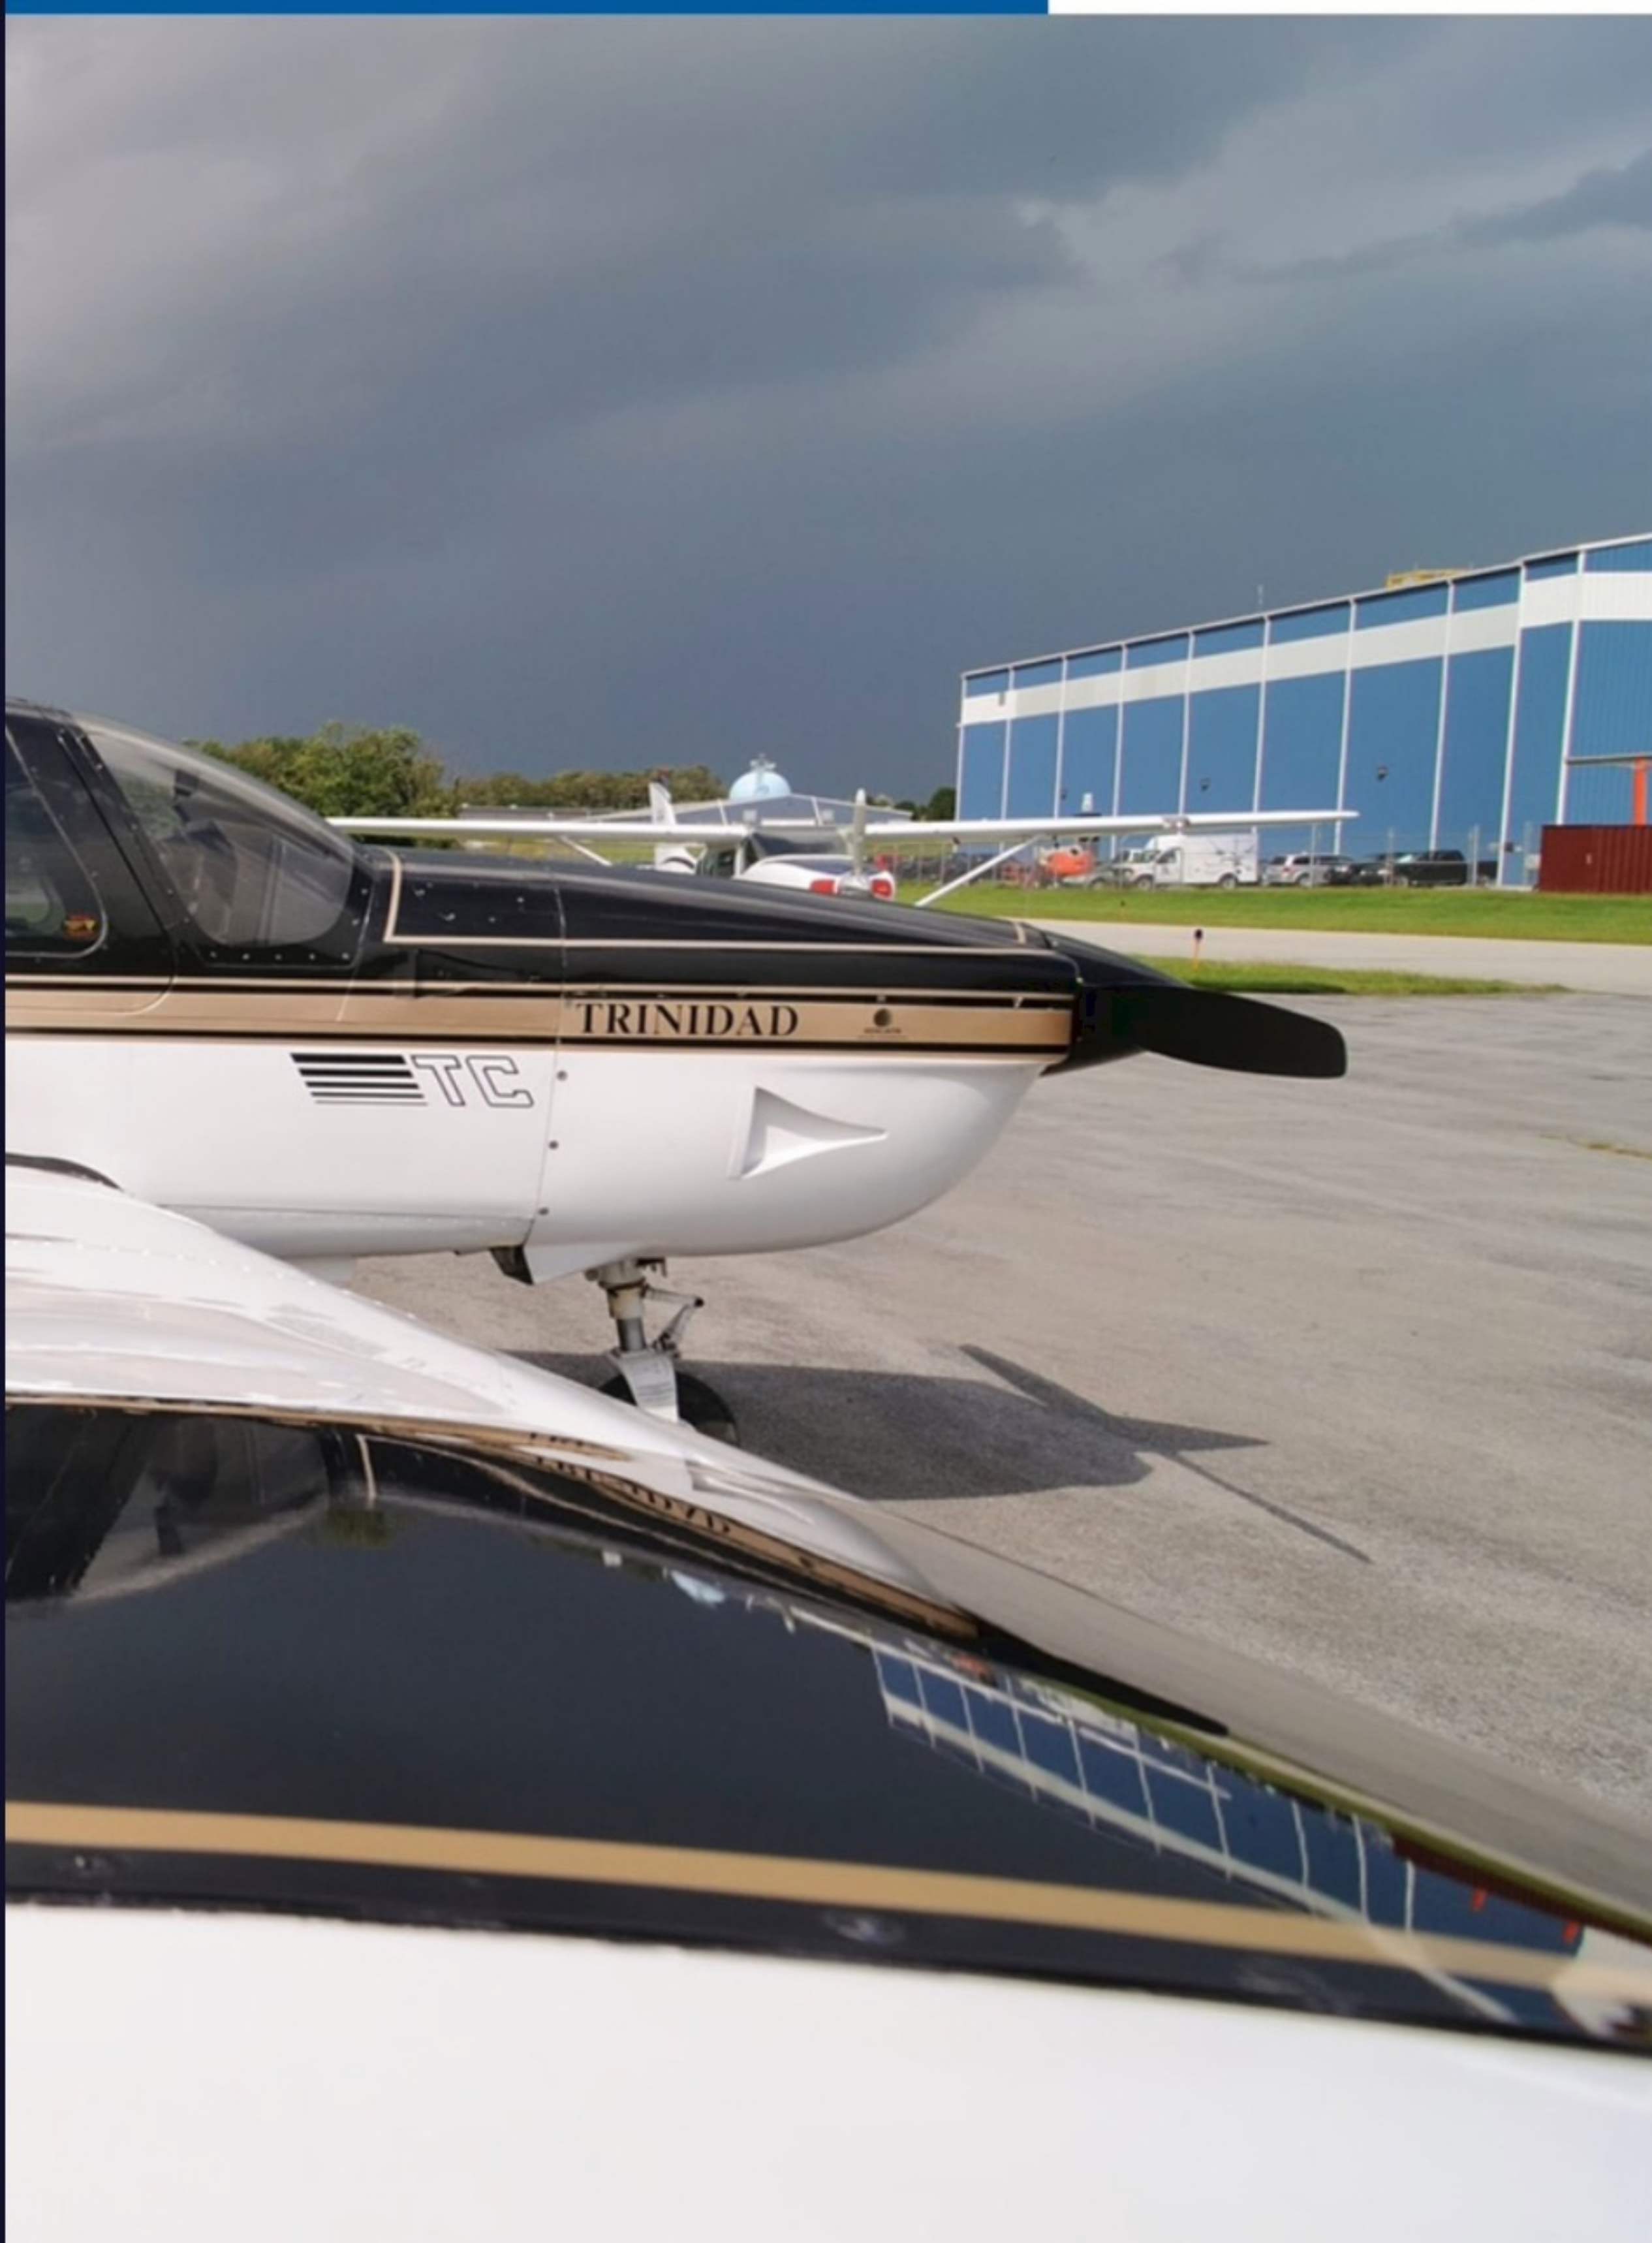
THE TRINIDAD’S WING awaits an assembly of ribs and new skins—which is carried from a workbench and fitted into position (left, from left to right). The finished wing basks in sun and new paint, after months in the hangar (below left).
