SERVICE BULLETIN

TB AIRCRAFT

SB 10-152

SUBJECT : HORIZONTAL STABILIZER INTERNAL STRUCTURE

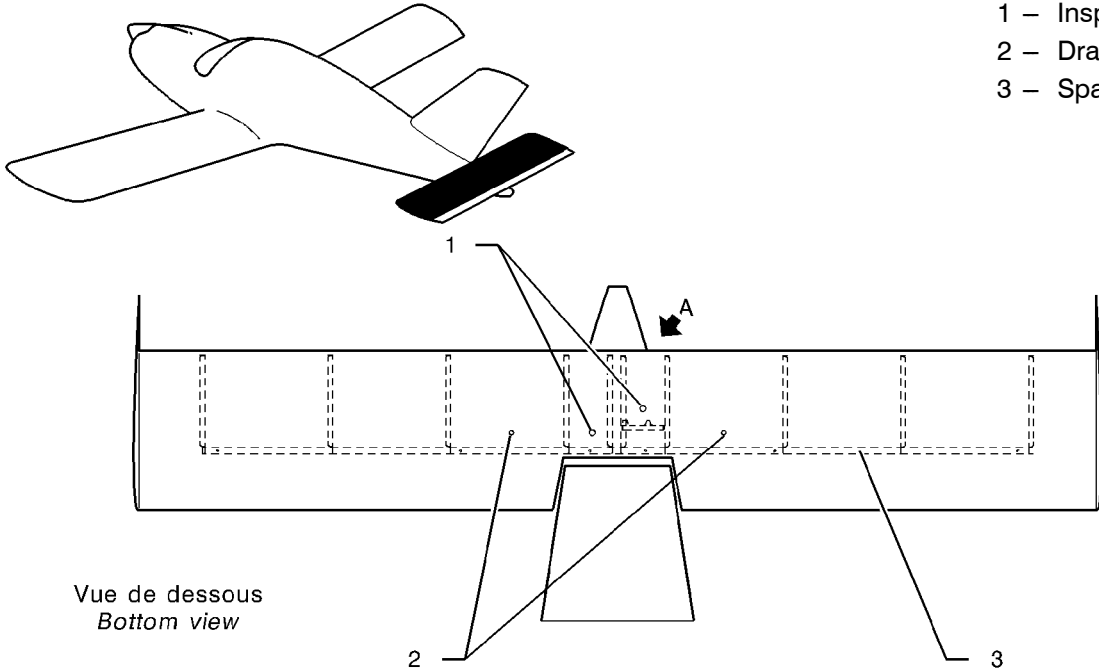
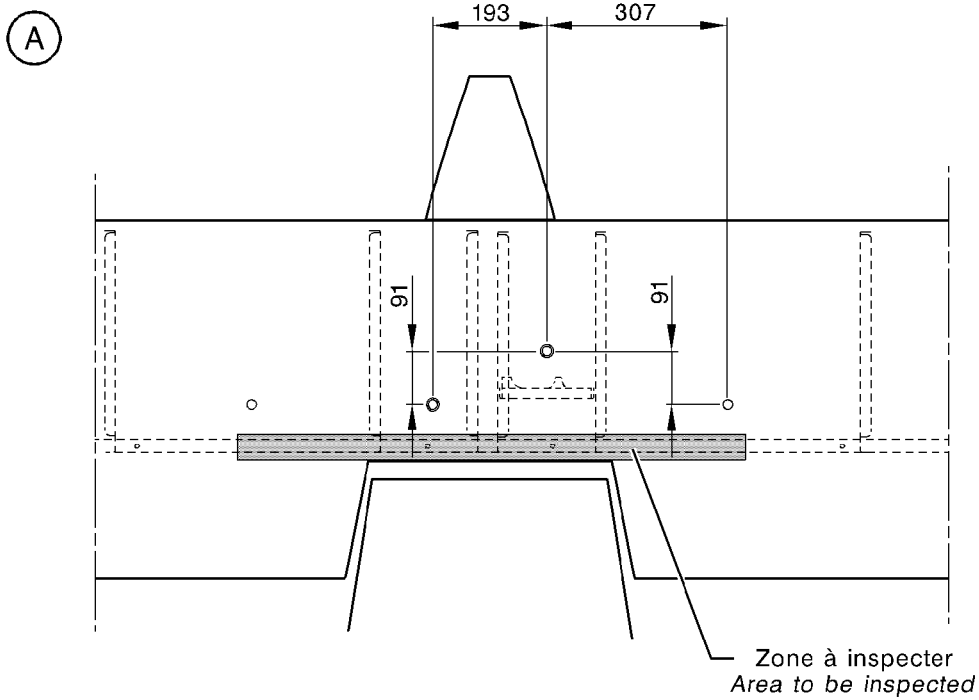
Figure 1 – Inspection of horizontal stabilizer internal structure

Field reports of corrosion on horizontal stabilizer spar.

Humidity accumulation on aircraft subject to severe environmental conditions.

- 1 – Inspection holes
- 2 – Drainage holes
- 3 – Spar

- 1) On the bottom surface, drill the 2 inspection holes (1) to dia. 1/8" (3.2 mm)
- 2) Bore to a diameter suitable with the endoscope dimensions, the 2 inspection holes (1) and the 2 drainage holes (2) using a counterbore with its associated guide pin 0.62 in. max (16 mm max). Deburr.
- 3) Vacuum chips and clean area with a clean cloth moistened with M.E.K.
- 4) Protect bare metal with Alodine 1200 or wash-primer, primer and finish paint.

- 1) Insert the endoscope through the 4 holes to check corrosion on the spar.
- 2) If the inspection does not reveal corroded area, spray Wadis 24 on the spar to protect it.
- 3) If the inspection reveals a corroded area, contact DAHER SOCATA.

- 4) Plug the 2 inspection holes with grommets.
- 5) Make sure all the tools and materials are removed and the work area is clean and free from debris.
