THE LAST FLIGHT OF 5376 XRAY

It was one of those rare clear, blue-sky days in Oregon. We had been operating in the Pacific Northwest for a week on business and the weather had cooperated fully, giving us day after day of perfect weather to enjoy this magnificent part of America. It was time to leave for Minneapolis and home. The aircraft was a Cessna 421B- N5376X.

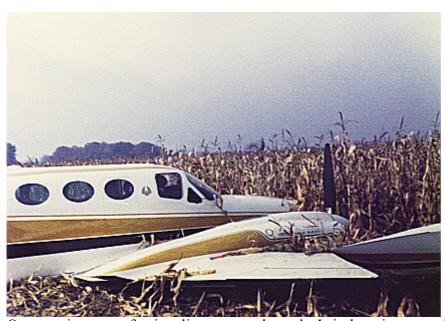
What's this? A hill? A lousy hill in my landing zone? Thank God I have some airspeed left for elevator authority. The stall warning start screaming. With no engines running it seems incredibly loud. We strike the hill just below the crest and rip off the landing gear, becoming airborne again for fifty feet. We come down again. Hard. With the landing gear ripped off, I am sitting about three feet above the ground.

The aircraft slides across the field into a stand of corn. Won't this ride ever stop? It's loud. The corn is beating on the nose, the wings, the windshield. On we go. Finally, after picking and shelling God knows how much of the crop, we come to a stop.

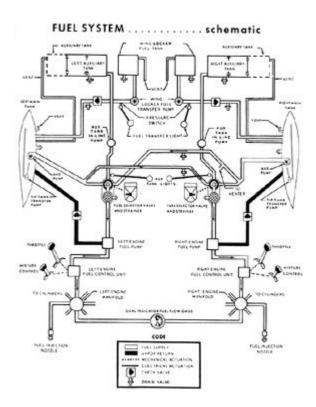
We performed tests with another 421B at Minneapolis. At any setting, other than full power, if the pumps were engaged with functioning engine pumps, the engines would flood out and die. Interestingly, if the fuel selectors were placed in the "cross feed mode" (where both engines are supplied by the same fuel tank), activating the electric pump would kill <u>both</u> engines.

This was one very powerful pump.
