THE TECHNICIANS NOTEBOOK

By Jerry Gordon

The Technician's Notebook Table of Contents

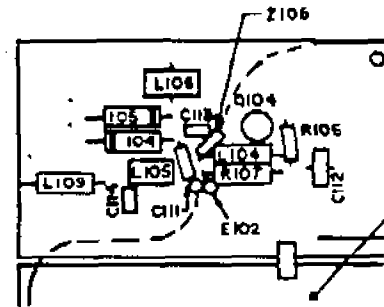
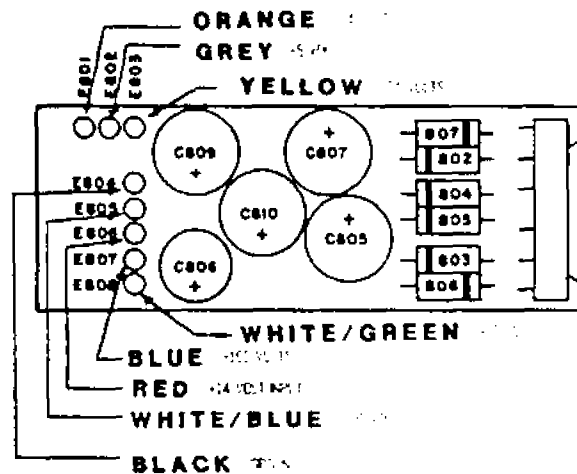
DME-890 One

Transmitter problems: Resolder areas of transmitter board around Q-101 and Q-103 and the variable caps. If you have distortion on the transmitter waveform, check for noise on the 14 volt line and replace the filter cap if necessary. (C-807)

Display problems: Some digits are lit brighter than others. Replace C-323. If you see some legends flashing dimly, trying to light, check for fuzz on the + 100 volt and -100 volt lines. If you have noise there replace C-805 and C-810.
