MOTORSERVICE
RHEINMETALL AUTOMOTIVE

Piston damage – recognising and rectifying

SERVICE
TIPS & INFOS

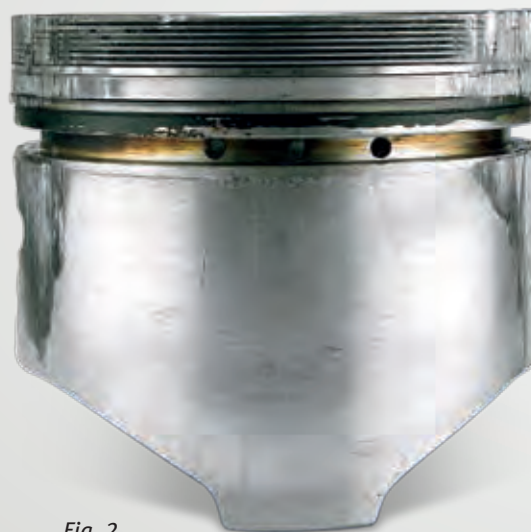
Fig. 2

- Seizure marks on both the pressure and anti-thrust sides, offset at approximately 45° to the piston pin axis.
- The seizures areas change from bright wear marks to relatively smooth, darkly discoloured areas of wear caused by rubbing (Fig. 1).
- Piston pin displays blue tempering colour (Fig. 3). Reason: piston pin bed has become hot due to insufficient clearance or a lack of oil.

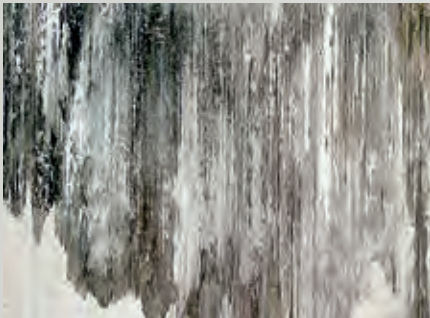
Seamless areas of narrow seizure marks, mainly on the piston skirt, showing a severely worn and darkly discoloured surface.

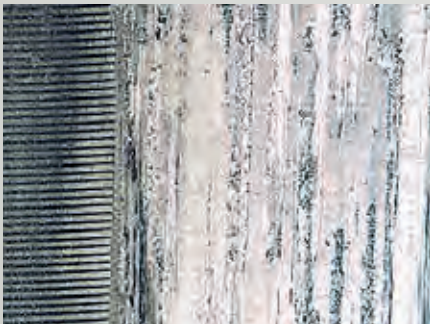
Identical to those described above, apart from the discolouration of the surface. The surface of the seizure areas has an almost pure metallic finish, with no dark discolouration. As the lack of oil affects the entire surface of the cylinder, there are often seizure marks on both the pressure side and the anti-thrust side in the piston, in many cases even in the early stages.

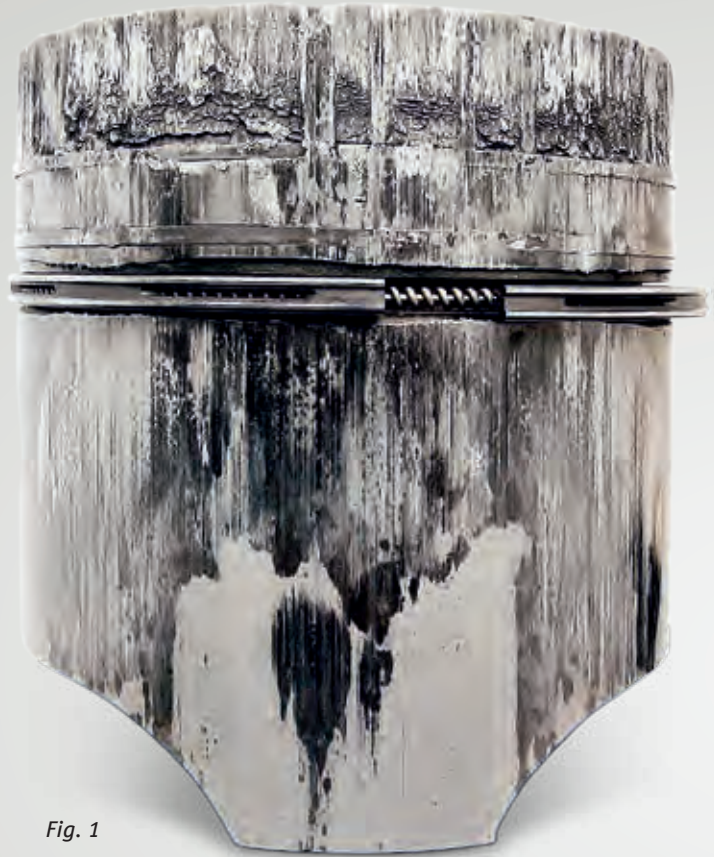
Fig. 1

In the case of seizures due to overheating, the oil film breaks down as a result of excessively high temperatures. Initially this causes mixed friction with individual friction marks. The material at the friction marks then heats up further and the piston loses all lubrication. The seizure areas have a dark discolouration and are badly broken up. Depending on the cause of the damage, the seizure due to overheating starts at either the piston skirt or the piston head.

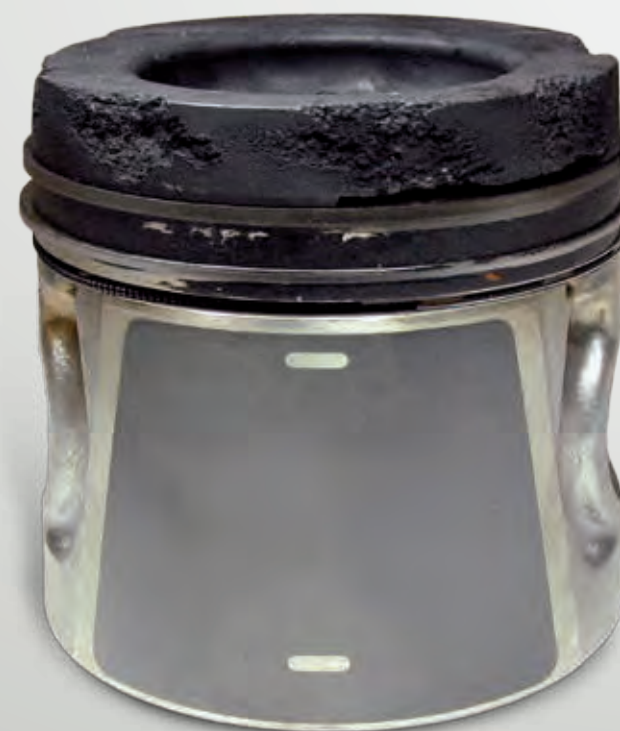
Fig. 2

- Erosive-type removal of material due to melting on the piston crown or the piston top land in the injection direction of the nozzle jets.
- No seizure marks on the piston skirt or the piston ring zone.

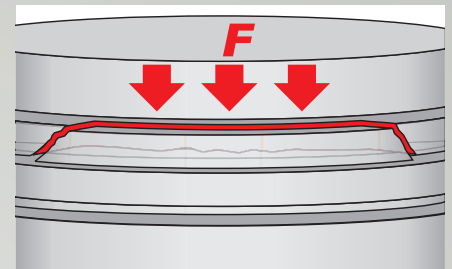
Fig. 3 shows the course of a fracture that occurs with knocking combustion and hydraulic locks: the force causing the fracture and acting from above on the ring land causes the fracture surfaces to extend downwards.

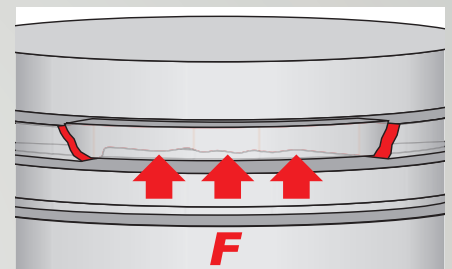
Fig. 4

The ring lands fracture in the reverse direction as the pressure comes from below in this case (Fig. 4).

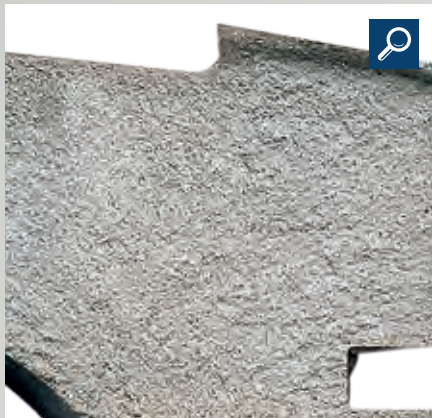
Fig. 1

A forced fracture (Fig. 1) is always caused by a foreign body that collides with the piston while the engine is running. These foreign bodies could be parts of the connecting rod, crankshaft or valves, etc. that have been torn off. A forced fracture of the piston can also occur if water or fuel gets into the cylinder.

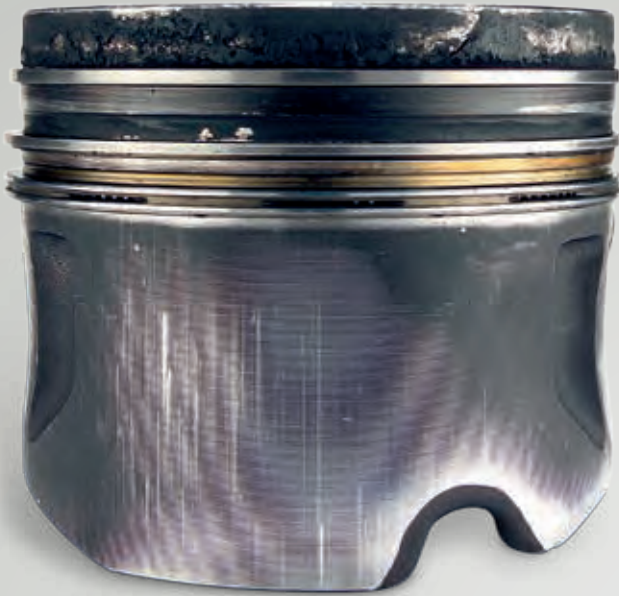
Fig. 4

- Asymmetrical piston wear pattern (Fig. 4).
- Piston pin boss and piston pin broken (Fig. 5 and 6).
- Pin bore hammered out in the area of the circlips.

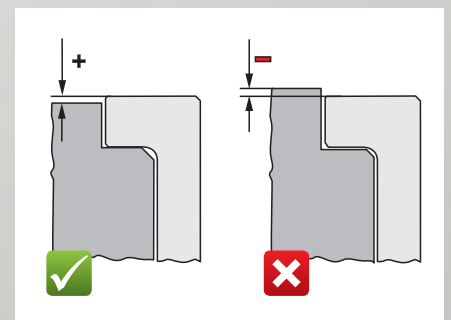
Fig. 6

- Prescribed liner protrusion not complied with (Fig. 6):
 - If the protrusion of the cylinder liner is too great, then the liner flange is pressed off when the cylinder head bolts are tightened.

When reworking the liner flange seating surface during engine reconditioning, the necessary protrusion of the cylinder liner over the cylinder surface must be ensured, either by inserting steel washers underneath or by using a cylinder liner with an oversized flange* (recommended).

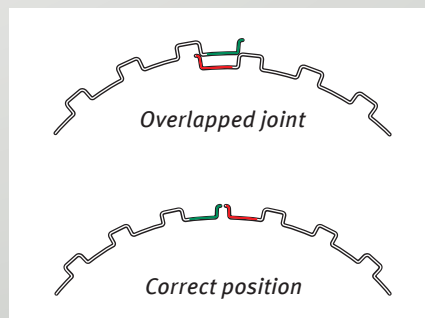
Fig. 2

- Incorrect oil control rings.
- Installation faults.

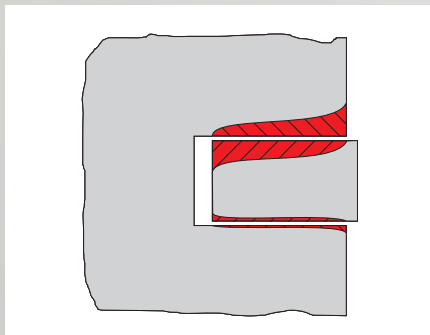
Fig. 2

- Piston: matt, ground wear pattern on the skirt with fine, small longitudinal scratches on the piston top land and the piston skirt.
- Tool marks created during machining worn away.
- Worn compression ring edges, on the first piston ring in particular as well as ring groove edges (Fig. 2).
- Axial clearance of the compression rings substantially increased, in particular on the first piston ring.

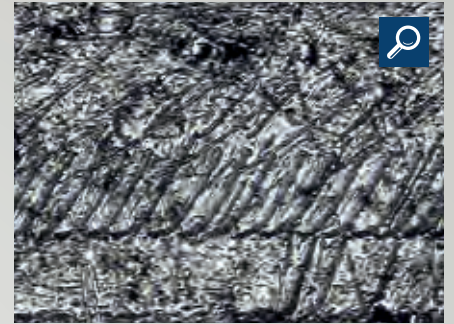
Fig. 4

Abrasive foreign bodies in the oil circuit cause scratches on the piston and piston rings, a matt wear pattern on the piston skirt and roll marks on the ring flanks (Fig. 4 and 5). As the piston rings are worn on the running surfaces and edges, they can no longer seal the cylinder against oil passing into the combustion chamber. At the same time, the pressure in the crankcase increases as a result of combus-

tion gases streaming past the cylinder. This may cause oil to escape at radial oil seals, valve stem seals and other sealing points. Roll marks on the piston rings are caused by dirt particles that become lodged in the ring groove. As the piston ring rotates in the groove it keeps running over the dirt particles, which creates the characteristic roll marks.

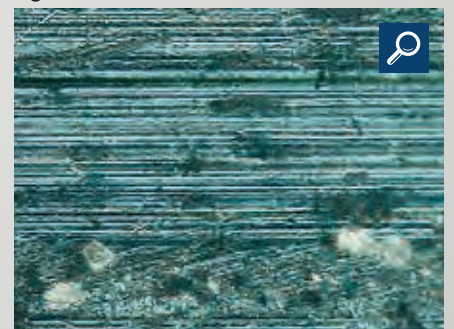
- Leaking points in the intake system, such as distorted flanges, missing gaskets or defective or porous hoses.
- Residual particles of dirt from engine reconditioning. Parts of the engine are often blasted with sand or glass beads during reconditioning work in order to remove persistent deposits or combustion residue from the surfaces. If the blasting material becomes deposited in the material and is not cleaned out properly, it may work its way loose when the engine is running, thus causing abrasive wear. Fig. 6 and 7 show microscopic images of damage caused by dirt, under polarised light. Fragments of the glass blasting material and entire beads of the glass can clearly be seen.

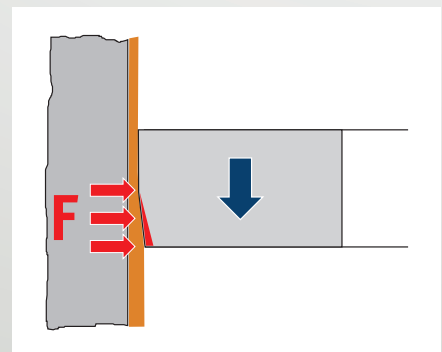
Fig. 2

The worn piston ring edges lead to high hydrodynamic forces (Fig. 2) between the running surfaces of the piston rings and the cylinder running surface as a result of the formation of an oil wedge. The piston rings float on the oil film during

the upward/downward motion of the piston and are lifted off slightly from the cylinder running surface. In this way, an increased quantity of lubricating oil reaches the combustion chamber where it is burned.

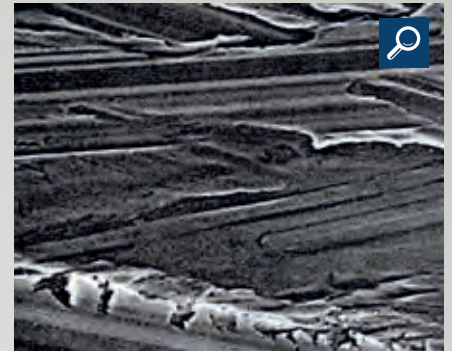
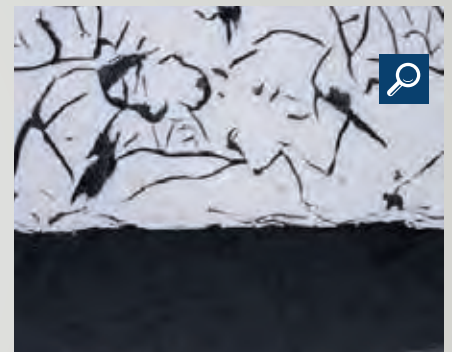
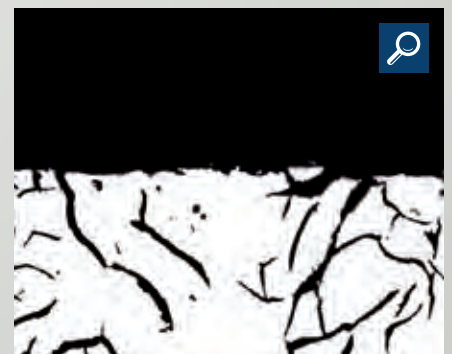
The burring is caused if the piston rings are refitted in less than ideal conditions after the engine reconditioning. The main reasons are insufficient or inappropriate cylinder finishing. If blunt honing stones are used for finish honing or excessive pressure is applied during honing, burrs and elevations form on the cylinder wall. These metal edges are folded over in the direction of machining (Fig. 3). This is referred to as the "peak folding formation" and causes increased friction during the running-in phase, preventing engine oil from becoming deposited in the fine graphite veins.

If these burrs are not removed in a final machining process referred to as plateau honing, this will result in premature wear at the piston ring edges during the running-in phase. The piston rings then take on the undesired duty of wearing away the folded peaks and cleaning the graphite veins. However, this leads to wear on the piston ring edges and the formation of burrs. From experience, burrs created in this way on the piston ring edge can only be run off with great difficulty. The damaged piston rings need to be replaced.

A second set of piston rings installed as replacement rings will encounter much better, virtually normal operating conditions. This is because the first set of piston rings will have removed most of the disadvantageous edge layer on the cylinder running surface (the "peak folding formation") through wear. The oil consumption will return to normal levels after replacing the piston rings. In many cases this is incorrectly attributed to poor-quality materials in the first piston rings that were installed. The microscopic enlargement in Fig. 4 shows the bent-over peaks through a section of the cylinder surface after the disadvantageous honing of the cylinder running surface (peak folding). Fig. 5 shows the surface after plateau honing. The burrs and peaks have been mostly removed, and the graphite veins have been exposed. The piston rings will encounter good conditions for running-in and should therefore provide a long service life. Hone-brushing the surface to create the plateau finish delivers particularly good results.

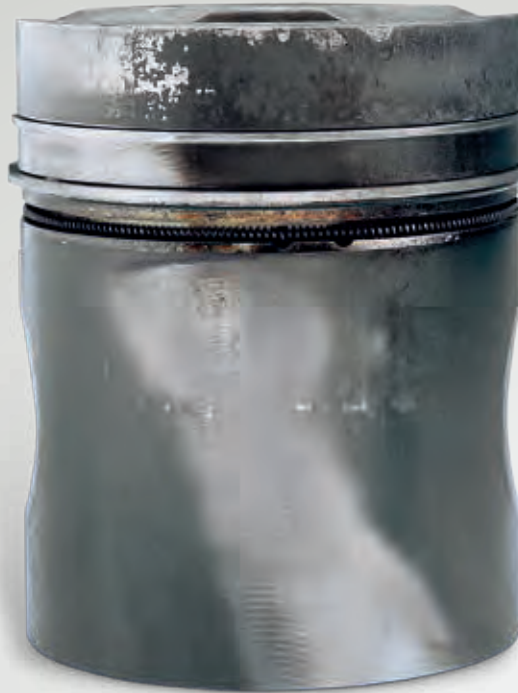
Fig. 1

- Asymmetrical wear pattern on piston over its entire height.
- Top land on left of piston above the piston pin bore and on opposite side at lower edge of piston rubbed bare.
- Uneven wear pattern on compression ring.

This type of asymmetrical wear pattern indicates that the piston has not been running perfectly straight in the cylinder bore and that the piston pin axis and the crankshaft axis are not parallel to each other. The piston rings cannot perform their sealing function properly due to the lack of proper contact with the cylinder. The hot combustion gases blow through

and heat up the piston rings and the cylinder wall excessively. This weakens the oil film, which may result in a seizure due to lack of lubrication. As the piston is running skew in the cylinder, its reciprocating movement creates a pumping effect at the piston rings, which pumps oil into the combustion chamber and thus increases oil consumption. Under certain conditions

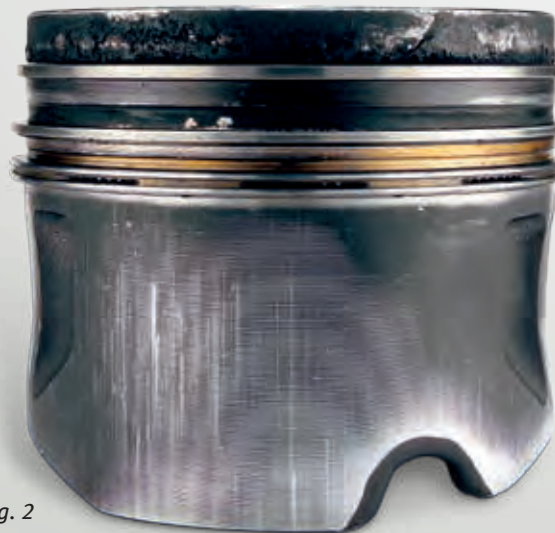
Fig. 2

- Piston running skew, with the wear mainly on the lower, right-hand edge of the piston at the recess for the cooling-oil nozzle and under the piston pin bore.

- Bent or twisted connecting rods.
- Connecting rod eyes bored at an angle.
- Cylinder bore not perpendicular to crankshaft axis.
- Individual cylinders not installed straight (distorted during installation).
- Connecting rod pins not parallel with crankshaft axis.
- Connecting rod eye bored at an angle (axes not parallel).
- Excessive connecting rod bearing clearance, particularly in conjunction with asymmetrical connecting rods (centre offset between connecting rod eye and the large connecting rod bearing).
