Safety Summit

"Maintenance"

Presented to: "14CFR part 141 Pilot Schools"

Orlando District Part 141 Findings

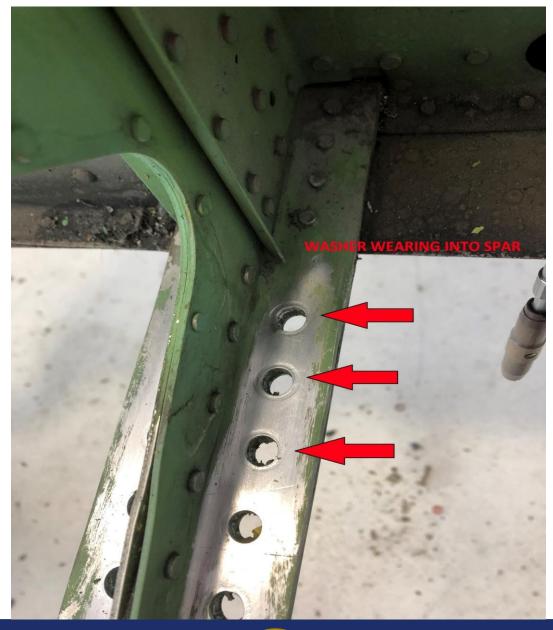
PA-28R-201 "Arrow" TTIS: 8570.2 – Wing movement noted. No wing damage noted in logbook.

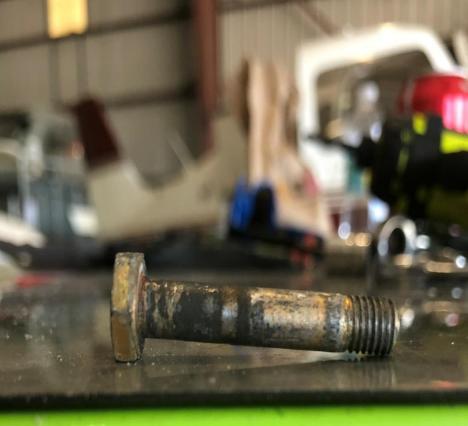
Small crack on forward leading edge top and bottom of bracket.

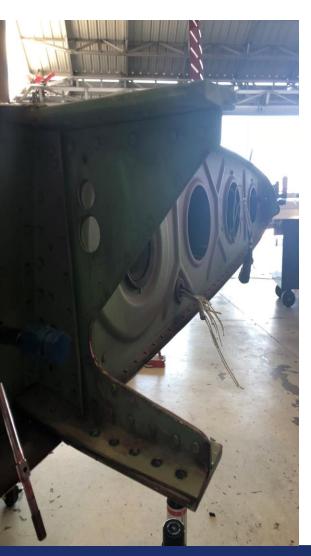
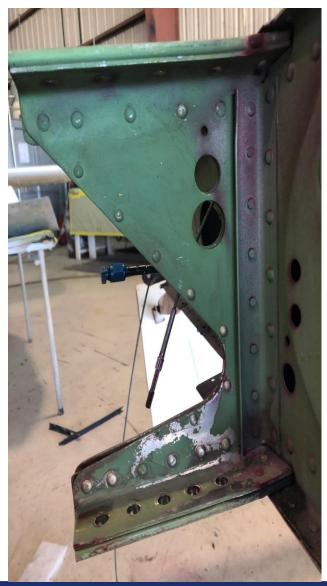
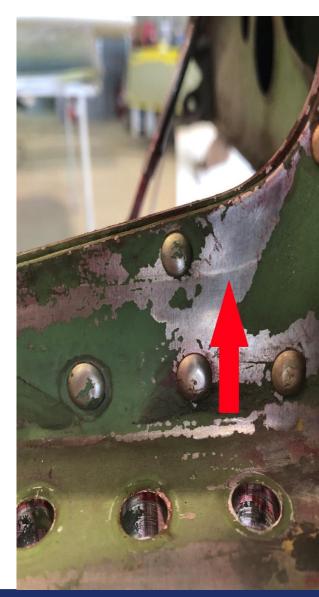
Wrinkle in spar.

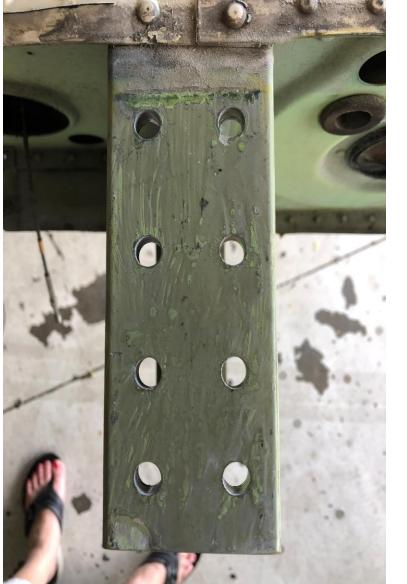
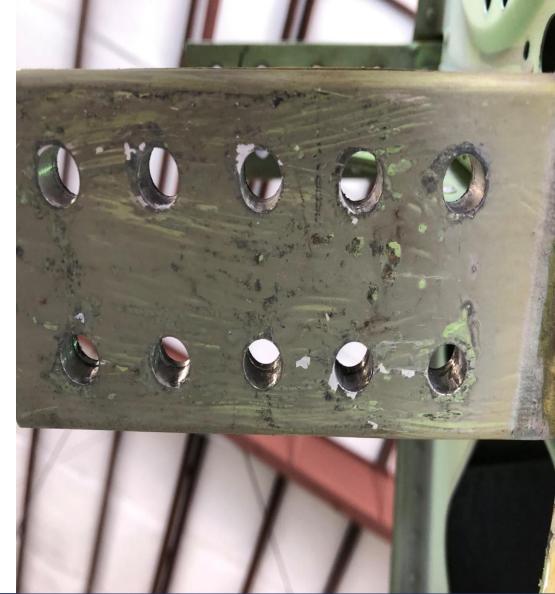
TTIS: 12913.9 – Wing movement noted. No wing damage noted in logbook.

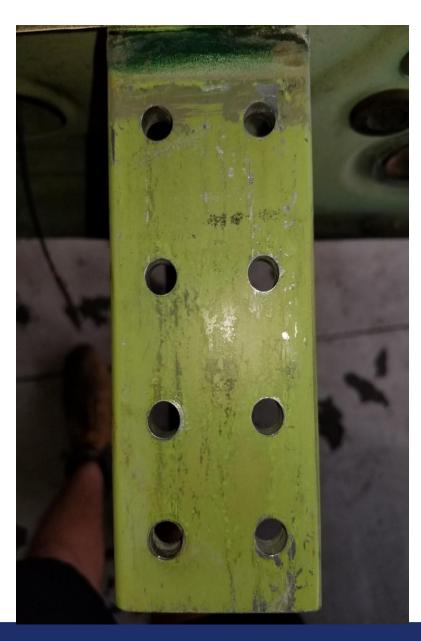
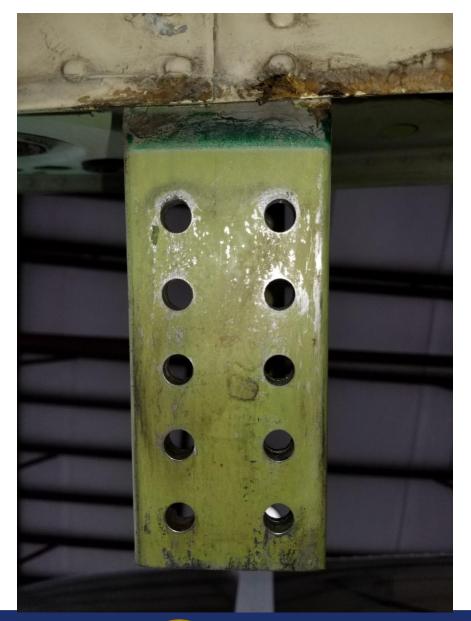
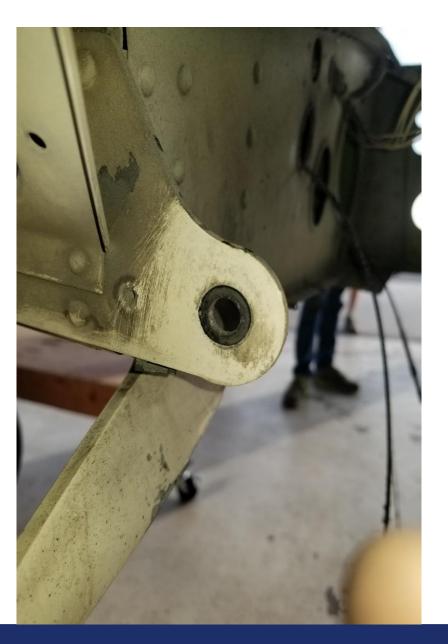
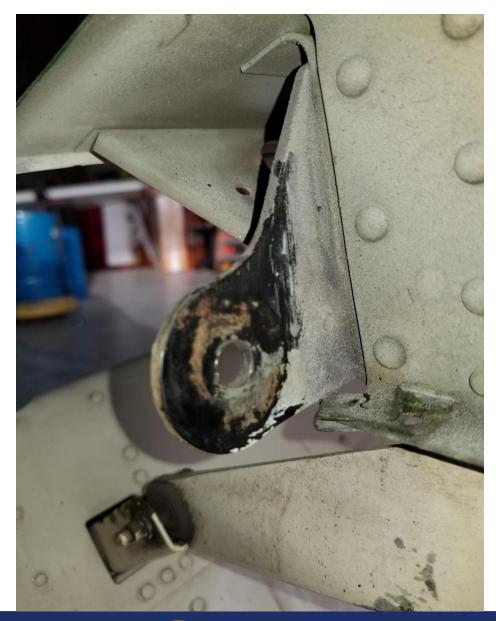
TTIS: 11697.7 – Wing movement noted. No wing damage noted in logbook.

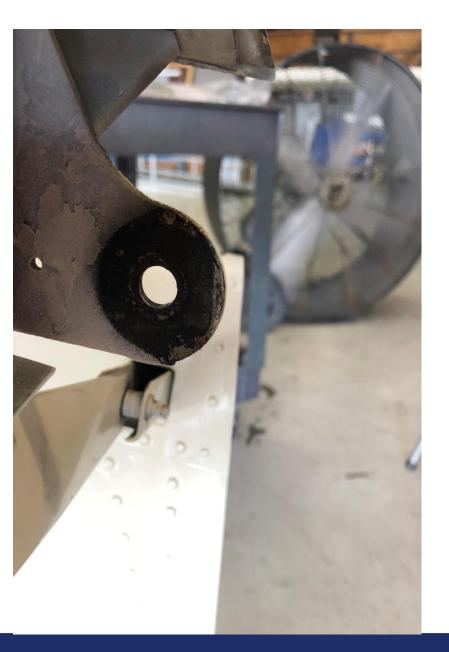
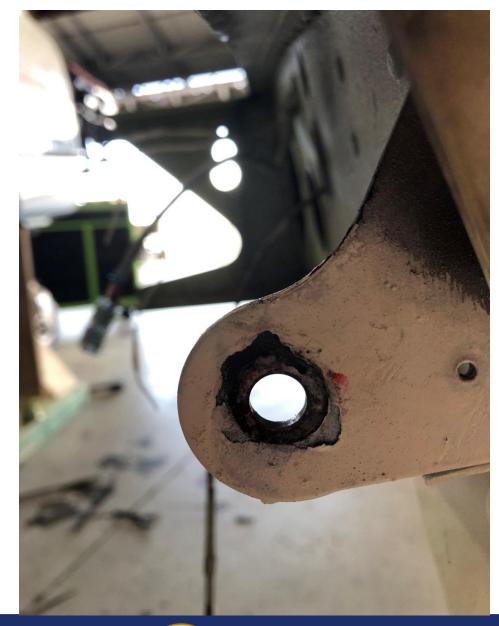
- Wing movement at front attachment point.
- Cracked spar at the bottom of the spar.
- Evidence of corrosion on the bolt holes of the spar. The forward fitting also has corrosion and rust.
- Oblong bolts holes on spar and wing box attach point, including bolt damage.

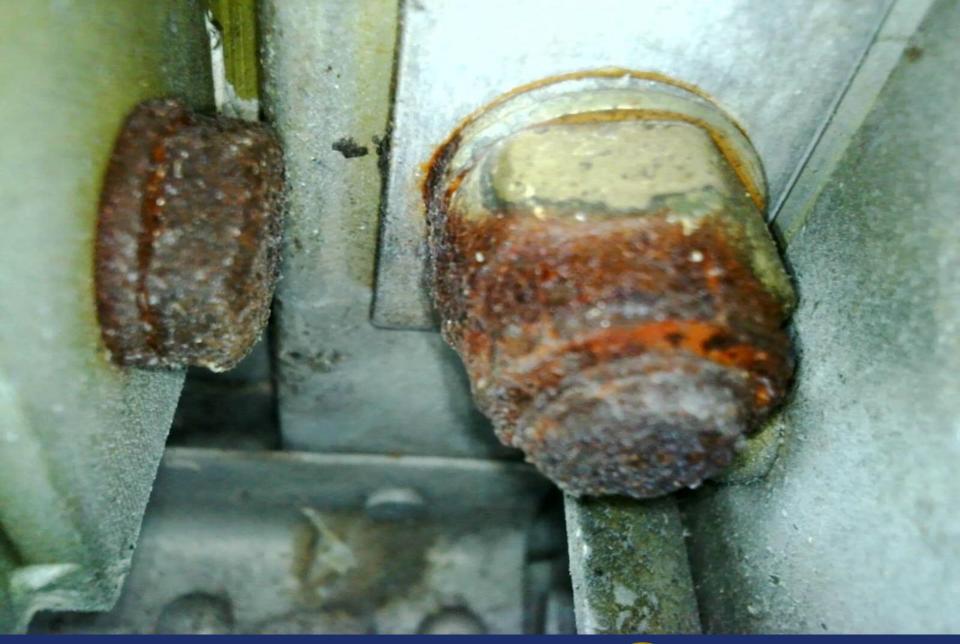
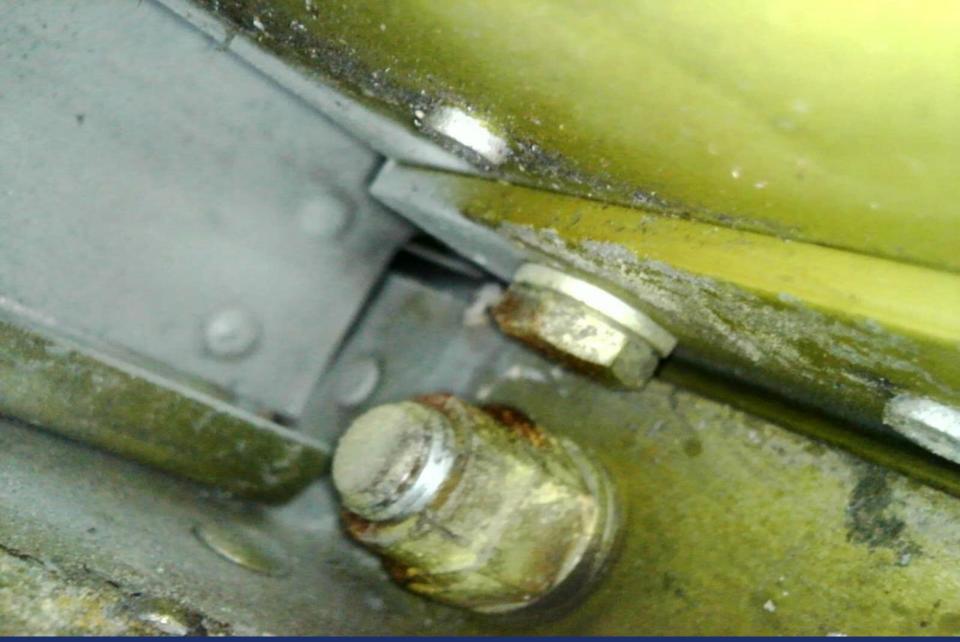
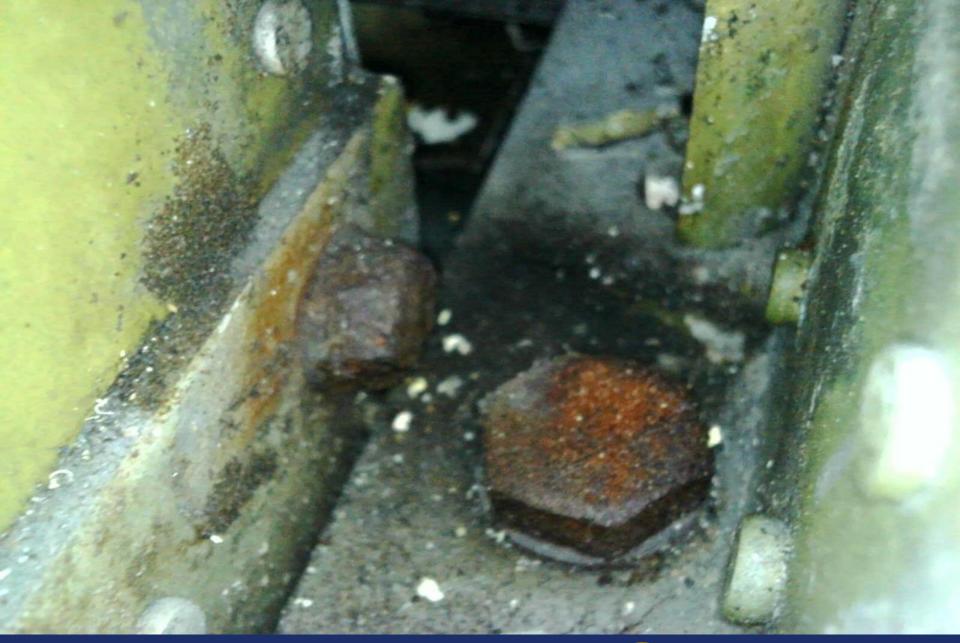
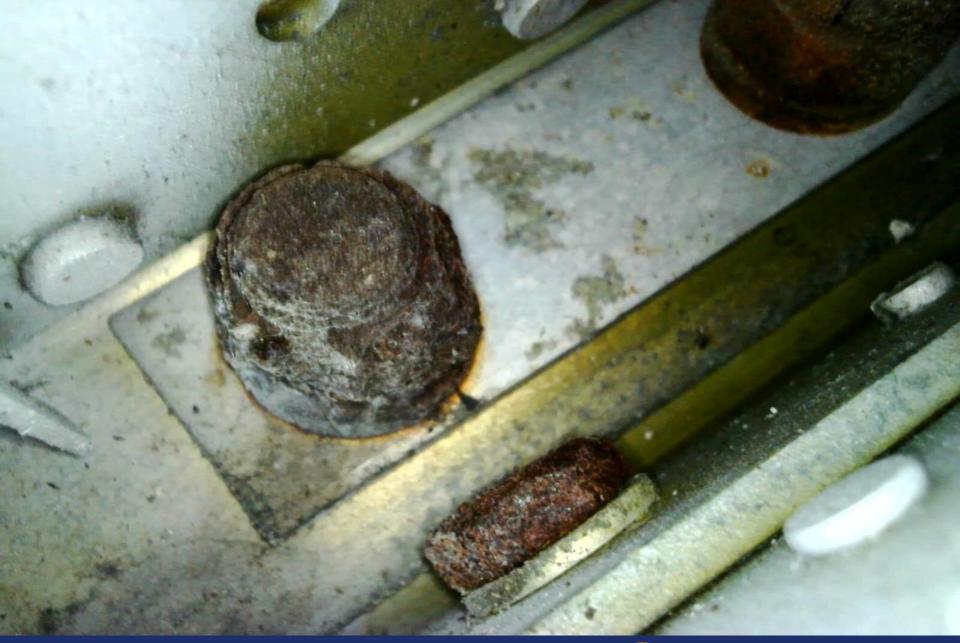
- Piper PA-28-140 (Cherokee)
- Airworthiness Date: 08/19/1967
- Tach: 1175.3 TTAF: 5293.0
- Last annual signed off 03/15/2017
- Currently at the Plant City Airport (PCM)
